Airworthiness Bulletin

AWB 65-001 Issue 1 - 27 September 2022

Helicopter Tail Rotor Drive Couplings

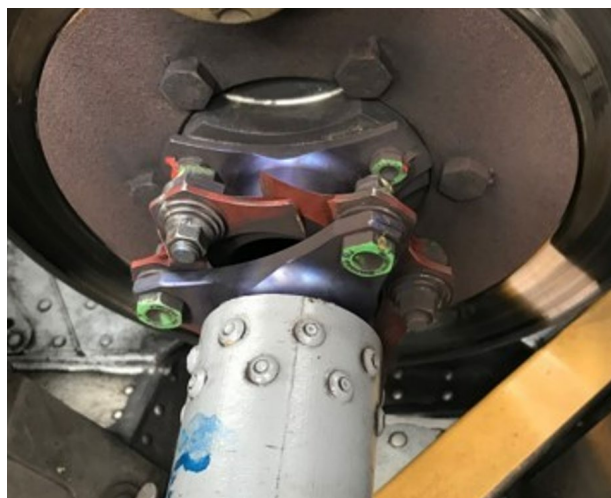
During normal operations a EC135 rotorcraft encountered unusual noise and vibration. The pilot landed the rotorcraft and further investigation revealed that the flexible coupling aft of the rotor brake had failed, (warped and cracked). Investigation of the operator's fleet revealed a second aircraft with a similar cracked flexible coupling.

Figure 1. EC135 Tail Rotor flexible coupling failure.

All rotorcraft pilots need to remain vigilant of any changes in vibration levels or noise being transmitted through the flight controls or airframe. Land the rotorcraft immediately for a thorough defect resolution process by appropriate licenced engineers. Engineers should examine the rotorcraft in accordance with manufacturer's instructions for signs of failing rotating components such as couplings, bearings and pitch change links. Engineers should look for indirect indicators such as smoking residue, budging (movement) of disks or noise during manipulation, pilots may not be aware of such indicators and may gain from understating what to look for during a pre-flight inspection.

The rotorcraft maintenance release/tech log must be endorsed invoking the rotorcraft as unserviceable and not to be flown until causal factors are rectified. Where the aircraft may need to be operated for further diagnosis, or to validate rectification, the operation is to be in a staged regime (i.e light on skids, hover, taxi flight) by pilots trained, primed and prepared for an emergency response.

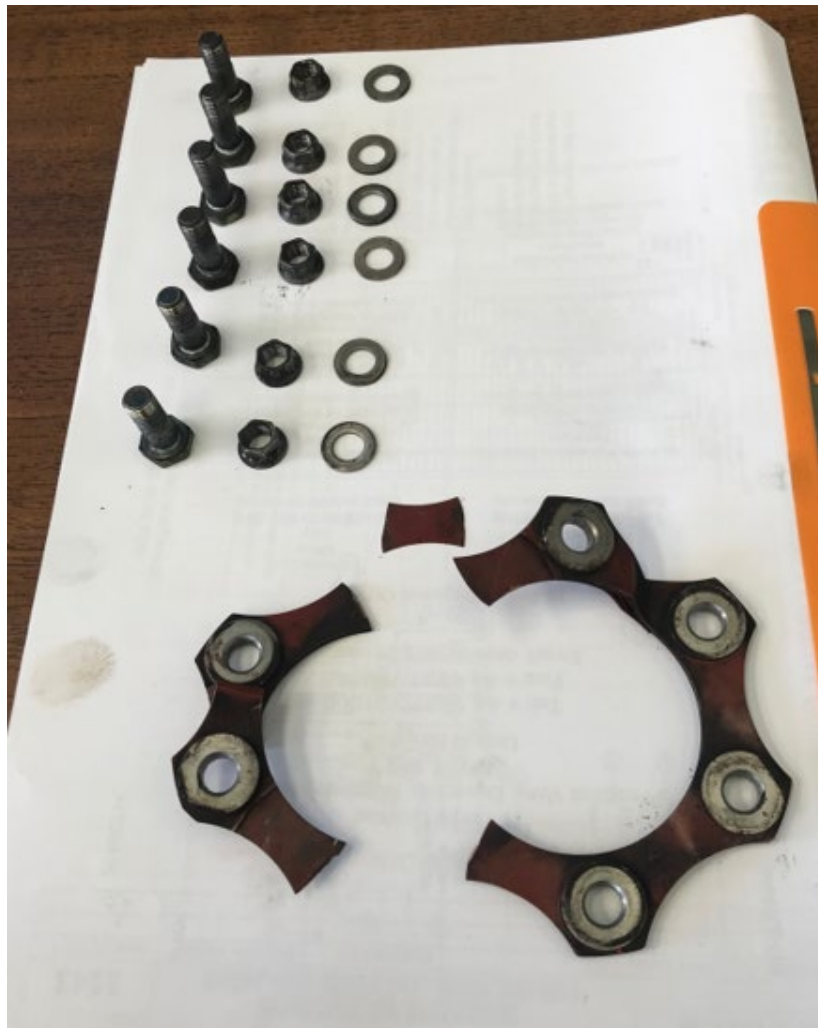
Figure 2. EC135 Tail Rotor flexible coupling failure.

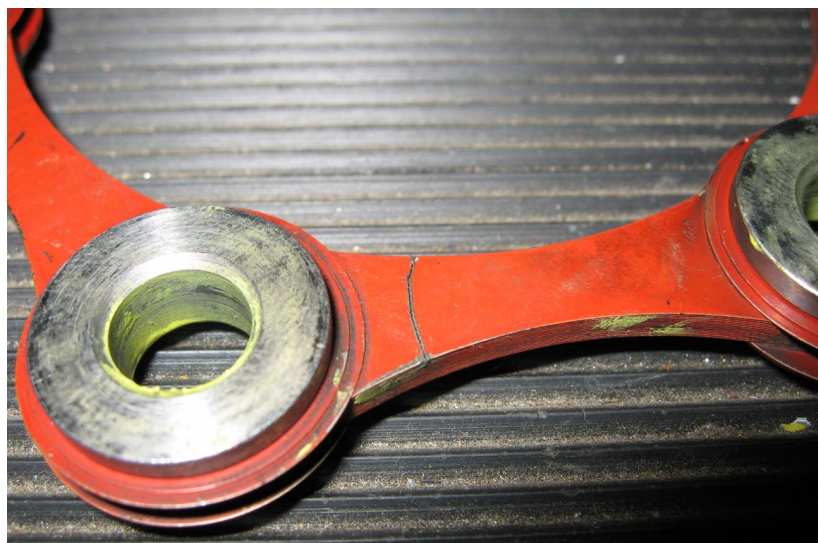
Figure 3. Eurocopter AS365 Dauphin flexible coupling failure.

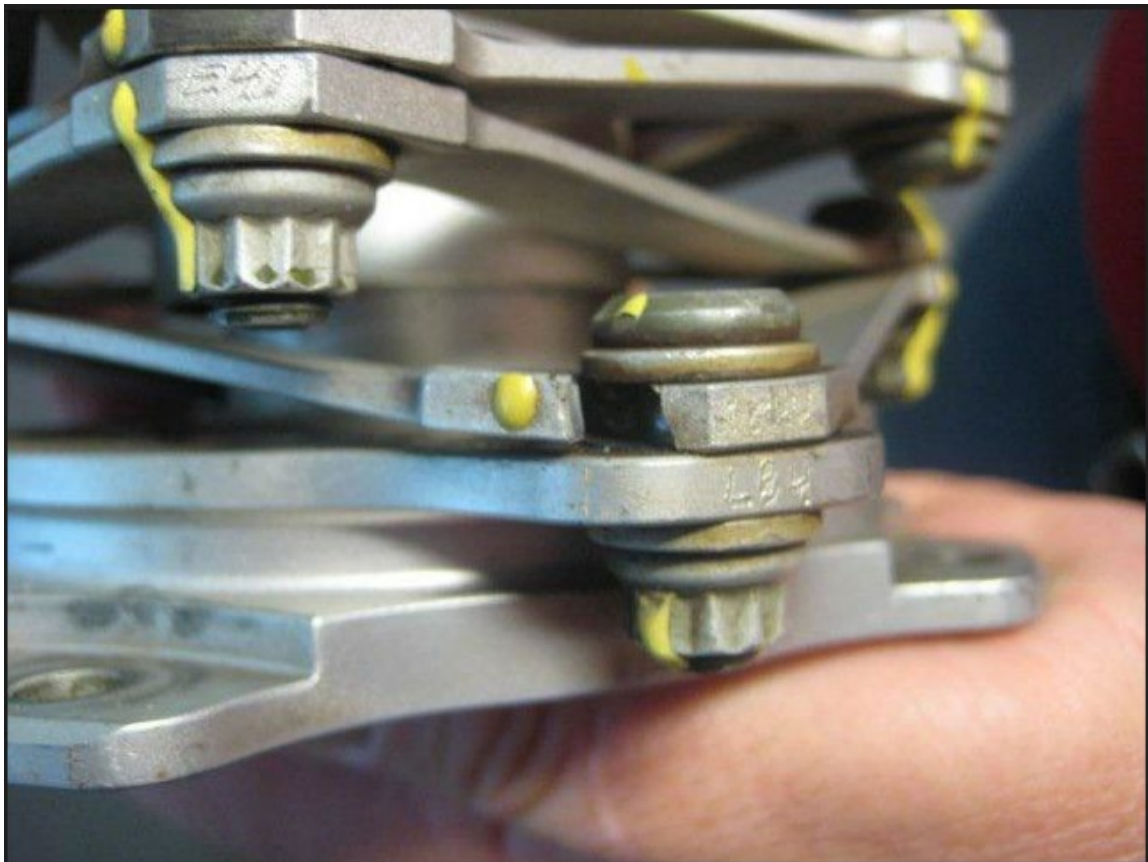
Figure 4. KAflex coupling segment failure.
