AIRWORTHINESS BULLETIN

AWB 63-006 Issue 4 – 28 February 2023

Issues related to the Robinson Helicopter Company (RHC) R22 Main Rotor Drive System

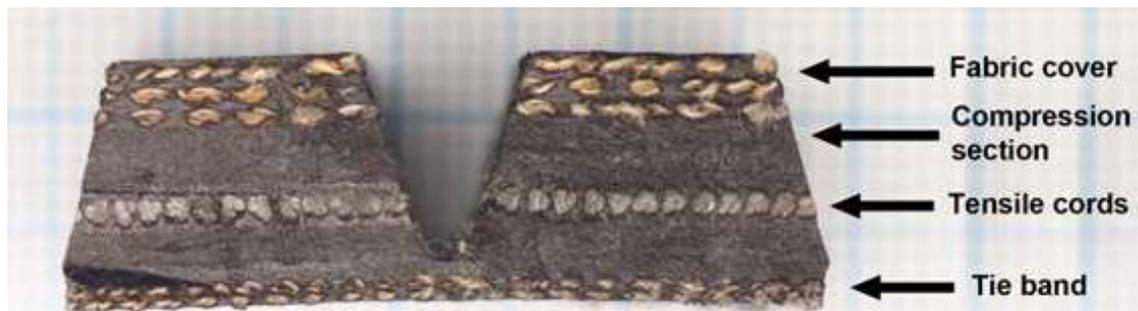
Cross-Section through a v-belt (Revision Z)
ATSB Transport Safety Report - Aviation Occurrence Investigation AO-2014-058

The CASA DRS data shows several failure mechanisms associated with newly installed and low hour main drive belts. Such reports typically describe new drive belts as feeling "sticky", "soft" and "stretchy" at the time of installation. With low hour belts presenting with tie-band splitting, debonding or stretched beyond serviceable limits. In one instance, a set of drive belts had a lumpy drive face profile, which caused excessive vibration at installation.

- a. Carefully inspect all newly manufactured main rotor drive belts for defects before installation,
- b. Consider the importance of the Maintenance and Operational related considerations highlighted in this AWB and disseminate the information throughout their organisations.

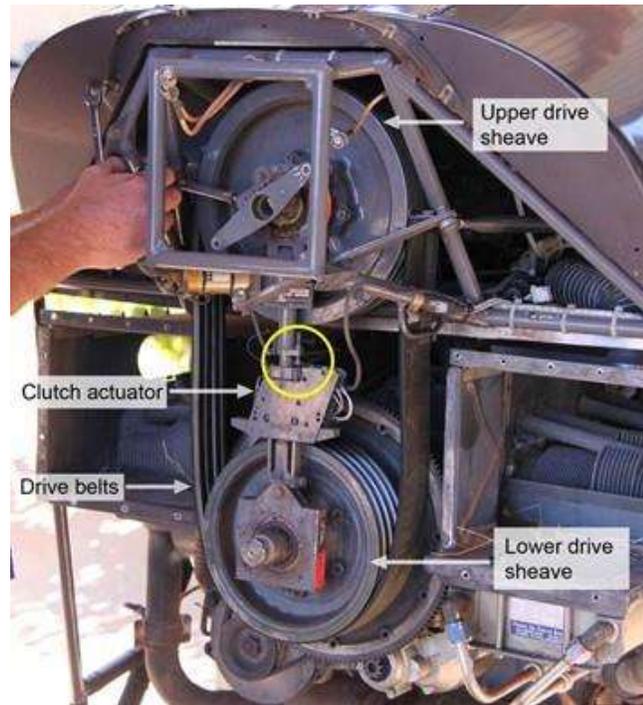
Mechanical arrangement of the R22 rotor drive system
ATSB Transport Safety Report - Aviation Occurrence Investigation AO-2014-058

Tests conducted by RHC indicate that most main drive belt drive problems and failures of the fan shaft bearing or upper actuator bearings are caused by misalignment of the main drive belt sheaves. Misalignment will contribute to abnormal main drive belt and sheave wear and belts jumping out of the drive grooves. Adverse loadings on the main drive belt drive faces will result in adverse wear of the drive belts and the sheave grooves. In addition to abnormal wear, the structure of the main drive belts will be stressed in a way not anticipated by the design of the belt and may contribute to premature drive belt failure. Alignment should also be checked typically:

- i. After each heavy landing
- ii. Following the installation of new main drive belts and/or the installation of new engine mounts
- iii. Any time any of the drive line components are disturbed for servicing,
- iv. Main transmission / engine change,
- v. Whenever the main drive belts are removed due to showing signs of distress, such as fraying / shredding.
