Airworthiness Bulletin

AWB 34-020 Issue 7 – 4 March 2022

Potential 5G Interference of Radio Altimeter Systems

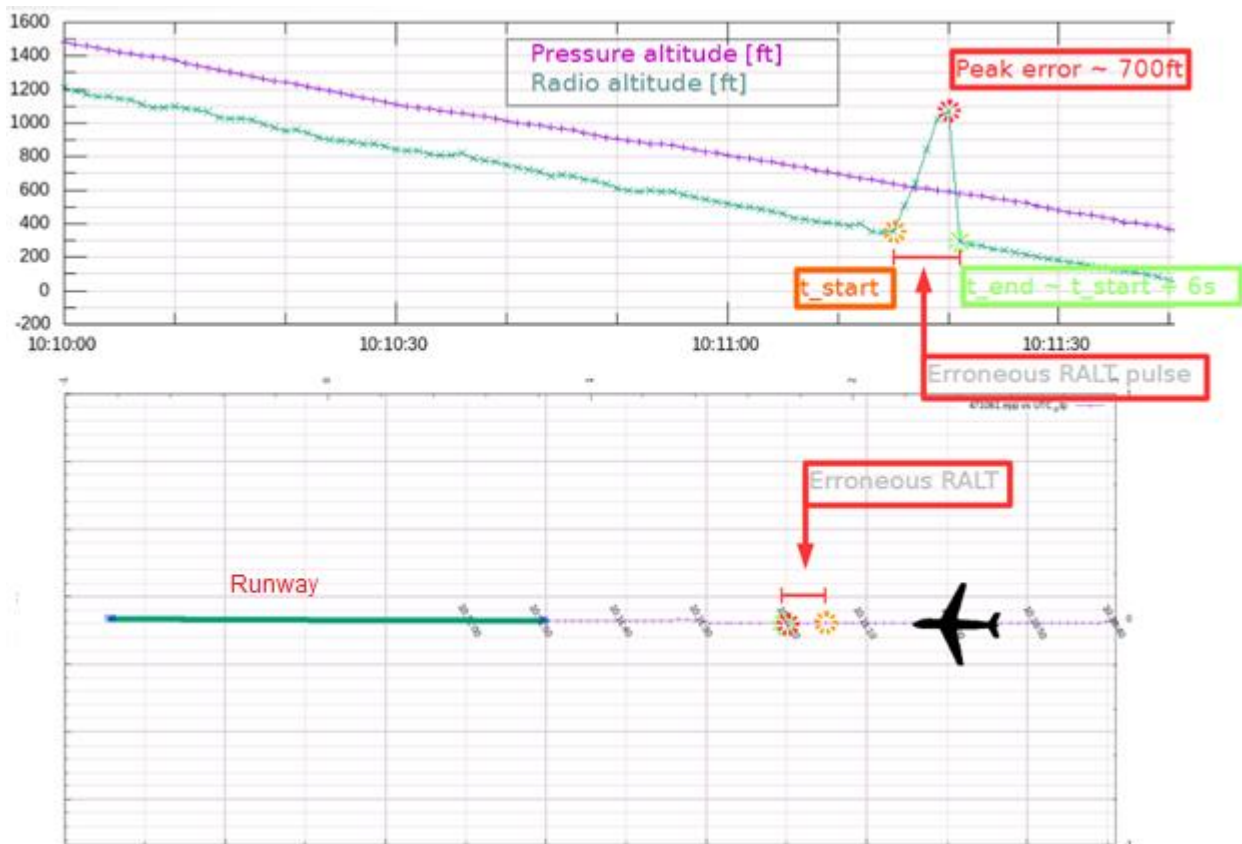
Figure 1 - Radio altimeter over-read

Depicted in figure 1, is an international example of an erroneous RA indication/output where licensed communications networks are suspected as the cause. Figure 1 maps the RAs output against the aircrafts pressure altitude. The RAs erroneous indication/output lasted for approximately 6 seconds. Other reported malfunctions have lasted to up to 60 seconds. Depending on the aircraft and the degree of integration of radio altimeter systems, a variety of different system malfunctions could occur.

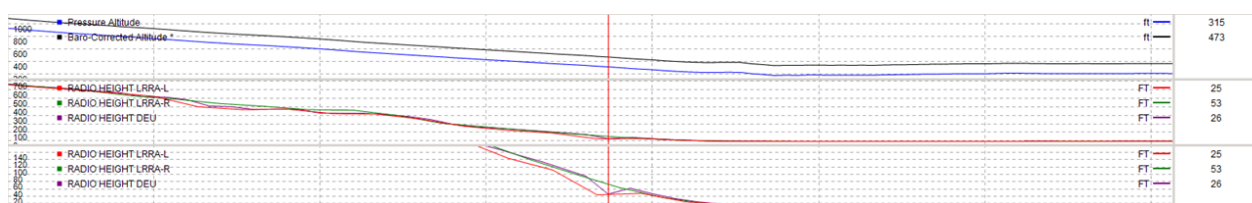
Figure 2 - Radio altimeter values compared to barometric altimeter

CASA has received notification from operators of errors or discrepancies with radio altimeter systems. These reports have been de-identified. The failures show erratic values, RA failures, autopilot disengagement, terrain warning systems and flight director failures. Where possible it is suggested to review the data output from radio altimeter systems such as in Figure 2 to check for discrepancies.

Spurious interference and its effects can be difficult to confirm as the interference may not be continuous nor happen every flight. Erroneous RA occurrences should be reported. If possible, check the output of the radio altimeter over the time of the event occurring if this data is easily retrieved. Discrepancies have been found in the radio altimeter data stream.
