AIRWORTHINESS BULLETIN

Suspected Unapproved Parts - Aircraft
Electronic Fuel System Instruments

AWB 01-028 **Issue :** 1
Date : 8 October 2013

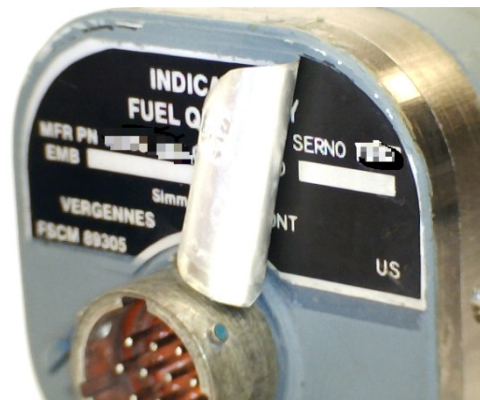
Case 1

An authorised repair facility identified a fuel quantity indicator with a non-original equipment label installed. The label had even changed the original part number of the indicator. There was no documentation available for the modification.

Problems with fuel quantity indicators could cause a fuel mismanagement problem.

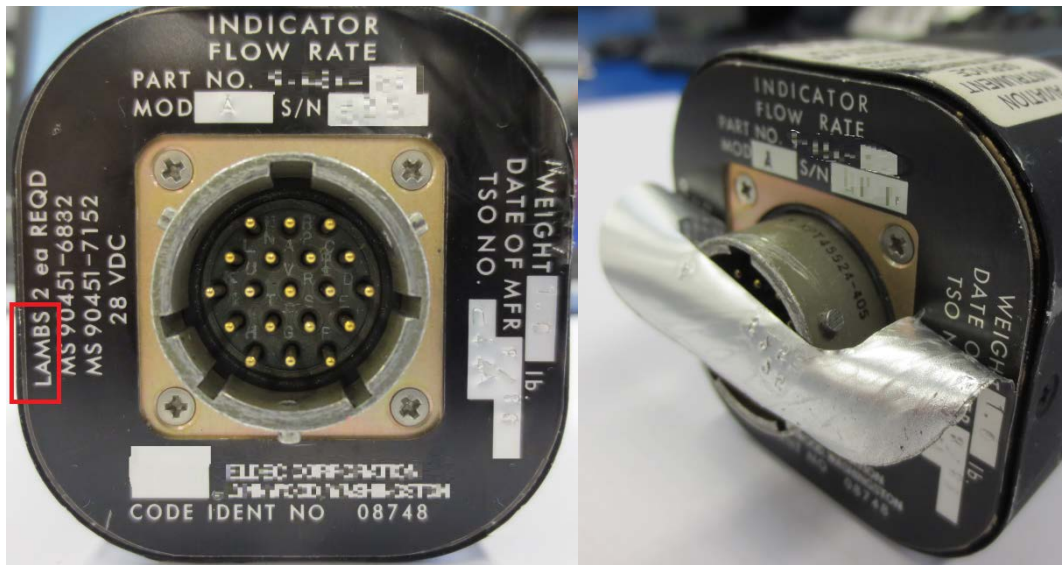
Case 2

An authorised repair facility identified a fuel flow indicator had been found modified to indicate kilograms per hour instead of pounds per hour according to the part number. An inspection found a non OEM sticker had been used instead of original dial face. The data plate was also found to be altered.

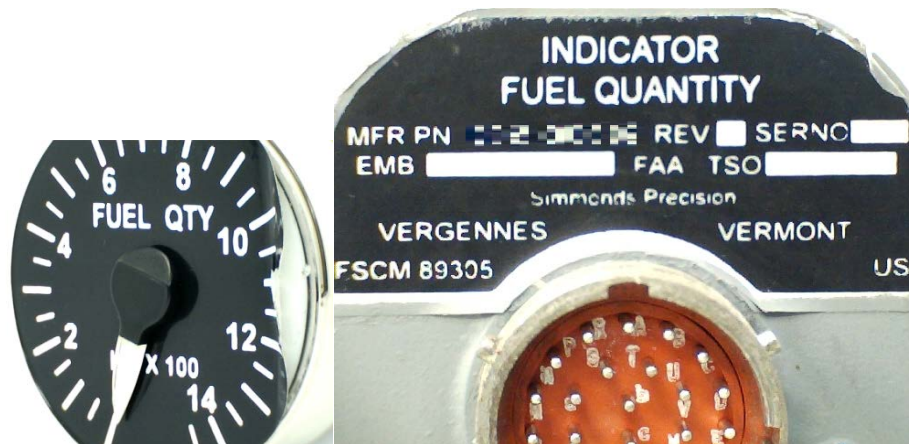
Case 3

Another case of a non OEM approved printed sticker stuck over the correct dial face. Part numbers in the Illustrated Parts Catalogue (IPC) should be verified against the units on the dial face.

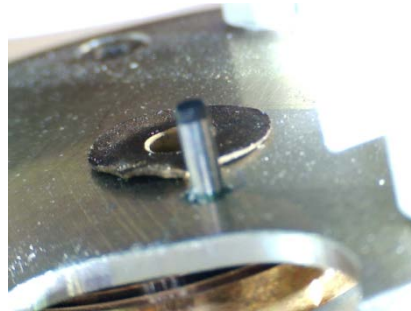
Case 4

During repair at an authorised repair facility an indicator was found to have a non OEM manufactured bushing replacing the original pointer shaft ball bearing.

The example above shows a bushing installed instead of a ball bearing. This could lead to premature failure of the indicator and possible loss of indication during flight.

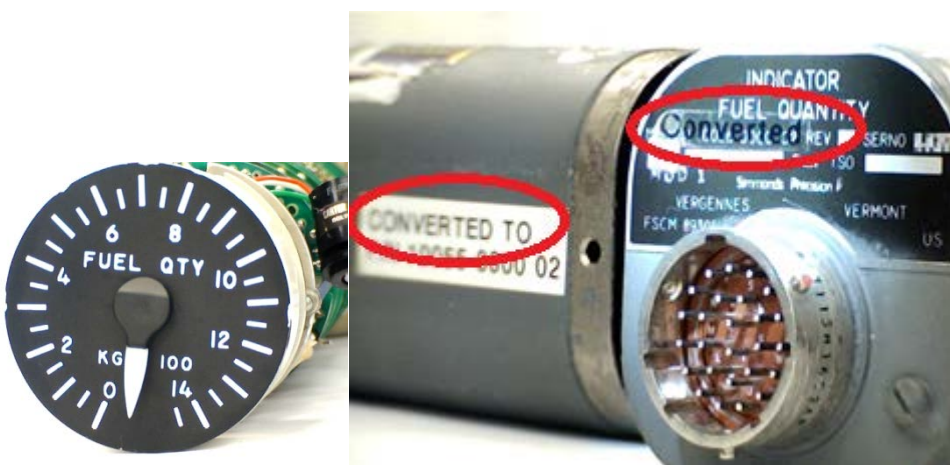
The same indicator was found with a 'CONVERTED' label stuck over the OEM data plate and indicator case. The indicator was also released from the previous repairer with a 'KG' (Kilograms) dial face installed in place of the original 'LBS' (Pounds) dial face.

The indicator was received with the previous repairers' tamper-proof seal still intact. This type of inaccuracy could cause a fuel load mismanagement problem.

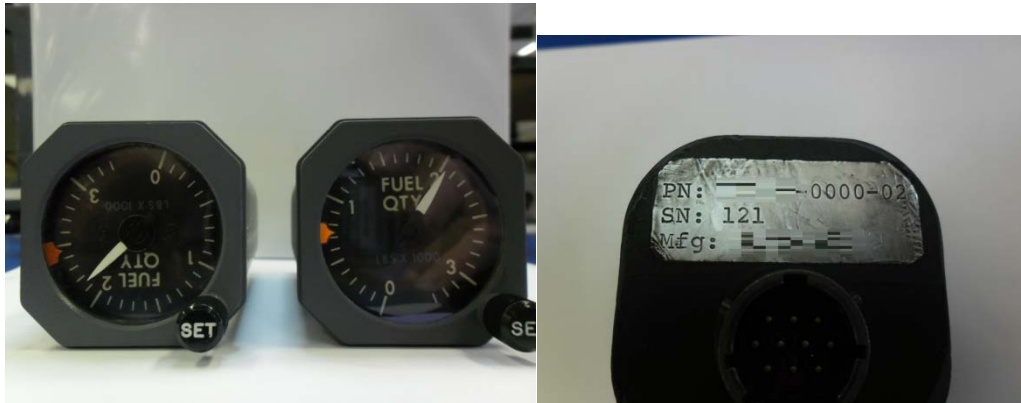
Case 6

In another case identified by an authorised repair facility, identified an indicator had a non OEM manufactured dial installed in an upside down position. Investigation also found the pointer failed the friction tests and became stuck at 2000lbs position. The indicator also had a non-approved identification label fitted.

Data plates should clearly identify the manufacturer and type of indicator.

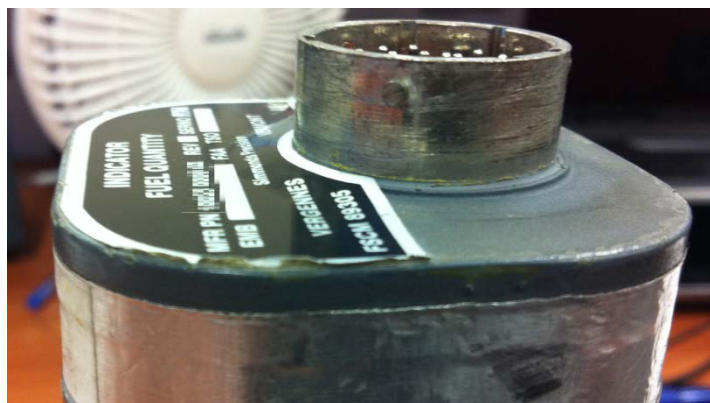
Case 7

This fuel quantity indicator had a decal for a dial face which was delaminating. Investigation also found a decal had been fitted in place of the correct identification plate. Further investigation found the indicator was an incorrect part. That is the wrong part for the intended system and could cause a fuel load mismanagement problem.

Counterfeit labels and dial faces requires experience and skill to detect. Registered operators and/or maintenance organisations are encouraged to look for any signs of tampering or changes that look out of the ordinary.
