Airworthiness Bulletin

AWB 14-001 Issue 3 - 5 February 2021

Cameron Stratus Double Burner Mount - Cracking and Failure

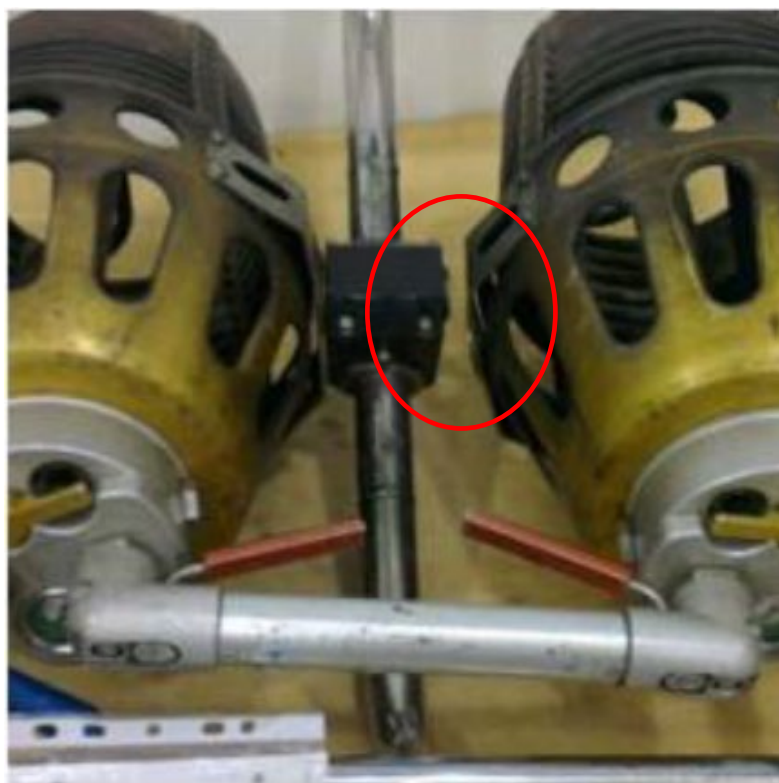
Cracks have been reported in the welds of burner gimbal mounting brackets fitted to Cameron Stratus double burner units. In several instances, this cracking has led to the complete failure of the weld where the burner has become detached.

The potential exists for causing catastrophic damage to the balloon and/or occupants should the burner(s) be in use. A recent example can be found in Figures 1 & 2.

Figure 1: Double Stratus Burner Unit (Note: Failed hanger circled in red)
Photo Reference: Cameron Balloons SB 28 Rev 0

- Inspect the weld of the Stratus double burner hangers (P/N CB8504 Issues A, B and C) in accordance with the instructions outlined in Cameron Balloons SB 28, within 30 days or 10 flight cycles (FC) whichever occurs first, and thereafter at intervals not to exceed 12 months
- If cracking is detected during an inspection, replace the hanger with P/N CB8504 Issue D or later, in accordance with the instructions of CB SB 28 before the next flight.
- If it is found that the Stratus double burner assembly installed (P/N CB8720 or P/N CB8721) uses a doubler plate to reinforce the central part of the hanger bracket, replace the hanger with P/N CB8504 Issue D or later, in accordance with the instructions of CB SB 28 within 30 days or 10 flight cycles (FC) whichever occurs first.

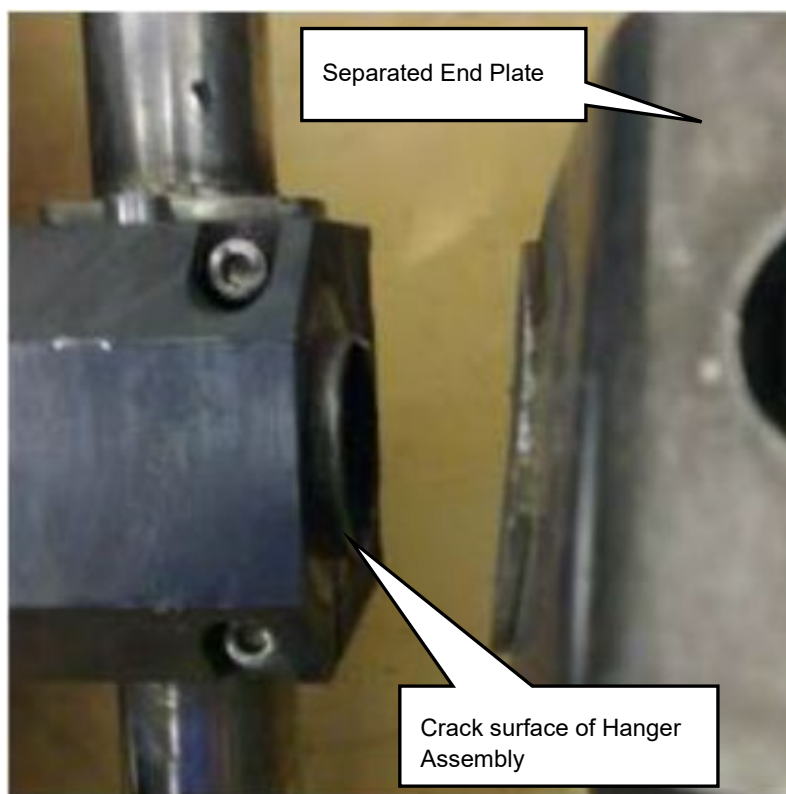
Figure 2. Close-up of weld failure.
Photo Reference: Cameron Balloons SB 28 Rev 0

Another occurrence was recently reported where a Stratus burner hanger, P/N CB8504 failed after landing, leaving one burner unit detached from the load frame. The suspected cause is fatigue cracking of the weld, caused mainly during ground transportation with the burner erect, combined with an overload event. This condition, if not detected and corrected, could lead to the burner falling on the balloon occupant's head, resulting in injury. It could also lead to an uncontrolled cold descent and hard landing, possibly resulting in injury to balloon occupants and persons on the ground.

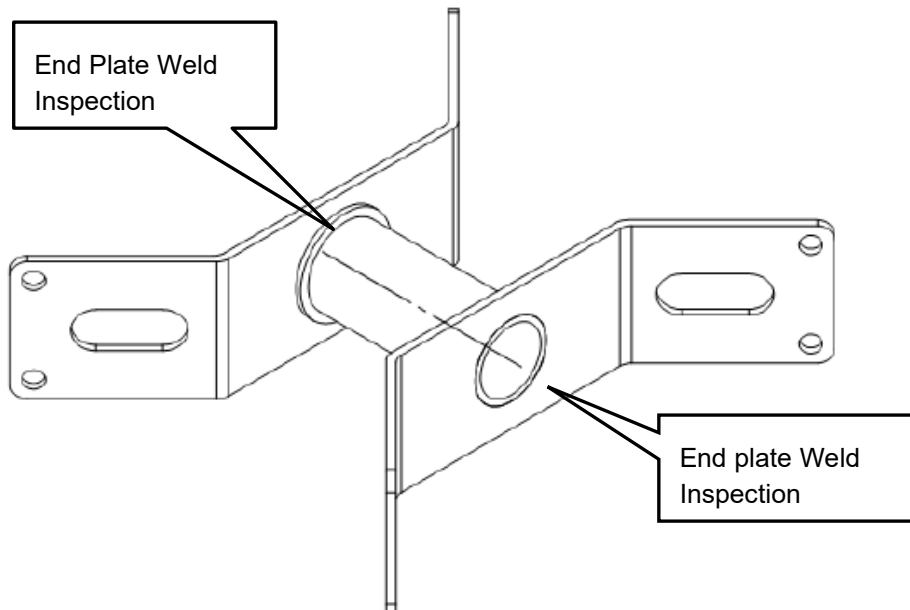
To address this potential unsafe condition, Cameron Balloons issued Service Bulletin (SB) 28, providing inspection and replacement instructions. It was determined that some burner hangers cannot be inspected as they are covered with a doubler plate to reinforce the central part of the hanger bracket.

Figure 3. Isometric view of Hanger Assembly P/N CB8504 and weld inspection locations
Photo Reference: Cameron Balloons SB 28 Rev 0
