Airworthiness Bulletin

AWB 24-002 Issue 2 – 1 February 2021

Aircraft Alternators and Generators

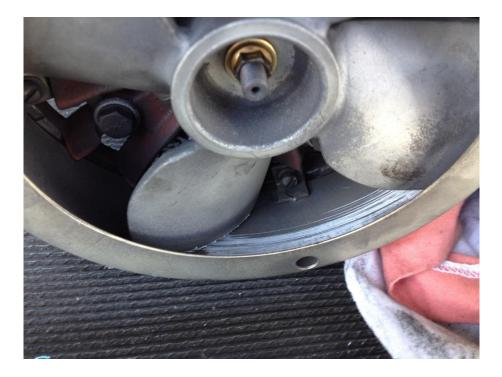
Figure 2, the starter/generator rear bearing race collapsed in flight causing failure of the generator system. Many manufacturers produce simple generic inspection and maintenance instructions to troubleshoot bearing issues.

Figure 2 – Starter/Generator fan damage due to bearing failure

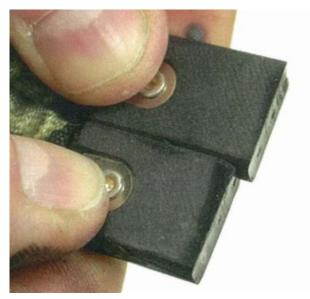
Damaged brushes, springs, contacts, inconsistent maintenance practices or contamination can lead to faster wear rates and more required maintenance. Brushes require a smooth clean surface to effectively transfer electricity. Poor contact with sliprings can not only cause electrical supply issues but produce radio interference. Brushes should be replaced in pairs. See Figure 7 for an example of uneven wear.

Figure 7 - Uneven Starter/generator brush wear rates

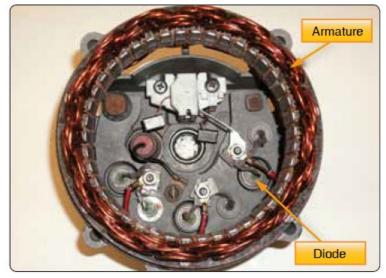
Typical aircraft alternators produce alternating current which are rectified by diodes, to produce DC power. Diode failure may cause supply issues from the alternator or damage to remaining diodes. Diode failures may be due to age, poor installation techniques at manufacture or overhaul, overheating and overloading of electrical buses.

Figure 9 – Alternator diodes
