AIRWORTHINESS BULLETIN

Goodrich Hoist Cable Cutter Wiring Inspection

AWB 25-017 **Issue :** 1
Date : 24 February 2011

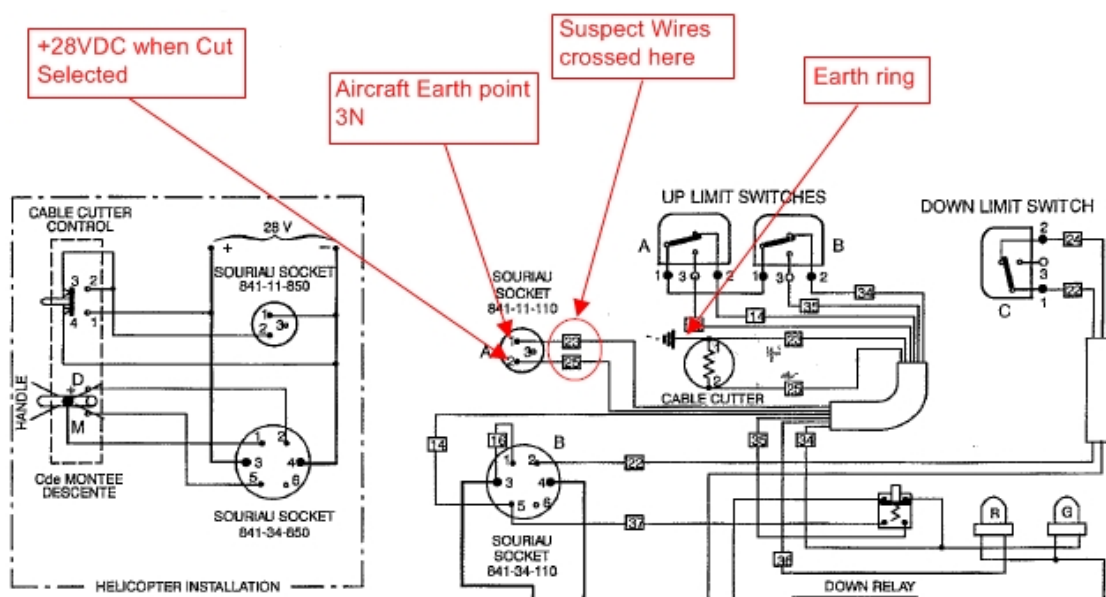
Figure 1: Goodrich Maintenance Manual 76370-XXX Item 25-64-97

A report has been received that, on initial installation of a recently overhauled hoist, the wires connecting the pyrotechnic cable cutter to the pilot's control switch had been reversed. Review of the interconnection diagram (Figure 1: Goodrich Maintenance Manual 76370-XXX Item 25-64-97) identified that, with the wires reversed, any attempt by the pilot to fire the pyrotechnic cable cutter would simply result in the tripping of the circuit protection with the cutter not being fired.

CASA recommends that the maintenance personnel responsible for the installation of the hoist perform a one off inspection of the Souriau socket No: 841-11-110 to confirm correct wiring configuration. This should be done prior to any further hoisting activities.
