Metro 23 Engine Over Torque AWB 31-006 Issue: 1
Recording in the FDR Date: 8 October 2013

M-7 Aerospace, SA227-DC Metro 23 aircraft.

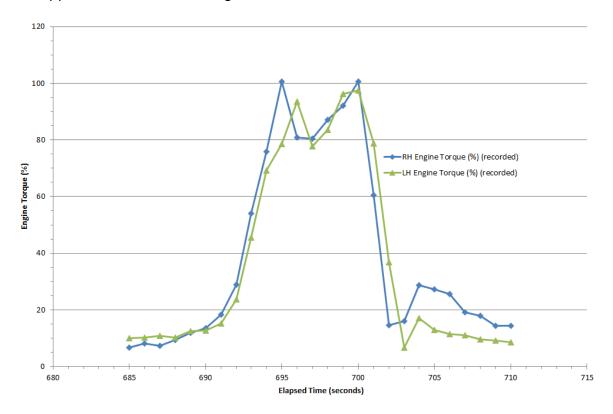
Figure 3 - Plot of Flight Data Recorder information from Rejected takeoff

The result is such that a cockpit indication of greater than 100% torque would be recorded with the same characteristic as a reduction in torque. A manual interpretation of the recorded values of engine torque is needed to assess whether an engine over-torque event has occurred.

The characteristic of the reduction in torque from the value recorded at 100%, seen in Figure 3, was unusual when compared with a normal take off power application as shown in Figure 4

Operators need to be aware when analysing engine over torque values from the FDR that engine torque values greater than 100% could appear as an under torque condition.

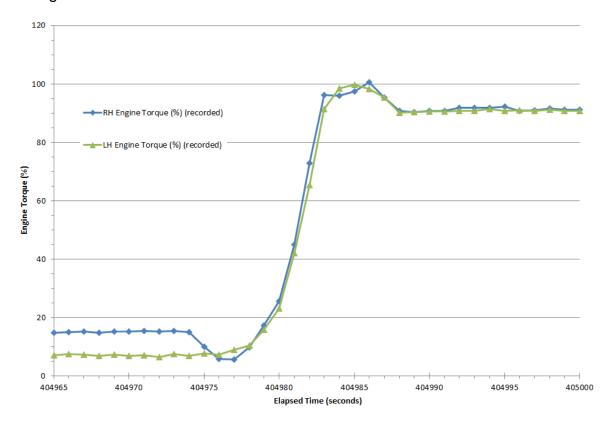
Figure 4 - Plot of Flight Data Recorder information from Normal takeoff

The recorded torque for the left engine shows a smooth increase, peaking at about 100% torque and subsequently decreasing to about 90% torque. The right engine torque shows a smooth increase until a value of about 96% torque when the trace appears to 'dip' while still rising to a maximum value of about 101%, a similar characteristic as observed during the rejected take off. The right engine torque subsequently follows the trend of the left engine torque and decreases to about 90% torque.

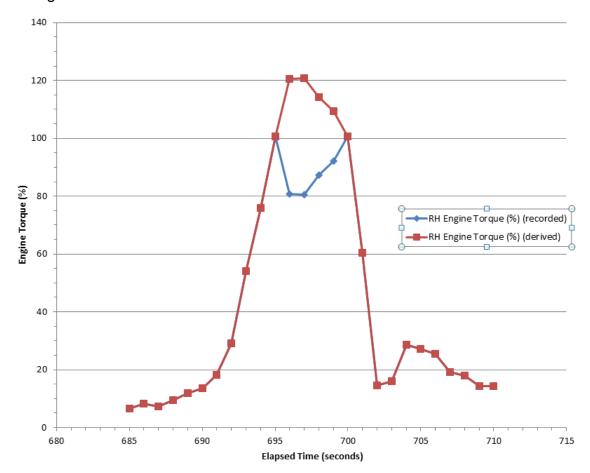
Figure 5 - Derived to recorded engine over-torque indications

Comparisons and calculations were made to determine the difference between the recorded engine over-torque indications and the derived indications. See Figure 5.

The values in the red trace were manually derived by determining the difference from 100% torque. These values were calculated on the basis that the flight data recorder input voltage had reduced below 0 volts dc and the torque value would have been increasing above 100%.
