AIRWORTHINESS BULLETIN

Undercarriage Pin Circlip Damage - AWB 32-011 Issue: 1
Diamond DA42 Aircraft Date: 21 February 2008

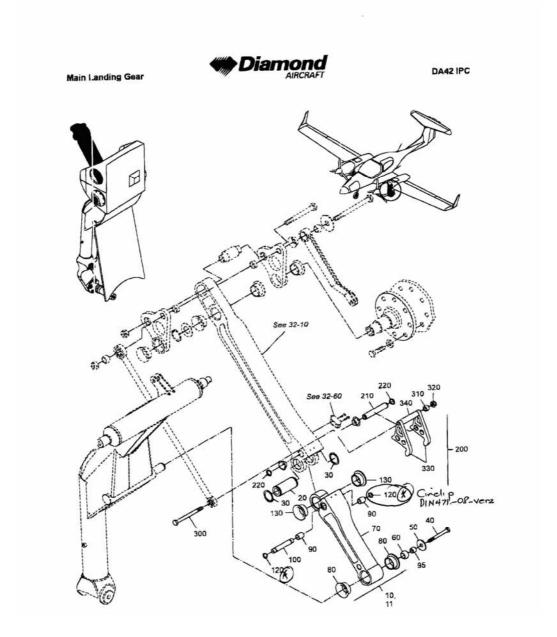
Two reports have been received indicating that the circlips part number DIN471-08-2P holding the main undercarriage pins in place have failed due to fatigue causing the pin to move to a position where the pin may fall out. There is no indication of this failure until the undercarriage becomes inoperative.

- Inspect all main undercarriage pin circlips part number DIN471-08-2P for damage, fatigue and security as soon as practical.
- Inspect all main undercarriage pin circlips at every periodic inspection for security fatigue and damage.
- Replace all main undercarriage pin circlips which show signs of fatigue or damage.
- Replace all main undercarriage pin circlips at 200 hrs TIS intervals.
- Report all damaged or fatigued main undercarriage pin circlips to CASA through the normal SDR system.
