AIRWORTHINESS BULLETIN

Cessna 150/152 Series Aircraft Horizontal
Stabiliser Spar Cracking

AWB 51-003 **Issue :** 2
Date : 8 February 2012

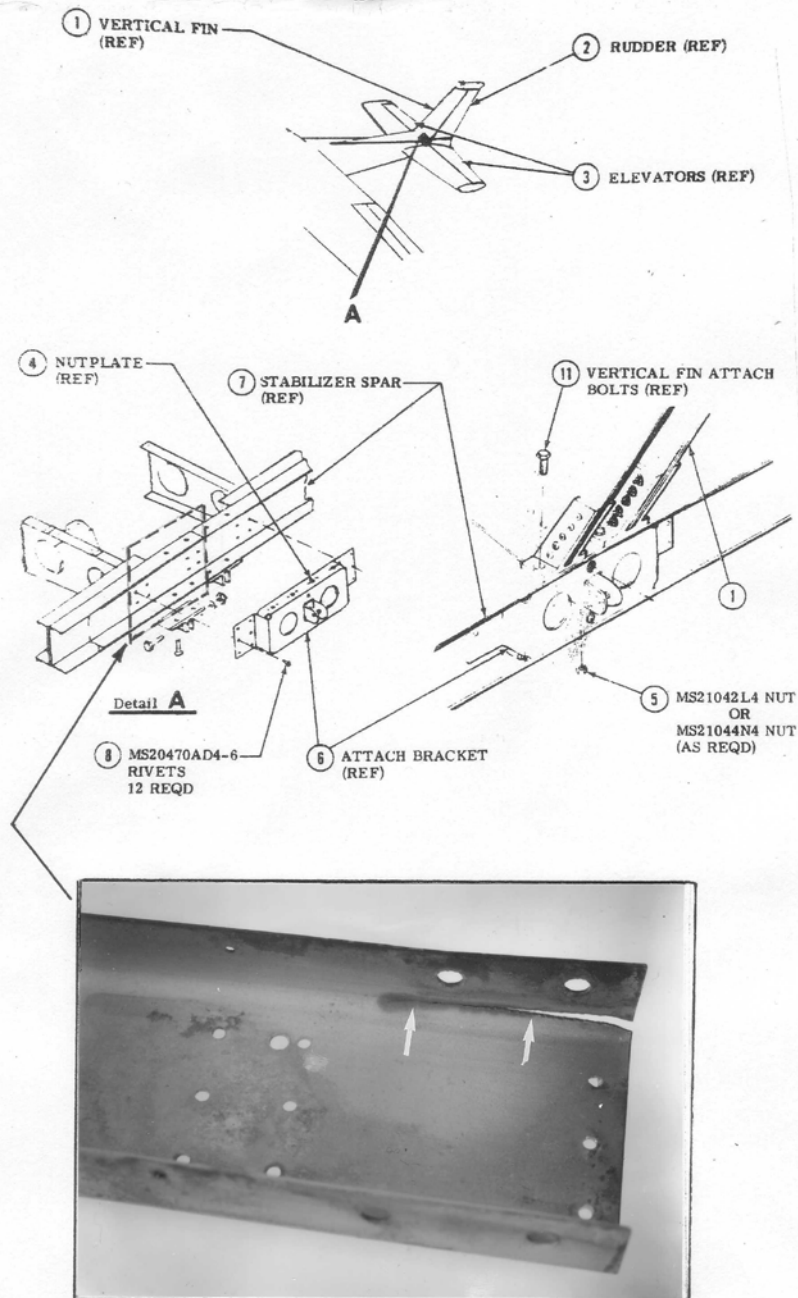
The purpose of this bulletin is to advise operators and maintenance organisations that cracks may exist in the vertical fin attachment bracket P/N 0432004-9, horizontal stabiliser spar P/N 0432001-56 and/or its reinforcement P/N 0432001-15 and to provide a method for a visual inspection to detect these cracks if they exist.

During inspections for the cracking in the vertical fin attachment bracket nut plates in accordance with AD/CESSNA 150/31 Amendment 4, several operators have noticed cracking along the edge of the plate welded to the forward face of the fin attach bracket. On very rare occasions, this cracking may extend into the horizontal stabiliser spar and its reinforcement. The vertical fin attach bracket is attached to this spar by twelve fasteners (6 each side) and when the bracket cracks, the additional loads are transferred directly into the spar, causing cracking. The cracking in the vertical fin attachment bracket is a slow, progressive failure during which time the tailplane assembly is still capable of withstanding the original design loads. Once the crack has extended into the stabiliser spar, the tailplane structural strength may be reduced below the original design strength.

Previous experience has shown that the cracking in the spar is a fatigue phenomenon, driven by in-flight cyclic loads on the tailplane structure. There have been no reported cases of in-flight horizontal stabiliser failure due to these cracks and only seven reported incidents of cracking in the type's history.

attention should be paid to the weld at the top, forward corner of the fin attachment bracket and the corresponding sections of the spar and reinforcement doubler.

2. Visually inspect the horizontal stabiliser spar and reinforcement for cracks using a bright light source, removing protective coating where necessary. See figure 1 for inspection location.
3. Re-protect the subject area with an approved protective treatment and return the aircraft to its original condition per the Cessna maintenance manual.
4. Report any cracks found in the stabiliser spar or reinforcement to CASA via a Defect Report form.
