# Airworthiness Bulletin

**AWB 52-005 Issue 1 - 22 July 2021**

## **Beech B300 - Passenger Door Latch Pins**

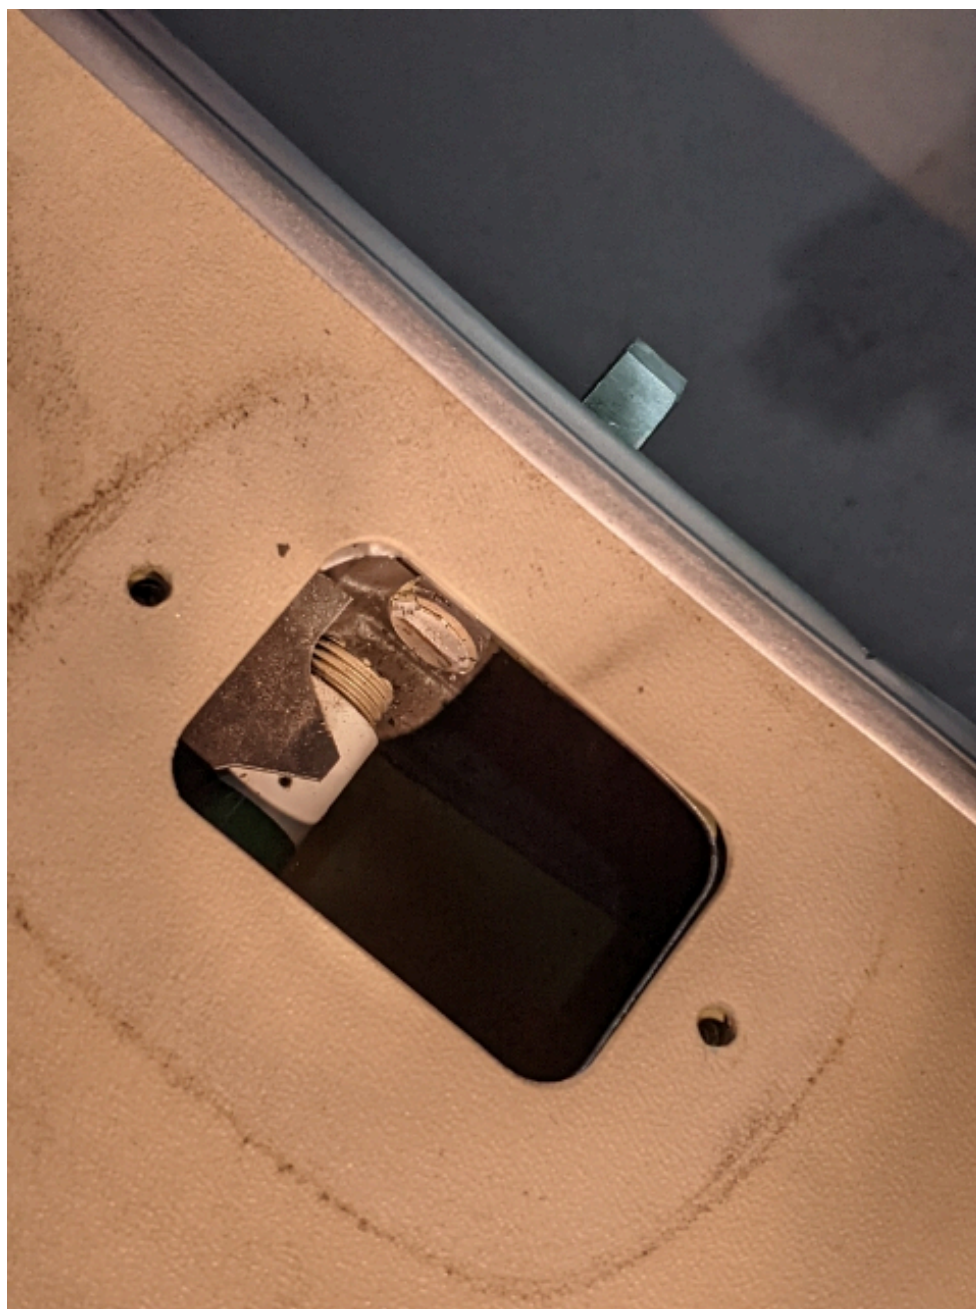
After landing, the aircraft cabin door could not be opened. It was discovered that upper aft locking pin/bolt P/N 50-430177-5 had sheared, with indications of corrosion in the middle of the sheared section suggesting that a fatigue crack may have been present for a period of time. See figures 1 and 2 below.

**Figure 1:**  
**General view showing access to the latch pin area (top left pin location)**

- Remove cover over the latch pin assembly to check the latch pin threaded area for corrosion or cracking. Corrosion or fatigue cracking may be a potential cause of this cracking however this is yet to be determined.
- The reported failed door latch pin appeared to have a crack that originated from one of the final cut threads before the treaded section transitioned into the rectangular section of the latch pin. The crack appeared to have originated on the pin side that is closest to the outer door skin (i.e. opposite side of the thread that is visible through the inspection window cover). It is recommended to inspect the thread area with a torch and mirror to access the underside thread section.

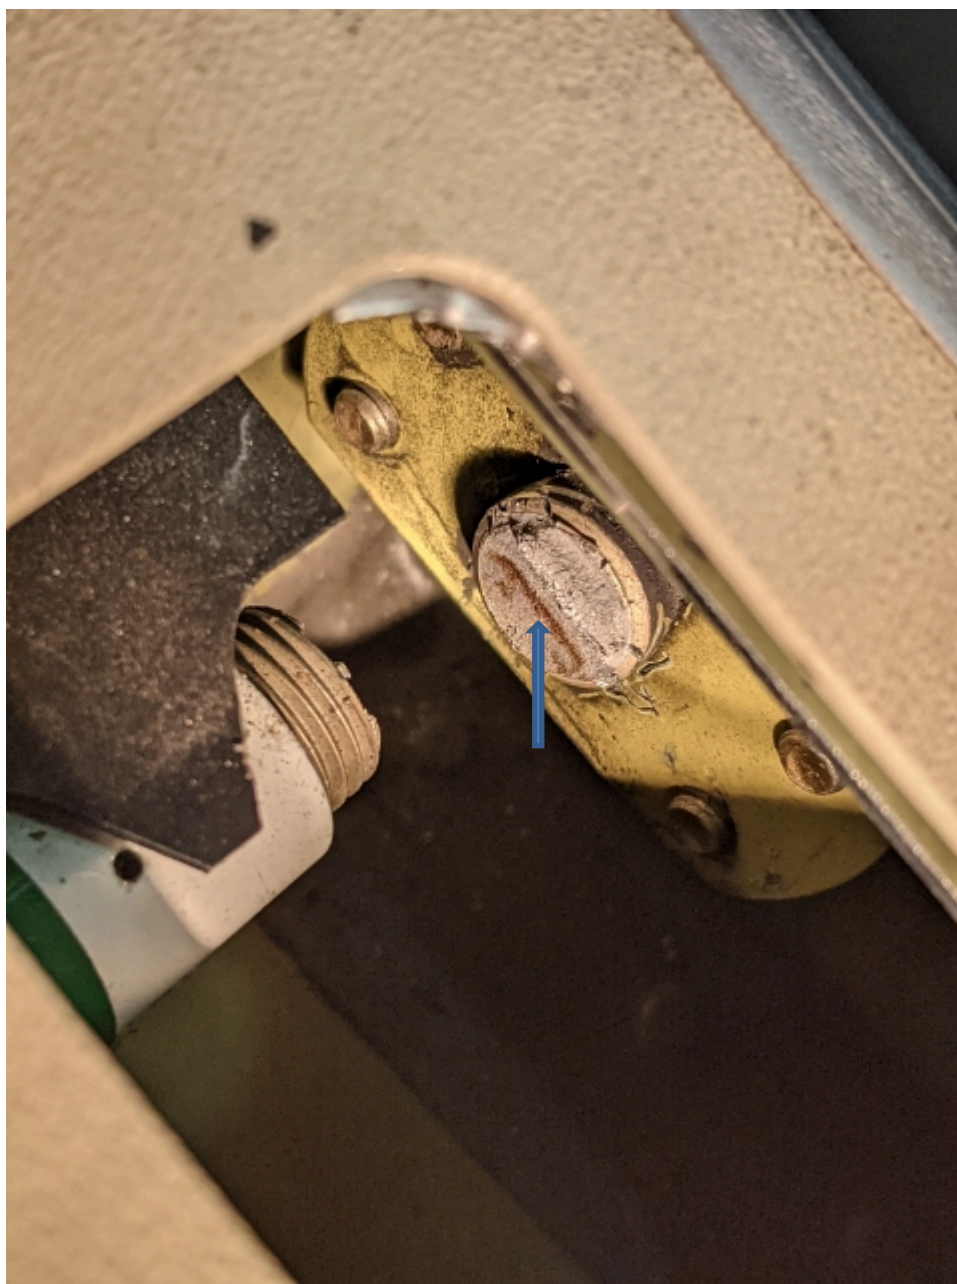
All 4 latch pins were replaced before the aircraft returned to service. The 3 other removed pins were NDT (MPI) inspected to identify if any cracks were present and the upper forward pin/bolt was also found cracked. There were no indications in the two lower pins. Textron has been notified of the results. The pins have a current Life Limit of 5000 FC and the failure has occurred at 542 Cycles.

**Figure 2:**  
Closer view showing fracture of threaded area. Arrow indicates corrosion product which indicates the crack was present for some time.
