AIRWORTHINESS BULLETIN

Embraer 120 Windscreen and Cockpit
Window Support Structure Cracking.

AWB 53-007 **Issue :** 1
Date : 08 December 2010

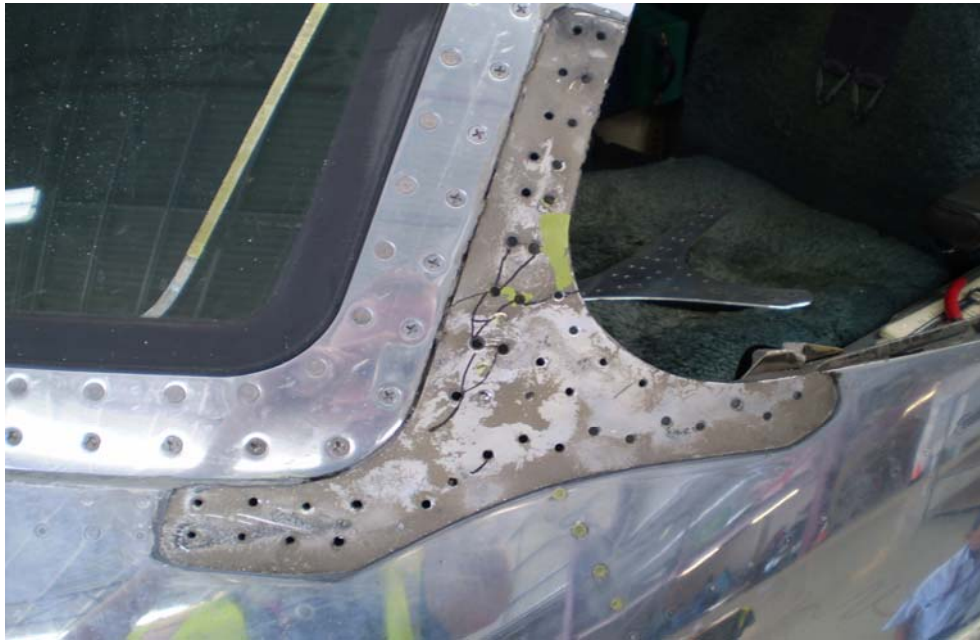
Location 1: Cracking in the windscreen support post external doubler and underlying fuselage skin (see figures 1 and 2).

Location 1: There have been reports to CASA of cracking in the external doubler P/N 145-30236-001 (Installed IAW SB120-53-0072) and the underlying fuselage skin in the same location. The crack appears to originate from a fastener in the doubler which has a low edge margin, as shown in the photograph below. The cracking then propagates to adjacent fasteners and reduction of load carrying capability of the doubler can lead to the underlying fuselage skin cracking shown in figure 1.

Figure 1 – Underlying fuselage skin cracking. This cracking would be hidden from view by the overlying external doubler which is installed IAW SB120-53-0072. Figure 2 shows the external doubler installed.

It is highly recommended that operators visually inspect for this cracking and if any cracking is found, rectify/repair by either contacting the Type Certificate holder, manufacturer or a CAR 35 authorised person.

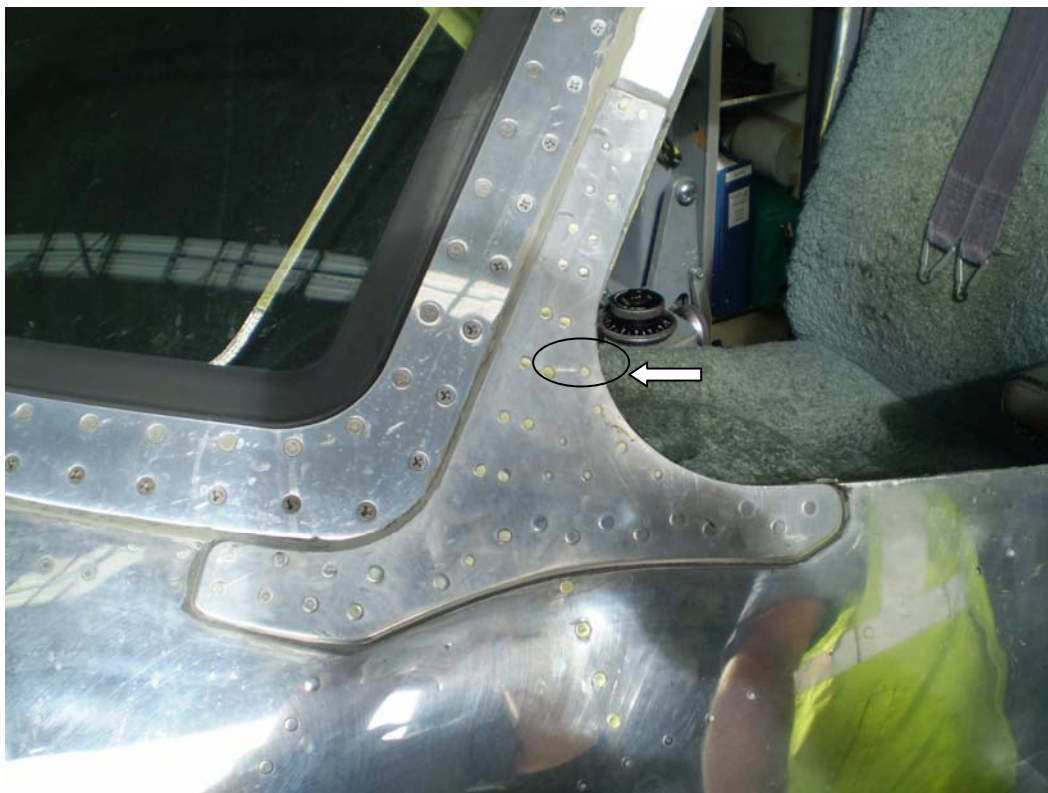
Figure 2 – showing external doubler installed. Initial crack has originated from the edge of the doubler to a low edge margin fastener at a location indicated by arrow in the figure. The crack has propagated between the group of three fasteners (circled).

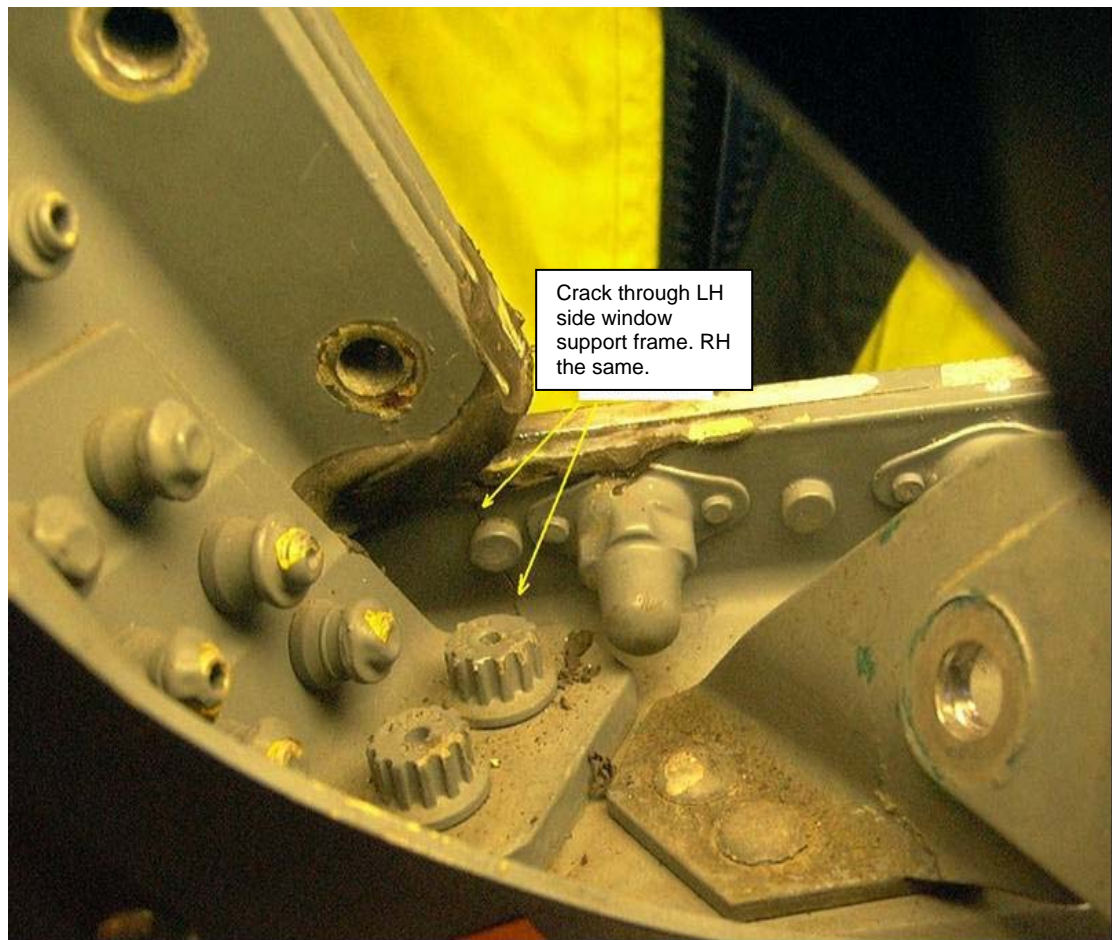
Location 2: Cracking in the left and right hand cockpit DV window lower horizontal support frame beams (see figure 3).

Location 2: There have been multiple reports to CASA of cracking in the left and right hand cockpit window lower horizontal support beams. The crack location and extent is indicated in figure 3.

Figure 3: Cockpit window lower support frame cracked from rivets on LH and RH sides.
