AIRWORTHINESS BULLETIN

Fairchild (Swearingen) SA226/SA227
Wing Skin Cracking – Station 81

AWB 57-010 **Issue :** 1
Date : 2 December 2010

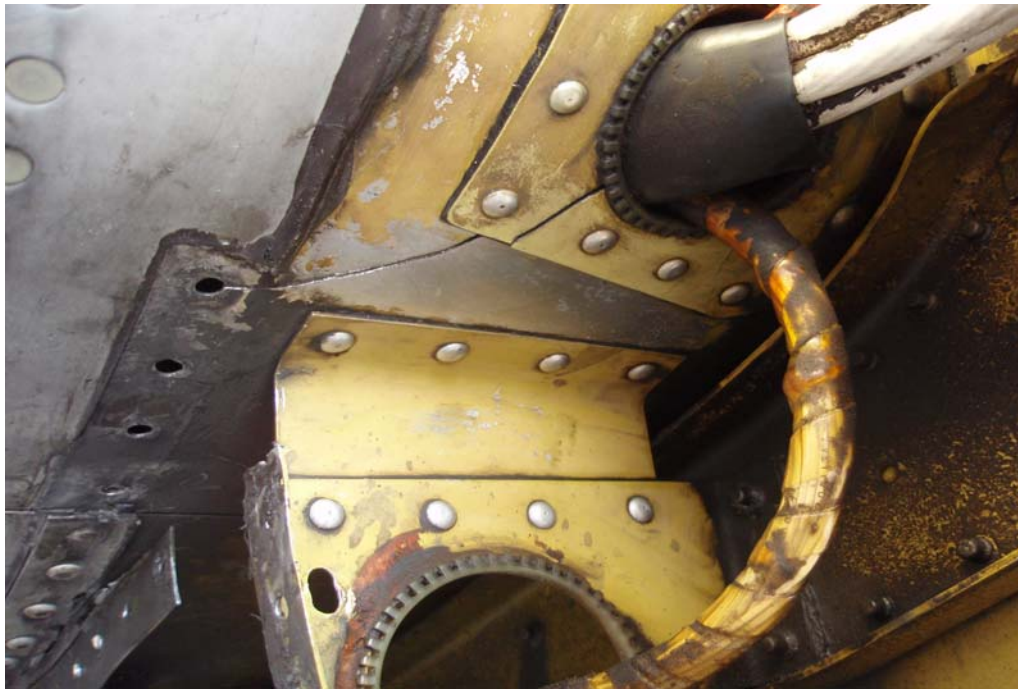
There have been reports to CASA of cracking in the wing leading edge skin P/N 27-31000-797 and doubler P/N 27-35084-018 at wing station 81. The cracks range in length from less than 0.5 inches to, in some cases, more than 0.5 inches in length. See picture below for a typical crack and location.

Photo showing approx 4 inch crack at Station 81. View from inside leading edge. Note crack has been arrested by a fastener hole. Cracks in the skin may be visible externally.

It is highly recommended that operators visually inspect for this cracking and if any cracking is found, rectify/repair by either contacting the Type Certificate holder, manufacturer or a CAR 35 authorised person.
