Piper PA-34 Aileron Hinge Fitting Assembly

AWB 57-013 **Issue :** 1
Date : 21 May 2013

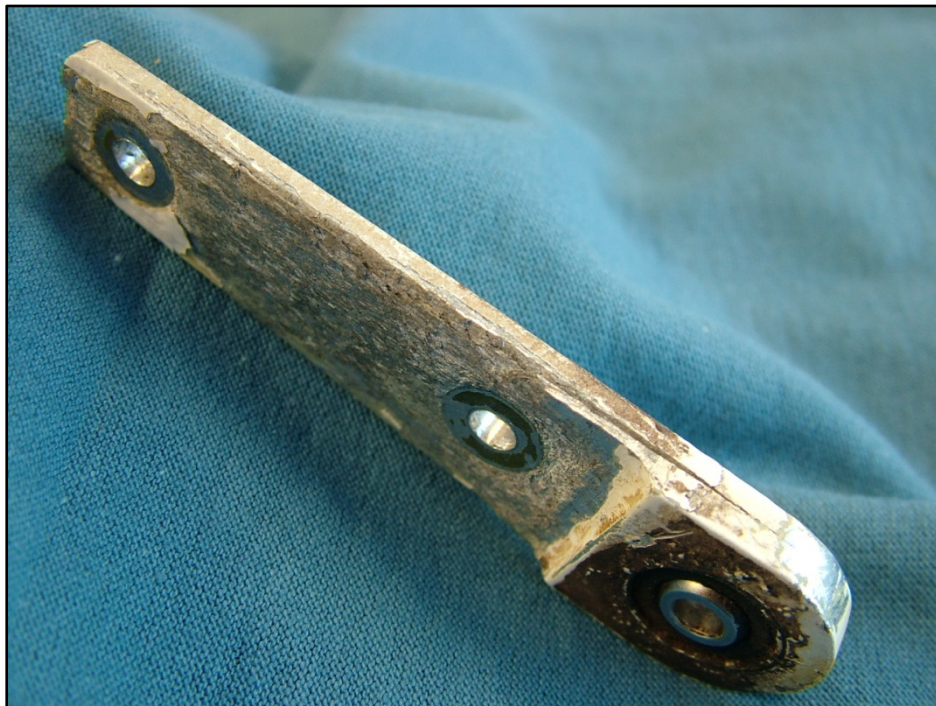
This AWB is prompted by a Service Difficulty Report which identified a Piper Seneca aileron hinge P/N 3721000 that was severely corroded.

Figure 1 Corroded Aileron Hinge

An initial inspection should be completed within a timely manner and thereafter every 100 hours as per the Piper maintenance schedule to ensure the integrity of the aircraft flight control system is maintained.

It is highly recommended that a detailed visual inspection be conducted on all the aileron hinge fitting assemblies for corrosion, with special attention to the section of the fitting enclosed by the aileron. Evidence of corrosion on the enclosed section of the fitting will necessitate removal of the fitting from the aileron to allow closer inspection.
