Wooden Propeller Maintenance (Rewrite  
of AAC 17-3 and AAC 187-1)

**AWB** 61-007 **Issue :** 1  
**Date :** 11 March 2008

# AIRWORTHINESS BULLETIN

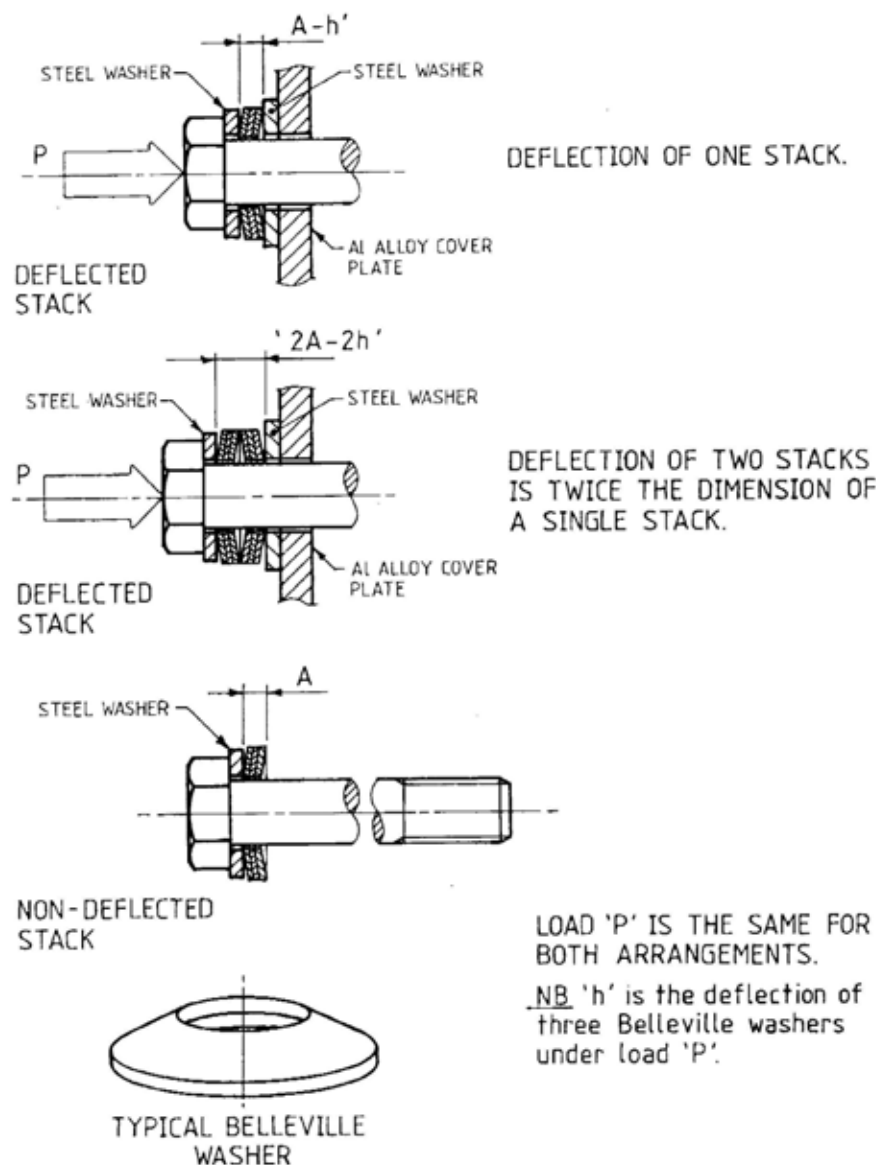
FIGURE 1.

- c. Install the 'Belleville' to compensate for the maximum changes in the wood thickness. See Figure 1 which shows how different washer arrangements will affect the spring rate available.

- d. Avoid flattening the washers. Measure the deflection then compare it to the pre-fitment size.
  - e. Use a torque wrench to tighten the bolts whilst simultaneously measuring the deflection. Subtract washers if they are not deflected sufficiently that is less than 1/2 deflection and add washers if the deflection is too great that is above 2/3 deflection.
