# **AIRWORTHINESS BULLETIN**

Robinson R44 Hydraulically Assisted Flight AWB 67-004 Issue: 1 Controls - Correct Assembly Date: 24 March 2011

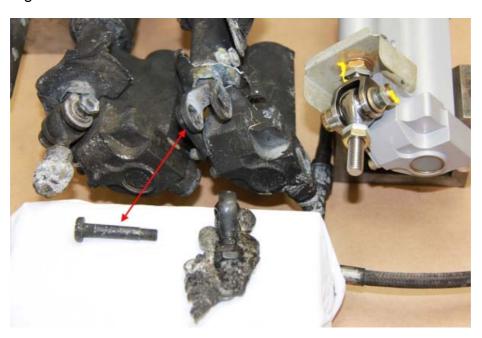
Figure 1

"Examination of the wreckage identified that a bolt securing part of the flight control system had detached". (See Figure 1)

NOTE: The detached bolt is associated with the centre actuator. The actuators on the left and right show the correct assembly.

CASA strongly recommends that all R44 operators and maintainers inspect and confirm the security of the aircraft's flight control system bolts, clevises, rod ends etc in the flight control linkages, particularly those associated with the hydraulic boost servos, as soon as possible.
