AIRWORTHINESS BULLETIN

Corrosion of #1 and #2 DC

AWB 80-002 **Issue :** 1

Starter/Generator Earth Points on Sikorsky **Date :** 03 April 2008

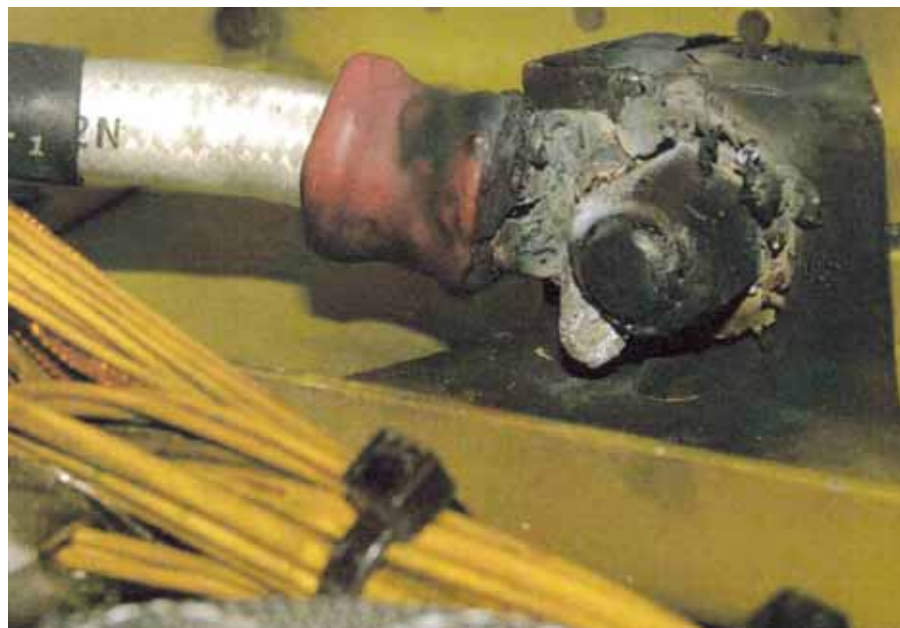
A recent investigation into the cause of a generator failure on a Sikorsky S76A rotorcraft, revealed that GRN FT1 and GRN FT 2 (#1 and #2 DC Starter/Generator earth points), had corroded and became loose, causing an open circuit which prevented the generator from operating.

Figure 1: Corroded and burnt Earth Terminal

- Have all DC Starter/Generator earth points inspected for correct torque and corrosion.
- Replace any DC Starter/Generator earth points which are found to be corroded or damaged.
- Re-torque and DC Starter/Generator earth points which are found to be loose or below recommended torque loading.
- Report all DC Starter/Generator earth points found to be corroded, under-torqued or damaged to CASA through the normal SDR reporting system.

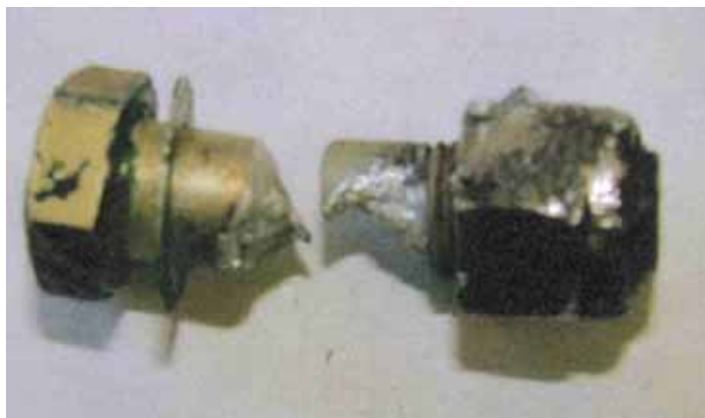
Figure 2: Corroded Earth Terminal Point
