## Piston Engine Rocker Shaft Boss Failures

**AWB** 85-016 **Issue :** 1  
**Date :** 2 August 2013

# AIRWORTHINESS BULLETIN

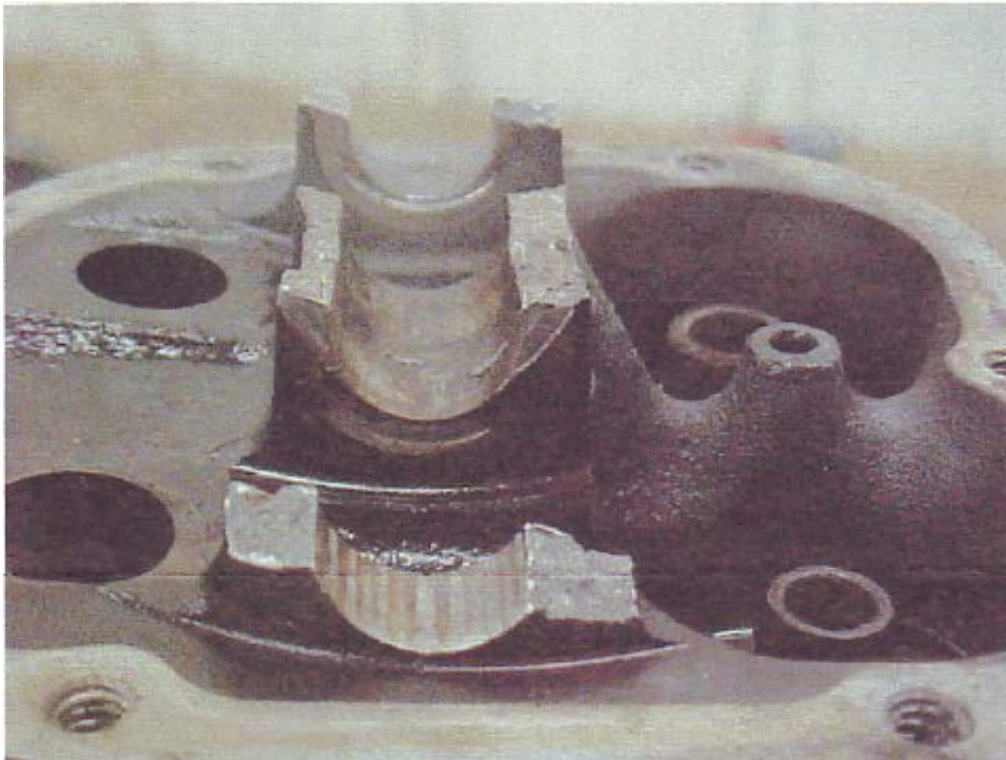
Service Difficulty Reports continue to be received describing in flight failures of cylinder rocker shaft bosses. The outer boss or lug typically breaks off at the base first, overstressing the centre boss leading to the rocker shaft breaking through the top of the centre lug or boss as the engine continued to operate. This type of failure results in a rough running engine which will not develop full RPM and power and, in some cases, may result in total engine failure.

Many failures may be attributed to not following the engine manufacturer's overhaul and maintenance instructions and / or not following good overhauling component handling practices. The bosses are cast into the head and are susceptible to any shock loading.

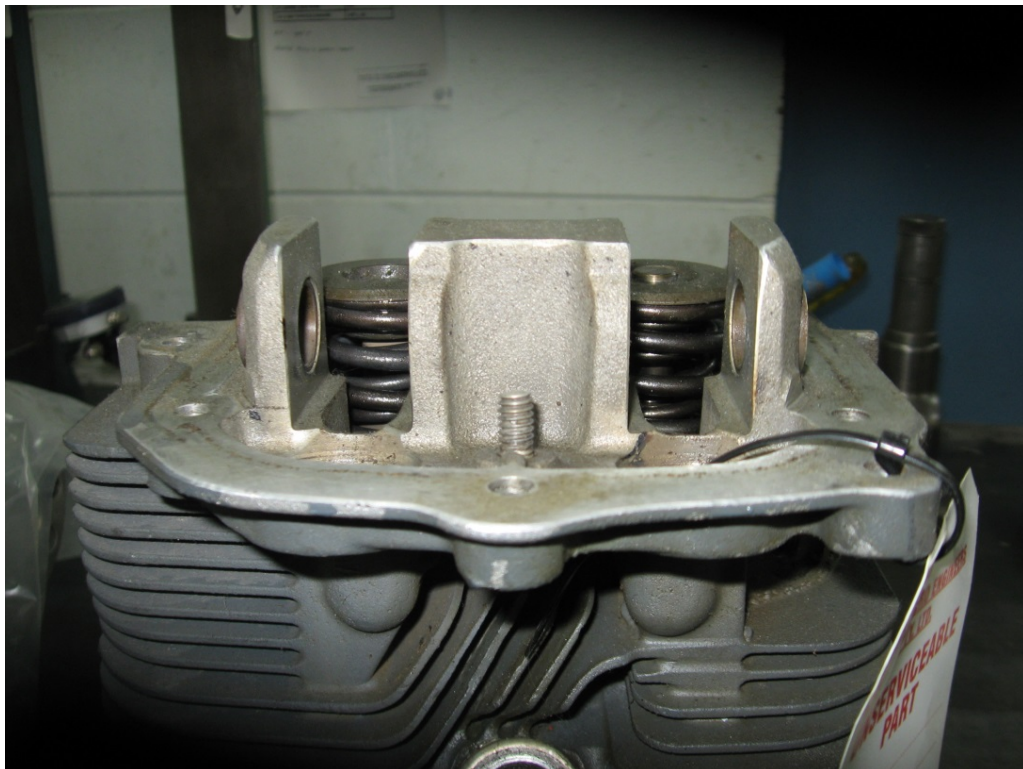
Driving a rocker shaft out of the shaft bosses (with a soft drift pin and hammer) without first relieving all valve spring pressure may result in overload shocks being delivered to the cast rocker bosses, possibly causing cracks which could remain undetected during initial routine maintenance. In addition, if the metal drift should contact the internal diameter of the boss during rocker shaft removal, it can nick or gouge it, causing a stress riser and introduce a potential failure point.

When removing or installing a valve rocker shaft without removing the cylinder from the engine, ensure that any valve spring pressure transmitted to the rocker shaft and boss through the rocker arm is relieved.

When inserting a rocker shaft into the bosses and the rockers, first remove varnish build-up on the pin or in the boss internal diameter. Test-fit the rocker shaft into the bosses and rocker by hand before final assembly with the rockers and thrust washers and push rods. Lubricate generously to assure smooth final assembly, which should be carried out without any valve spring pressure.
