Airworthiness Bulletin

AWB 27-022 Issue 1 – 2 November 2021

Cicare CH-7B Tail Rotor Pitch Control System

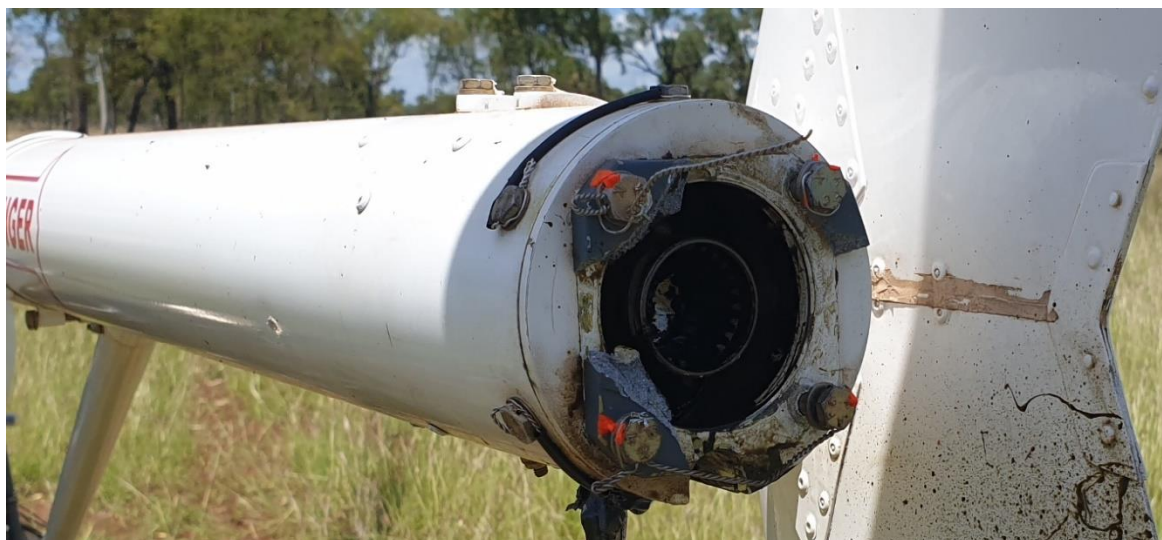
Two recent separate incidents have highlighted that Cicare' rotorcraft encountered increased vibrations at the tail rotor section of the rotorcraft. The two separate incidents have occurred in addition to two accidents that were investigated by the Australian Transport Safety Bureau (ATSB) investigations (ATSB Investigations AO-2014-086 and AO-2015-089). The recent incidents involved the Tail Rotor Gear Box (TRGB) departing the tail boom, the second with excessive vibrations following unapproved repairs to the pitch control mechanisms.

Figure 1. Tail Rotor Gearbox departed from CH7 tail boom section.

Operators and maintainers should follow manufacturer's maintenance instructions for continued airworthiness and be acutely aware of increases in vibrational feedback via the rotorcraft flight control inputs.

Similarly, all repairs outside of the manufacturer's maintenance instructions should be accomplished IAW manufactures approval or CASR 21 approved design data.

Finally, owners are to ensure that their rotorcraft have a CASA Experimental Certificate issued on completion of assembly, and that an approved CAR 30 maintenance organisation complete the appropriate track and balance of main and tail rotor systems prior to the rotorcraft's first flight.
