# Airworthiness Bulletin

**AWB 01-038 Issue 1 - 27 November 2023**

## **Suspected Unapproved Part - Bell Helicopters 206, 214ST, and 505 - Main Rotor Blade Retaining Bolt Nut**

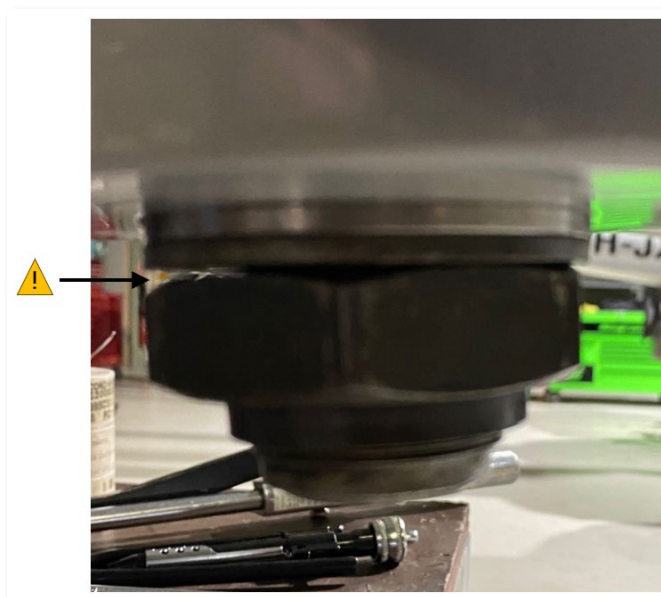
The nut of the blade bolt securing the main rotor blade to the hub assembly was observed to be defective, with the upper mating surface not in full contact.

Figure 1 – Retaining bolt nut mating surface was observed to be not in full contact.

- a manufacturing error has occurred during formation of the major features of the nut. The bore was found to be both off-centre and at an inclined orientation.
- there was nil evidence of maintenance error (e.g. cross-threading; over-torquing)
- the defective nut had likely been manufactured using a low-carbon steel that did not meet the specifications of either the OEM or PMA part
- there are nil identification marks to indicate that the nut is either OEM or PMA.

1. prior to further flight, at a minimum:
  - a. replace the nut with a serviceable part of confirmed origin;
  - b. inspect the grip tangs for evidence of damage;
  - c. inspect the bolt in accordance with the corresponding Bell Helicopters Component Repair & Overhaul Manual (CR&O) to verify serviceability.If in doubt, contact the Type Certificate holder for further instructions.
2. given that the suspected nut may have historically alternated between the two rotor blade positions, it is recommended to inspect the grip tangs and bolts associated with both rotor blades
3. take photos of the defect prior to any disassembly. For close-ups, 'macro' mode on your camera will likely provide clearer photos
4. quarantine all removed parts as you may be asked to hand these over to CASA to assist in further investigations.

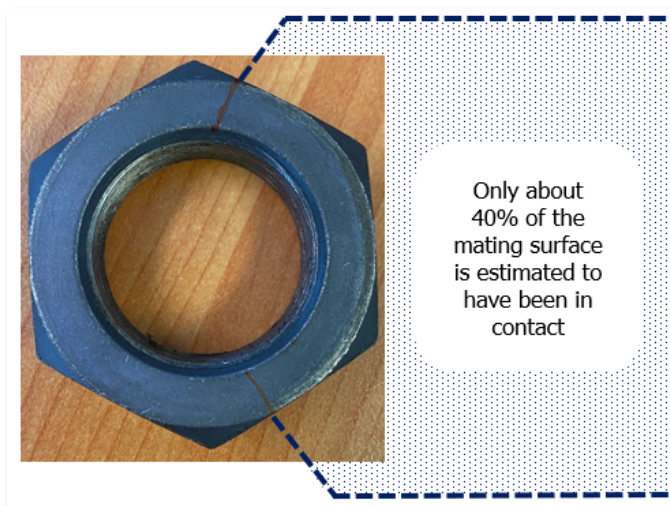
Figure 2 – Estimated contact area.

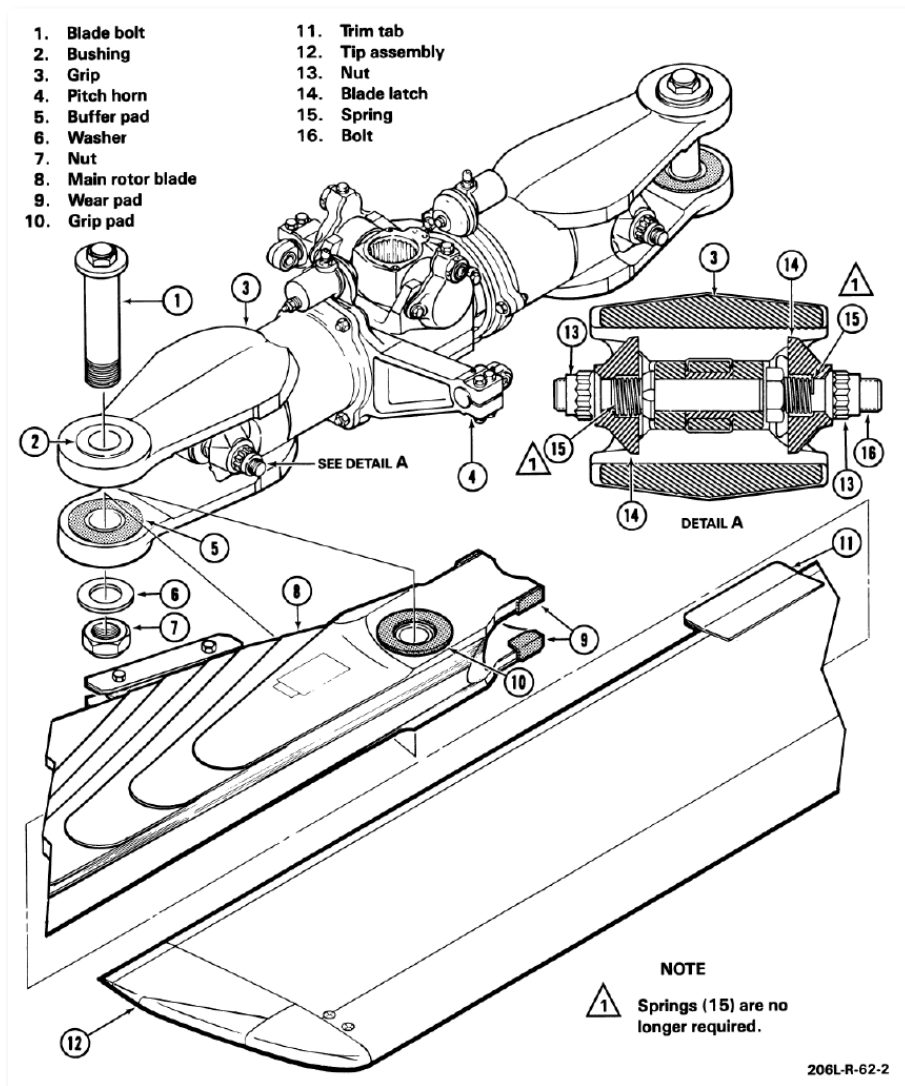
The retaining bolt and nut secures the main rotor blade to the hub assembly and serves to hold the grip tangs firmly together. Failure of this mechanism has the potential to result in structural failure of the hub assembly with catastrophic consequences.

Figure 3 – Main rotor hub and blade installation typical of the Bell 206.
