Airworthiness Bulletin

AWB 76-004 Issue 2 – 15 February 2024

Propeller Governor Control Cable Failure

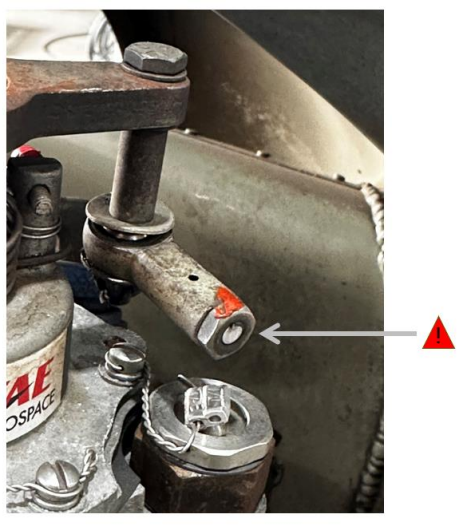
During troubleshooting following an inflight event, the propeller governor control cable linkage was found sheared at the rod end locknut, (See Figure 1).

Figure 1. Failed governor control shaft.

Extension of the cable beyond the intended limits of linear movement has the potential to cause damage similar to that shown in Figures 1 and 2 above.

1. Operators and licenced engineers pay particular attention to correct rigging procedures stipulated within the aircraft ICA and that push-pull rod ends are not extended beyond their linear movement.
2. Operators schedule a visual inspection of the governor linkages on their aircraft. Shafts with misaligned or bent ends should be replaced prior to further flight.

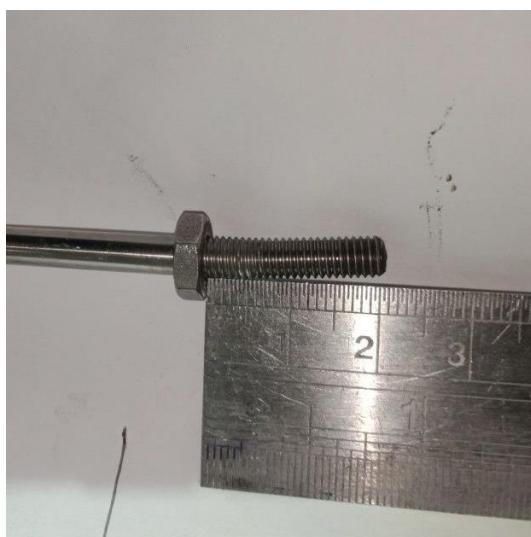
The operator undertook a fleet wide inspection and found an additional three (3) aircraft with this linkage bent but not sheared at the locknut, (See Figure 2).

Figure 2. Bent rod end of propeller governor control shaft.

The AMM procedures for the '*Engine Controls Function Check*' includes a Detailed Inspection of related hardware, namely the propeller speed control cable from cockpit lever to governor lever. The level of disassembly required for the task may not expose the damage observed in Figure 2, however, the task does provide a maintenance opportunity at which operators could verify control cable serviceability.

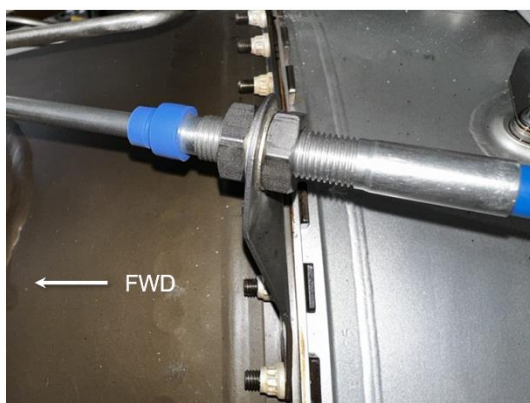
The AMM procedures for rigging the propeller governor control cable requires the LAME to adjust the cable mounting bracket fittings (located on the flange of the reduction gearbox) until there’s a cushion of between $\frac{1}{8}$ ” and $\frac{1}{4}$ ” at the propeller speed control lever in the cockpit, when the lever is at the ‘max RPM position’. See Figure 3 and 4 below.

Figure 3. Cable mounting bracket fittings, located on the flange of the reduction gearbox

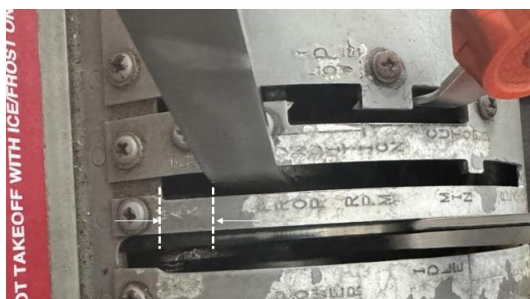
One operator has reported findings across their fleet of almost $\frac{1}{2}$ ” cushion, well outside the limits stipulated in the AMM. Textron have provided the following clarification to the operator about the ‘cushion’ that is referred to in the AMM procedures:

“The system is designed with a primary and secondary stop. The primary stop is at the propeller governor and the secondary stop is at the throttle quadrant/pedestal. The word “cushion” as used in the AMM defines the distance measured between the lever and the secondary stop within the throttle quadrant/pedestal, when the speed adjustment lever at the propeller governor is against the max rpm stop or primary stop.”

Figure 4. The 'cushion' of the propeller speed control lever

Maintainers are also urged to consider the potential for changes to the cushion dimensions that might occur if the friction lock is subsequently adjusted. Where in doubt, further clarification can be sought from the Type Certificate holder, Textron Aviation Inc.

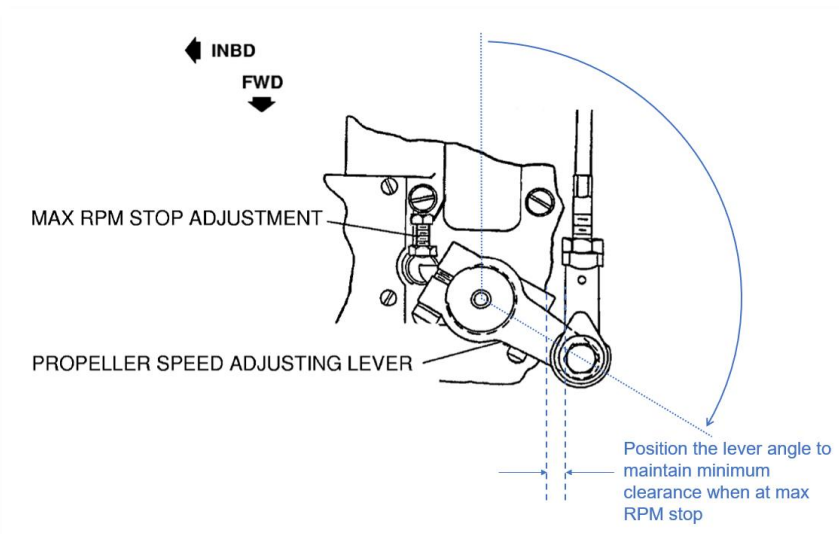
During assembly, the speed adjusting lever on the governor body must be installed onto a serrated shaft. The position of the lever on the shaft must ensure that clearance between the cable (including the rod-end) and governor body is maintained. See Figures 5 and 6 below.

The serrations on the shaft enables the lever to be positioned in 5-degree increments. If the lever is too far clockwise when held against the 'max RPM stop', the cable may be pulled into a position where the rod end contacts the governor. When correctly rigged, the rod end should not contact the governor body at any stage of the linear movement of the cable.

Figure 5. Top view drawing indicative of governor and cable rod end assembly.

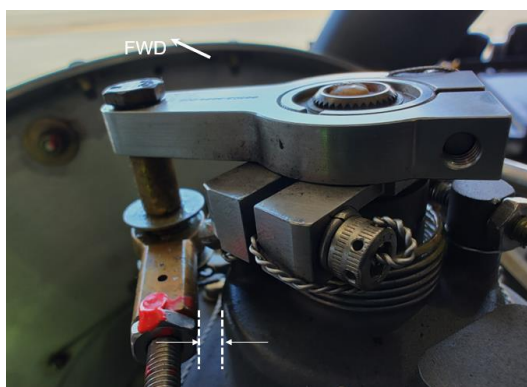
Figure 6. Nil contact between the cable (including the rod end) and the governor body.
