# Airworthiness Bulletin

## AWB 63-004 Issue 4 – 5 March 2024

### Kamatics Corporation KAflex Drive Shafts – UH-1 and Bell 206/407/412

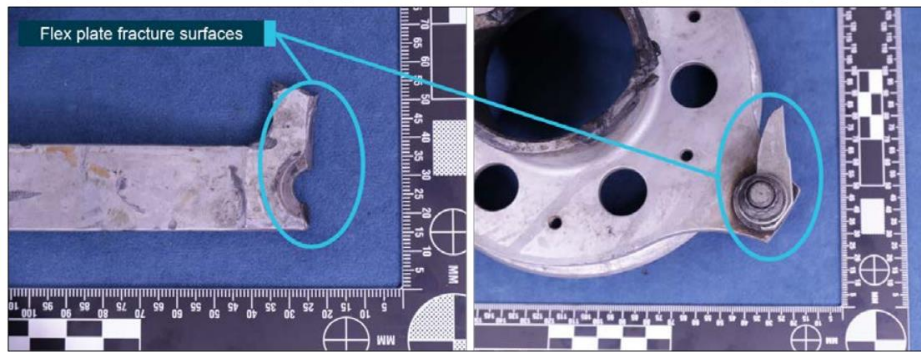
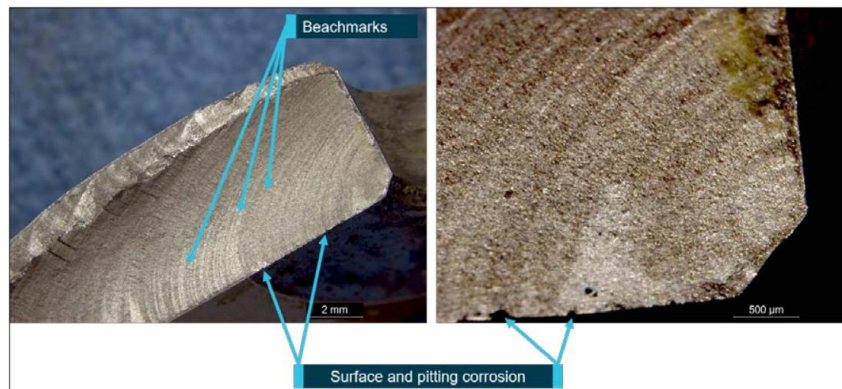
To advise that two ATSB investigations (AO-2019-070) and (AO-2022-006) found that fatigue failure of a flex plate at a bolt hole and missing hardware as findings to the two incidents, highlighting the importance of performing a preflight inspection of the engine to transmission drive assembly.

**Figure 2** - Images highlighting failed flex plate from KAflex drive shaft.  
Source: ATSB report AO-2019-070

- a. Visually check for broken, loose and missing flex frame connecting hardware (washers, nuts or bolts).
- b. Inspect flex frame and mount bolt torque stripes for evidence of slippage/misalignment that may indicate rotation / movement of the connecting nuts or bolts.

**CASA Note:** *Evidence of slippage and Indications of loose hardware may include traces of “brown dust” (fretting particulate) coming from any flex frame fastener area.*
