Airworthiness Bulletin

AWB 67-007 Issue 1 – 07 Mar 2025

AW139 Tail Rotor Pedal Control Tube Cracking

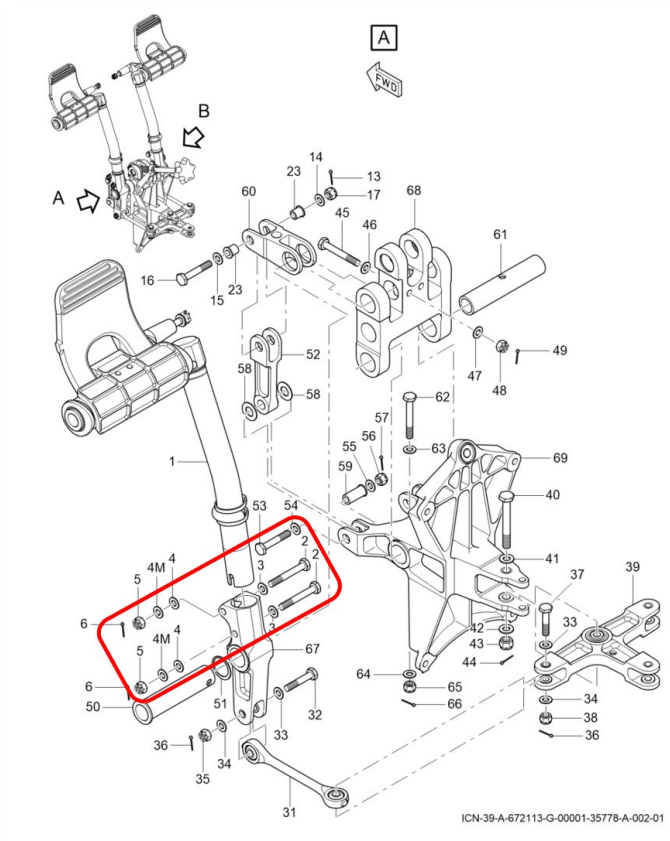
CASA has been made aware of cracks found in the tail rotor pedal control tube assemblies of five (5) AW139 aircraft operating with three (3) different operators. See Figure 1 for indicative crack location and Figure 2 for an example of the cracking presented.

Figure 1. Indicative location of cracks found.

However, given the failure of a tube could lead to loss of tail rotor control, CASA strongly recommends that all AW139 operators conduct an urgent fleetwide inspection to a timeline and rigor appropriate to your fleet and risk-exposure.

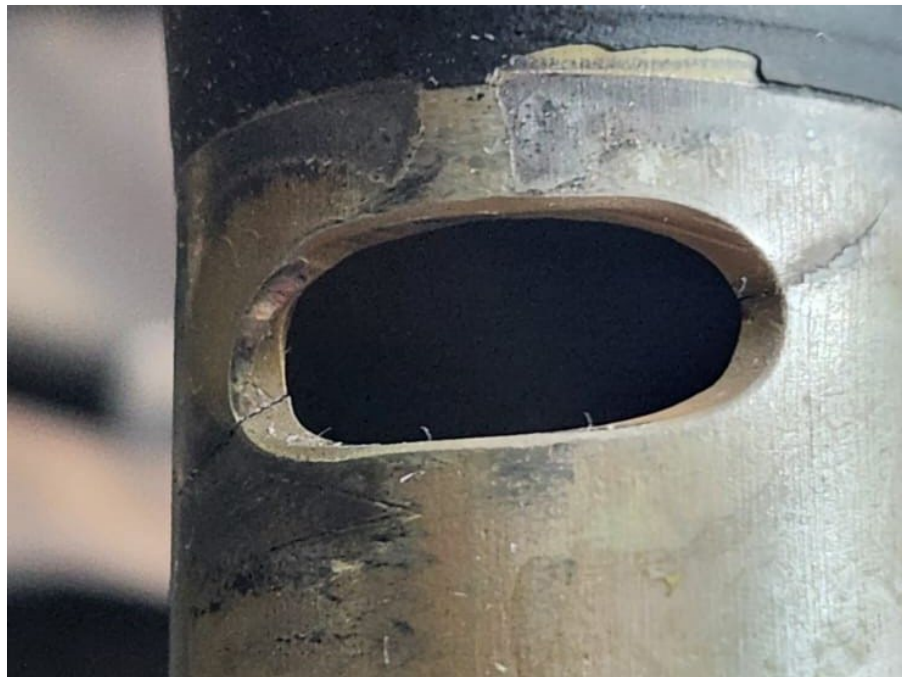
The cracking was first observed when an operator gained access to the area for unrelated defect rectification. The operator then launched a fleetwide investigation to find cracking on further aircraft, after which they have informed other AW139 operators known to them.

Figure 2. Crack presentation of the first finding reported to CASA.
