Airworthiness Bulletin

AWB 27-024 Issue 1 – 22 October 2025

Possible Presence of Corrosion in PA-25 Jury Struts.

Corrosion in wings's Jury Strut Assy.

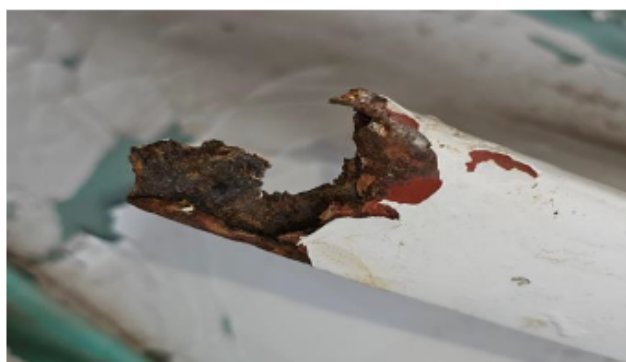
Figure 1 - Intermediate Jury Lift Strut P/N: 64260-000

The investigation carried on by the registration state, revealed the presence of severe corrosion on the outer LH Jury Strut, as shown in Figure 1.

Figure 1 shows that corrosion reduced the jury strut's cross-sectional area, decreasing its load absorption capacity.

If any of the JS's tubes show signs of external corrosion, perform an ultrasonic NDT, to verify the tube wall thickness. The JSs were manufactured with 0.035 inches thickness tubes. Tubes with a reduction of up to 10% are acceptable, giving a minimum allowable wall thickness of 0.0315 inches.

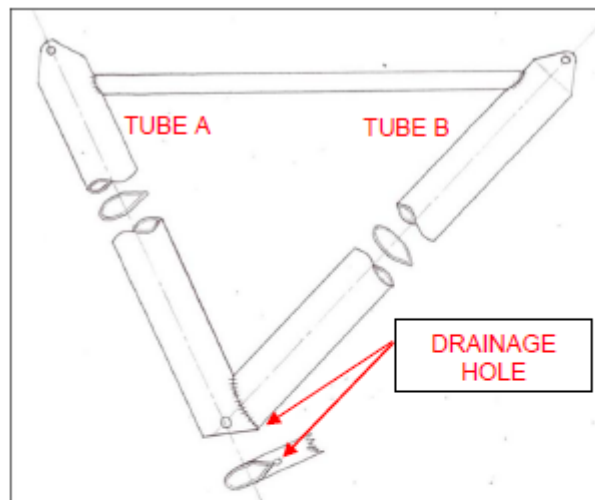
1- For P/N 61066 (Strut assy – Jury), applicable only to PA-25, the dwg indicates a drainage hole in the lower portion of the rear tube. That hole is 0.098-inch diameter.

2- The RH figure shows exactly where the drainage hole is located.

3- The upper-end lugs, which connects the JS with the Struts, are open. This condition might result in water entering inside the tubes. Therefore, the drainage hole must be free of blockage in order to drain properly. Since TUBE A and TUBE B intersection is welded, TUBE B might only drain via the drainage hole described before. For the TUBE A, it is open in both ends.

- 1- For P/N 61066 (Strut assy. – Jury) used in the PA-25, during each annual inspection, verify that the drain hole is free of any obstruction. If the hole is blocked, perform an ultrasonic NDT to check tube's wall-thickness as indicated in the 2nd paragraph of the RECOMMENDATIONS section.
- 2- For JSs installed on PA-25-235 and PA-25-260 with the following P/N:
 - a. 64262 (Strut assembly - Inboard jury)
 - b. 64261 (Strut assembly – Outboard jury)
 - c. 64260 (Strut – Intermediate outboard jury)
 - d. 64259 (Tube assembly – Support, outboard jury strut)

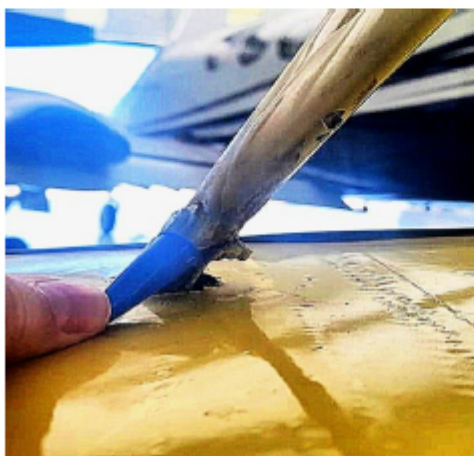
Figure 3 – Strut assembly inboard jury P/N 64262

- 7- Figures 3 and 4 show JSs that are OPEN in their lower end. However, their upper end is SEALED, as shown in Figure 5:

This condition might lead to corrosion inside the JSs due to ambient humidity.

Every Annual Inspection check that all JS's ends are sealed. If any of the them does not have all of their ends sealed, perform an ultrasonic NDT every 500-flight hours or every 5 years, whichever occurs first, to verify tube's wall-thickness as indicated in the 2nd paragraph of the RECOMMENDATIONS section
