# Airworthiness Bulletin

## AWB 64-003 Issue 1 - 11 December 2025

### Bell 47 HAC Tail Rotor Blade Leading Edge

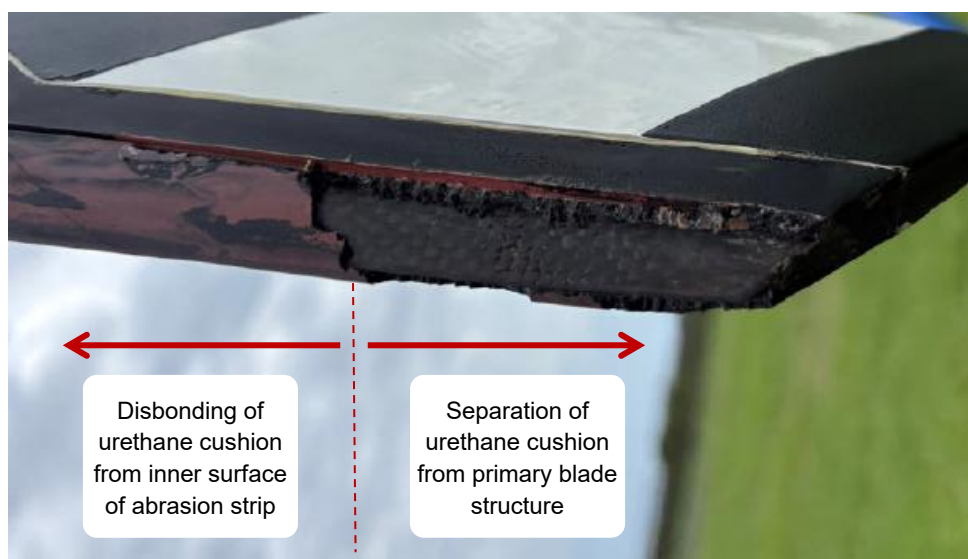
The suspected cause of the occurrence is that disbonding of the urethane cushion has reduced the dynamic load bearing capacity of the assembly, leading to the loss of the abrasion strip and partial loss of the urethane impact cushion.

At the time of the occurrence, the blade had completed 500 hours of the life limit of 4,000 hours.

Figure 1. Close up of damaged tail rotor blade leading edge

- A daily / preflight inspection of the tail rotor blade leading edge; and
- A detailed visual inspection (DVI) and / or non-destructive inspection (NDI) to be done during the periodic scheduled maintenance inspections for the aircraft.

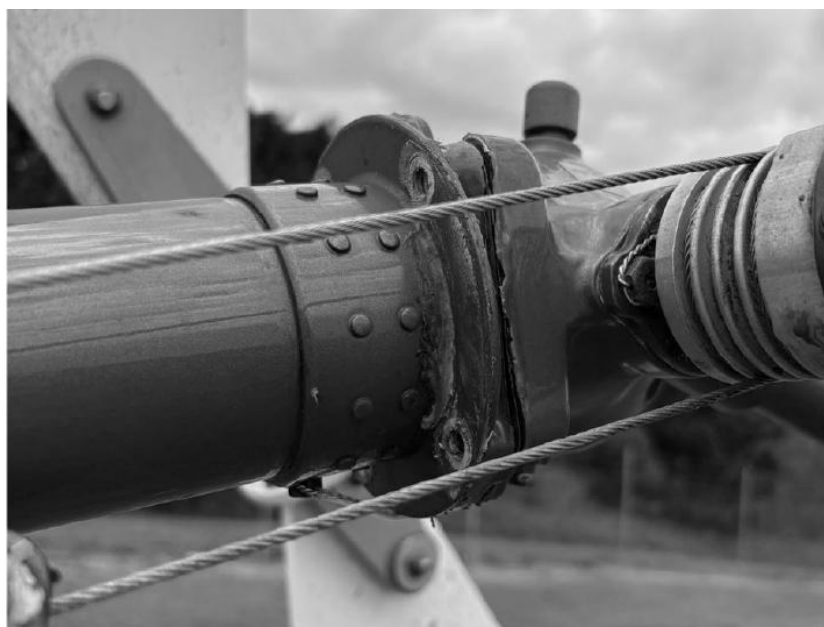
It is likely that the subsequent vibrations caused by the unbalanced tail rotor then caused the gearbox mounting studs to shear off and dislodge the control cable idler from its mount.

Figure 2. The gearbox mounting studs were found to have sheared off

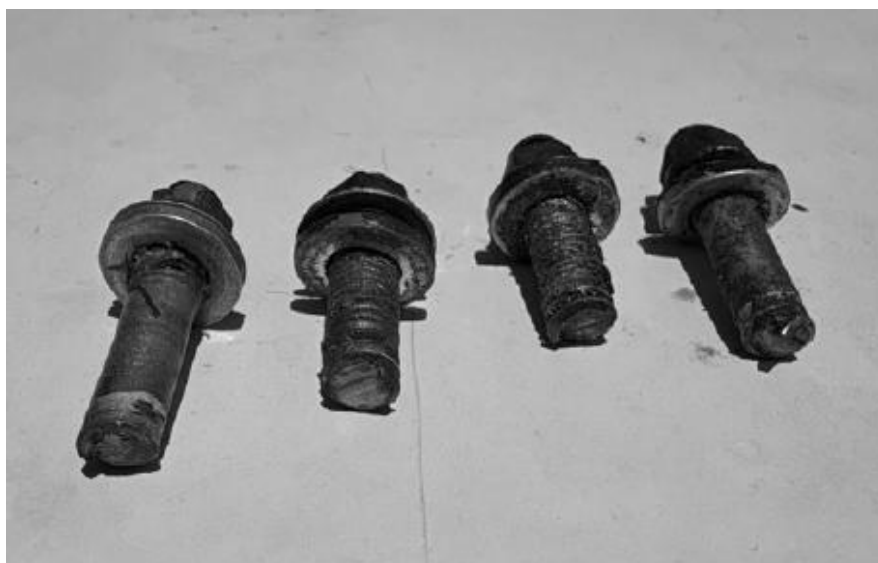
Figure 3. The four missing mounting studs were found on ground, close to the landing site
