Airworthiness Bulletin

AWB 62-008 Issue 1 - 30 January 2026

UH-1B Bell 204 TT Strap

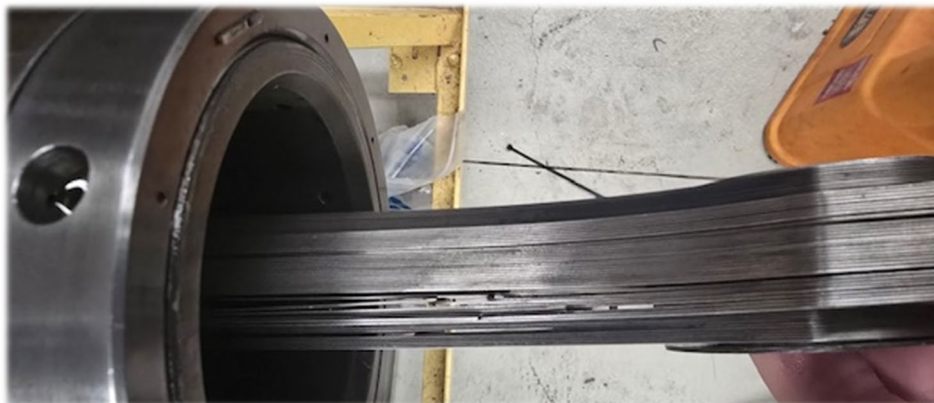
The purpose of this CASA airworthiness bulletin (AWB) is to advise UH-1 operators and maintainers of a defect report (DR) that was submitted to CASA where the TT strap part number 204-011-113-1 was found to have cracked / failed segments within the TT strap. See Figure 1.

Figure 1. Subject failed segments of Main Rotor Tension Torsion Strap

Whilst a definitive cause for the failed segments is to be determined, the initial investigation has highlighted disparities between the operator's maintenance program (based on military TMPs) and the civil variant's airworthiness limitations. For example, the P/N in question is operating on a significantly longer life limit compared to the identical P/N when installed on the civil equivalent Bell 204.

Secondly aircraft utilisation may need to be factored into the life limit of the subject TT straps, particularly in light of ultra-low utilisation of some UH1 aircraft in Australia.

Regardless of the final conclusion of why the TT straps in question failed, CASA recommends that operators and maintainers of UH1 aircraft do the following:

1. Consider incorporating any requirements that are *more restrictive* within the civil variant's airworthiness limitation section, particularly when part numbers are identical.
2. Ensure that pilots report main rotor overspeed or abnormal flight loads and any irregular vibrations to engineering and annotate the Maintenance Release accordingly, directing maintainers to take a closer look for potential damage.
3. Consider the safety implications of using "new old" military stock with no hours in service but has been in storage for multiple decades, often without storage instructions from the original equipment manufacturers (OEM).
