# Airworthiness Bulletin

## AWB 62-008 Issue 2 - 27 February 2026

### UH-1B Bell 204 TT Strap

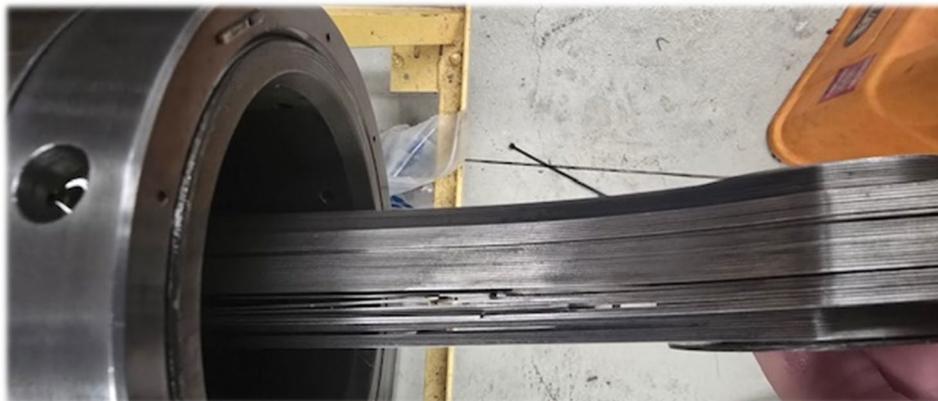
The purpose of this CASA airworthiness bulletin (AWB) is to advise UH-1 operators and maintainers of a defect report (DR) that was submitted to CASA where the TT strap part number 204-011-113-1 was found to have cracked / failed segments within the TT strap. See Figure 1.

The failed TT strap reported to CASA raised concerns as the TT strap part number 204-011-113-1 is not included within the applicability of either CASA AD/UH-1/18 or FAA AD 2002-20-01.

**Figure 1. Subject failed segments of Main Rotor Tension Torsion Strap**

1. Consider incorporating any requirements that are *more restrictive* within the civil variant’s airworthiness limitation section, particularly when part numbers are identical.
2. Factor aircraft utilisation into the life limit of the subject TT straps, particularly in light of ultra-low utilisation of some UH1 aircraft in Australia.
3. Ensure that pilots report main rotor overspeed or abnormal flight loads and any irregular vibrations to engineering and annotate the Maintenance Release, accordingly, directing maintainers to take a closer look for potential damage.
4. Identify and mitigate the safety risks arising from the use of “new old” military stock with no hours in service but which may have been in storage for multiple decades, often without storage instructions from the original equipment manufacturers (OEM).

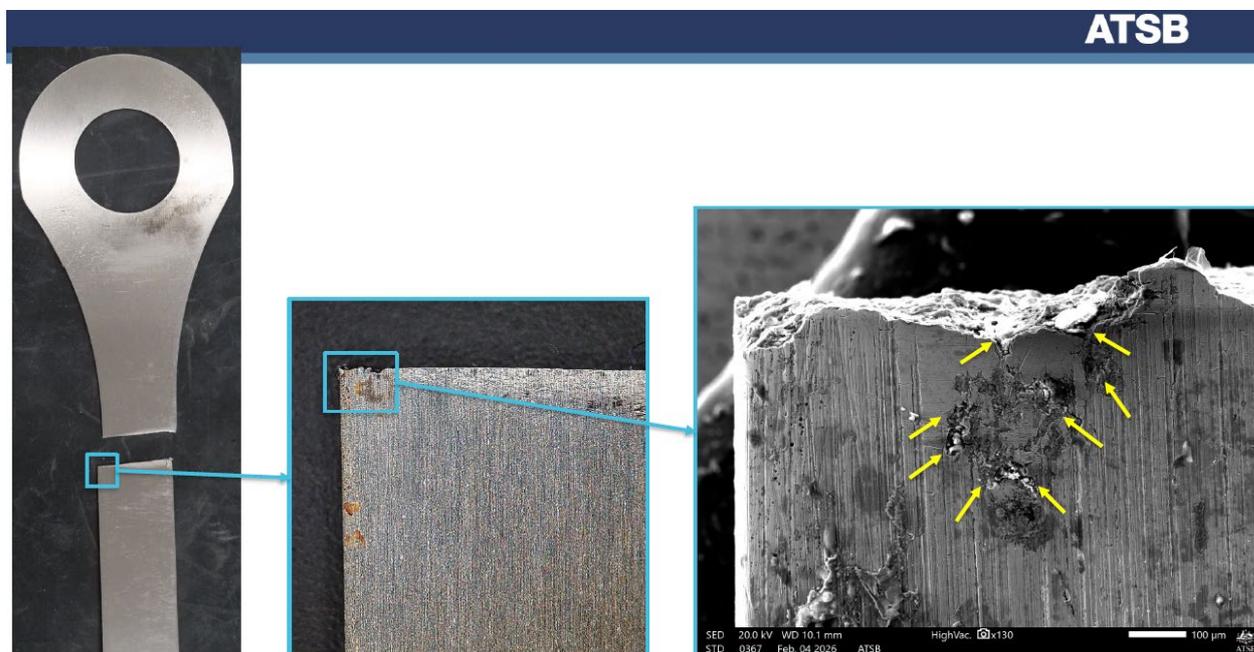
A detailed material analysis completed by the Australian Transport Safety Bureau (ATSB) laboratory observed chloride-induced crevice corrosion which lead to stress-raisers at the edge of the plates, with in-service loads then causing a progressive failure. See Figure 2 below from the ATSB analysis.

**Figure 2. Scanning Electron Microscope (SEM) images of corrosion pitting indicated by the yellow arrows**

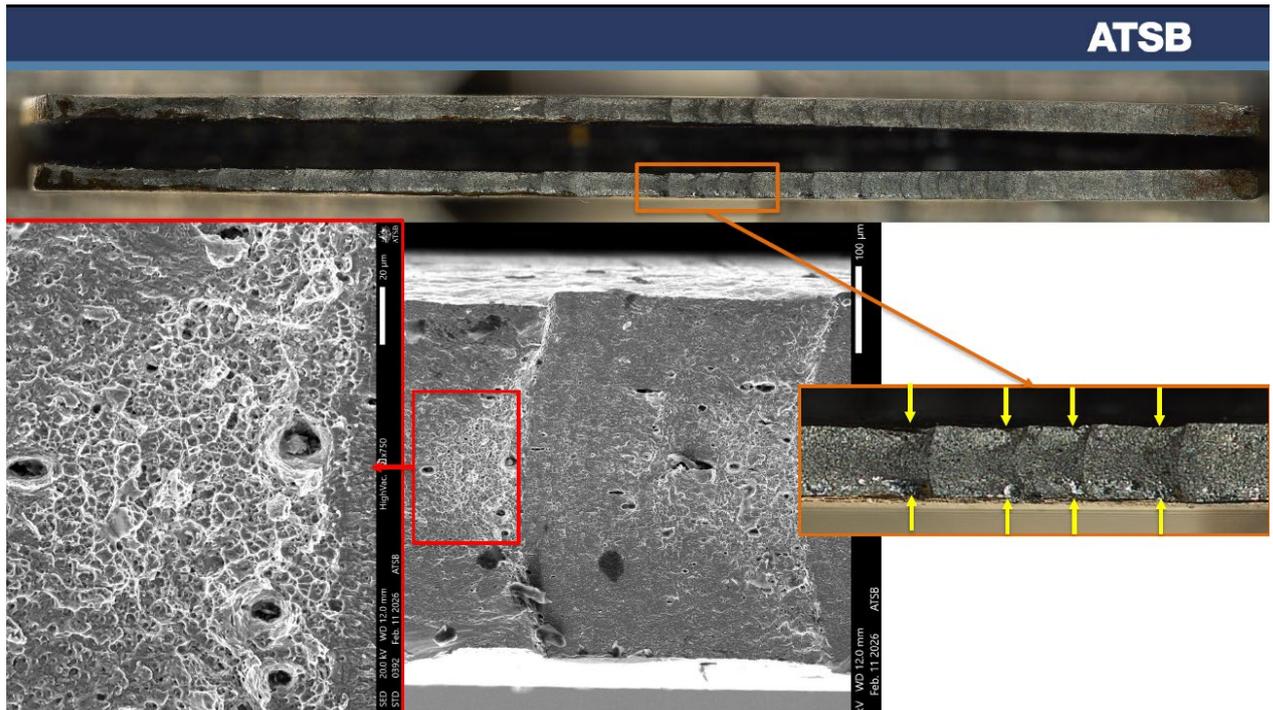
Further SEM images and analysis of the crack propagated surfaces by the ATSB, see Figure 3 below, “show crack arrest (beach) marks associated with fatigue crack progression. As the crack progressed from approximately one quarter of the crack length, pockets of uniform, ductile rupture and plastic deformation (as would be expected from tensile failure) punctuated the beginning of each crack cycle. This indicated crack progression under relatively high strain conditions.”

Figure 3. SEM image provided by the ATSB laboratory.
