AIRWORTHINESS BULLETIN

Unapproved Parts - Challenger Aero
Engineering - Chrome Plated Engine Cylinders

AWB 01-027 **Issue** : 1
Date : 25 January 2013

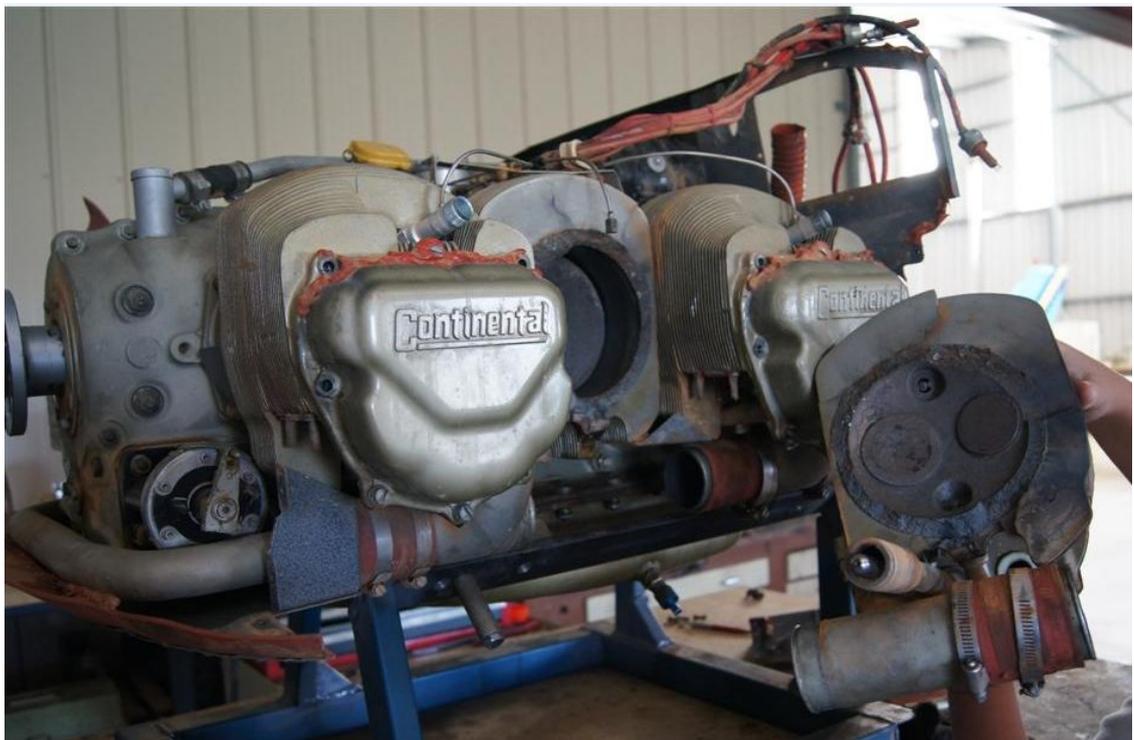
Figure 1. Typical cylinder head separation for Lycoming and TCM engines for illustration purposes only. (The failed cylinder depicted was not repaired by Challenger)

Given that some damage (wear) must occur to the threads during removal and re-installation, it can be seen the re-alignment can take place at less than optimal pre-load. Merely achieving the same alignment as before may not achieve the design pre-loading for the threaded joint. Less than optimal pre-loading predisposes the assembly to fatigue failure which typically results in the head separating from the barrel – usually in flight. (See figure 1.)

- (a). Maintainers, overhaulers, operators and owners should pay particular attention to determining the source and identity of all components used on their engines and use only approved parts.
- (b). All cylinders repaired by Challenger Aero Engineering (formerly Challenger Engineering) should be removed from service, identified and subjected to mutilation and disposal to prevent re-use.
