Cessna 400 Series Electro-Hydraulic
Undercarriage Systems

AWB 32-017 **Issue :** 3
Date : 19 September 2014

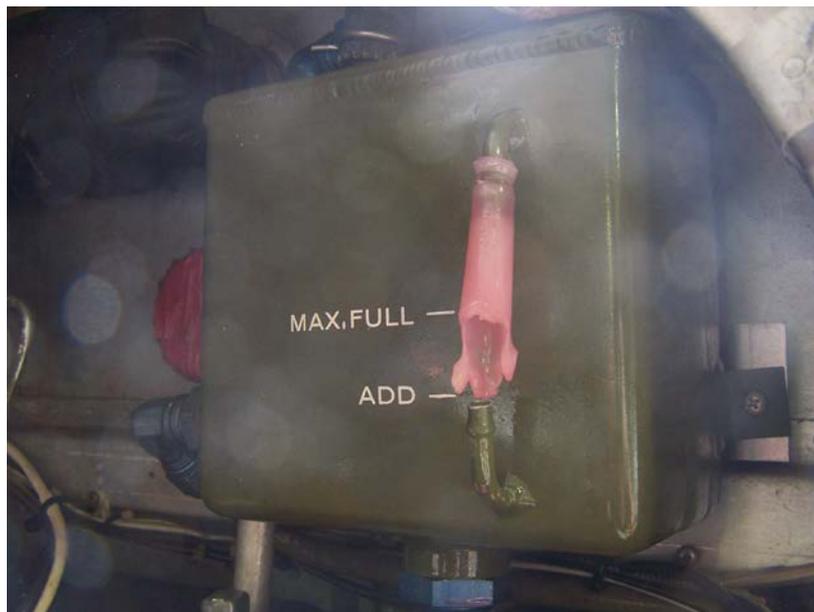
The sight 'glass' in the undercarriage system hydraulic reservoir is a plastic tube showing the level of the oil in the reservoir. In-flight failures of the sight tube are usually due to the plastic tube melting due to contact with overheated hydraulic system hydraulic oil. When the plastic sight tube melts, it releases hydraulic system oil into the fuselage nose section and can be accompanied by reports of smoke in the cockpit.

Hydraulic system oil overheats when the undercarriage has not fully completed the 'up' cycle. Whenever the off-loading valve remains energised in the 'loaded' position, it causes the engine driven pumps to continue to pump oil at high pressure against the weight of the undercarriage and through small orifices in the system. This heats the oil very quickly, melting the hydraulic reservoir sight tube, liberating overheated system oil, with resulting smoke in the cockpit.

Fig. 1 Melted hydraulic reservoir sight tube.

Catastrophic in-flight failures of the hydraulic reservoir sight gauge due to system hydraulic oil overheating may be avoided by following the procedures in the aircraft Flight Manual.

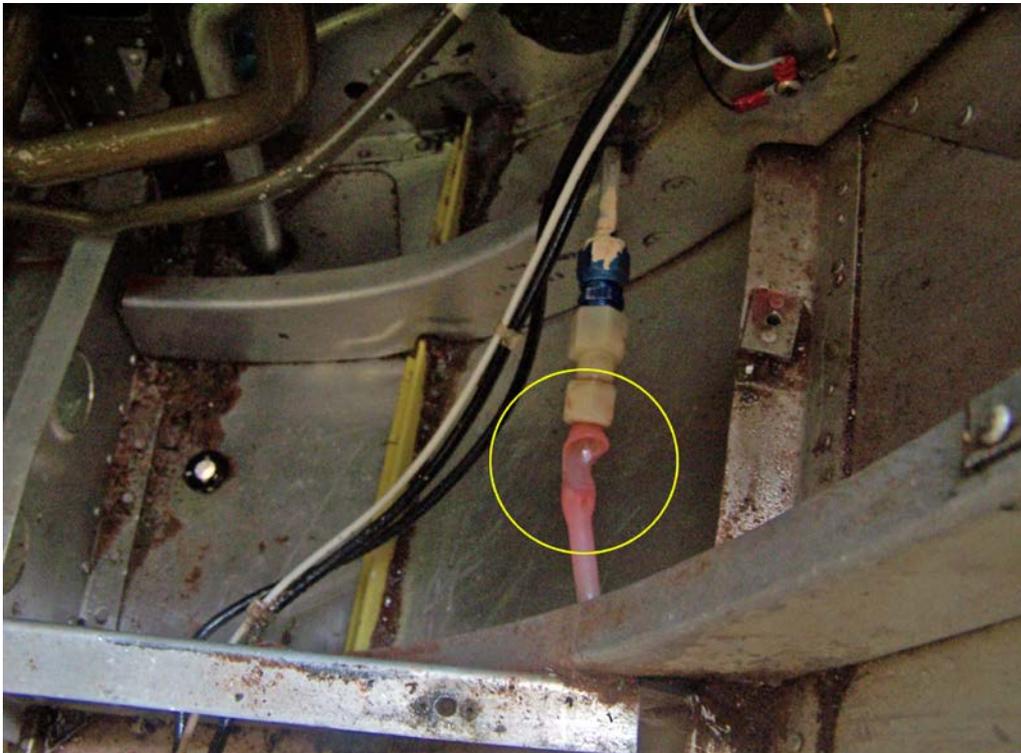
Fig. 2 Melted captain's Pitot tube under the baggage compartment floor.

The hot oil not only melted the hydraulic reservoir sight tube, but the resulting hot oil released also melted the captain's air speed indicator pitot line under the floor of the nose baggage compartment. This resulted in the the captain's ASI displaying zero knots in-flight.

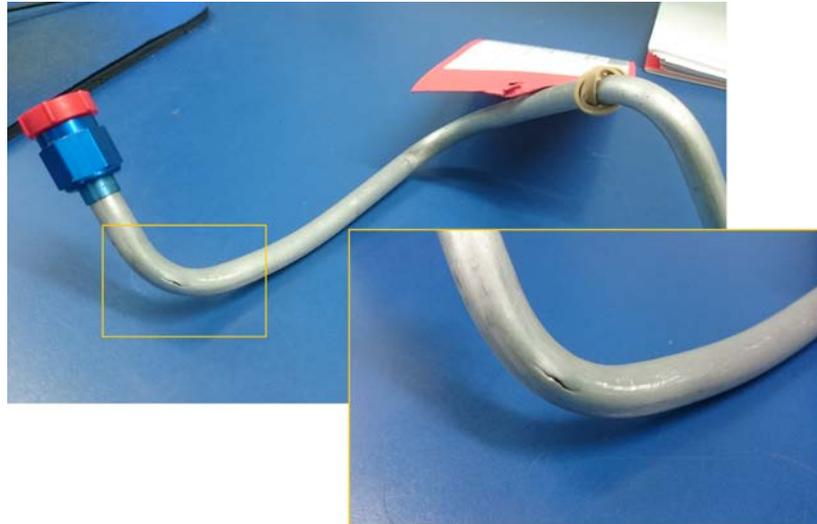
Fig.3 Cracked hydraulic line.

Reports show that in some cases, internal corrosion pitting had developed into pin holes which developed into significant leaks. In addition, sections of aluminium piping have failed due to fatigue and chaffing. Such failures allow the undercarriage system hydraulic oil to be pumped overboard or into the wing cavity and allow the engine driven pumps to run dry, leading to possible pump failure and hydraulic system contamination.

As may be appreciated, the hydraulic system pipes experience continual pressure cycles and can suffer fatigue failure. Further, fatigue cracking in a hydraulic pipe or line on one side of the aircraft hydraulic system can be followed by the corresponding hydraulic line failing on the opposite side of the aircraft shortly afterwards, due to similarity in design and enduring similar pressure cycles.

The Cessna 400 Maintenance/Service Manuals require visual inspections of all of the plumbing in the system at regular intervals. In some cases there is also a requirement to pressure test the plumbing in the system to approximately 50% above the normal maximum system operating pressure, in order to reveal any potential weaknesses in the plumbing.

- Include a periodic close inspection of the hydraulic system lines or pipes, particularly in the wing leading edges, wheel wells, etc. in accordance with applicable manufacturer's data.
- Advise and remind pilots to ensure they check/test the function of the aircraft annunciator panel as a part of their daily/pre-flight inspection.
