1. Effectivity

Aircraft incorporating pilot-operated primary flight control surface trim tab systems and trimmable horizontal stabilizers.

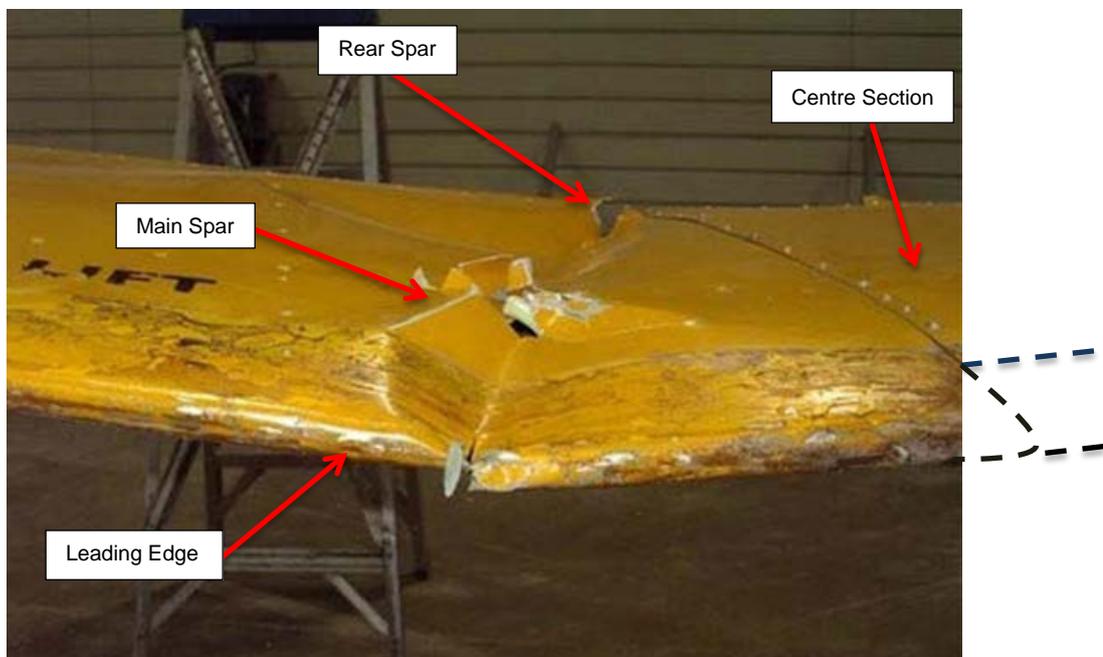
Figure 1. Cessna U206F. Failure of both the front and rear spars in the right hand horizontal stabilizer following failure of the trim jack threaded rod end (Transport Canada Civil Aviation SDR RDIMS No: 5537310.)

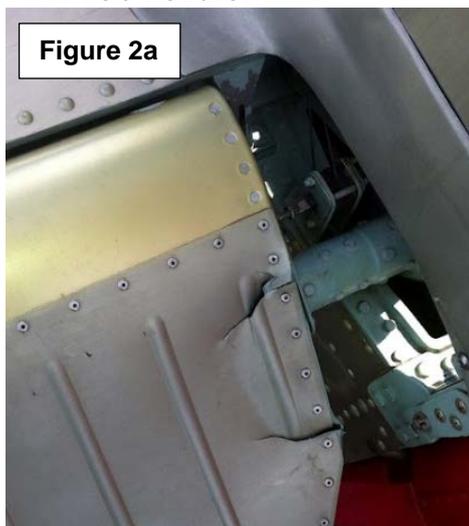
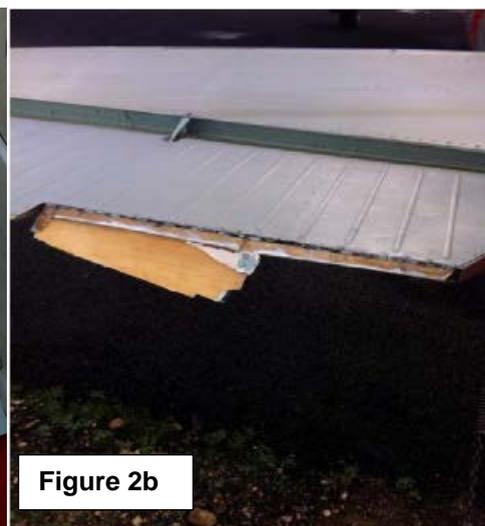
Watch the event [here](#).

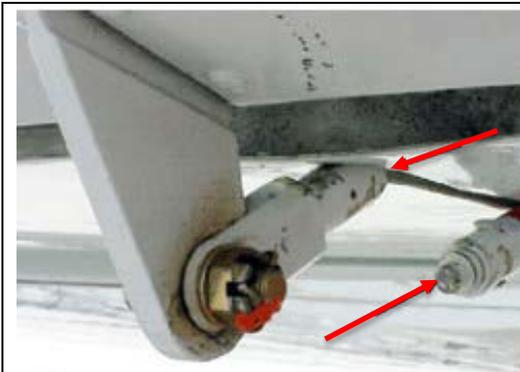
Figure 3. Beech King Air C90 Failed elevator trim tab push rod due to fatigue.

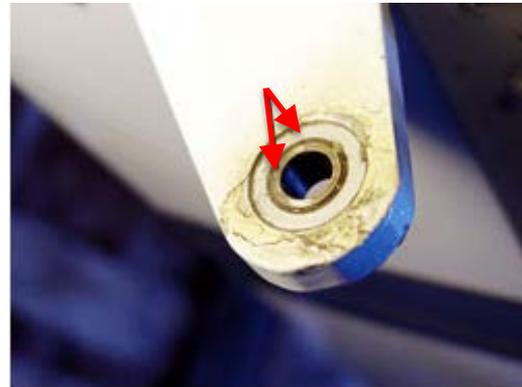
Figure 4. The Inner and outer bushing arrangement had become seized.

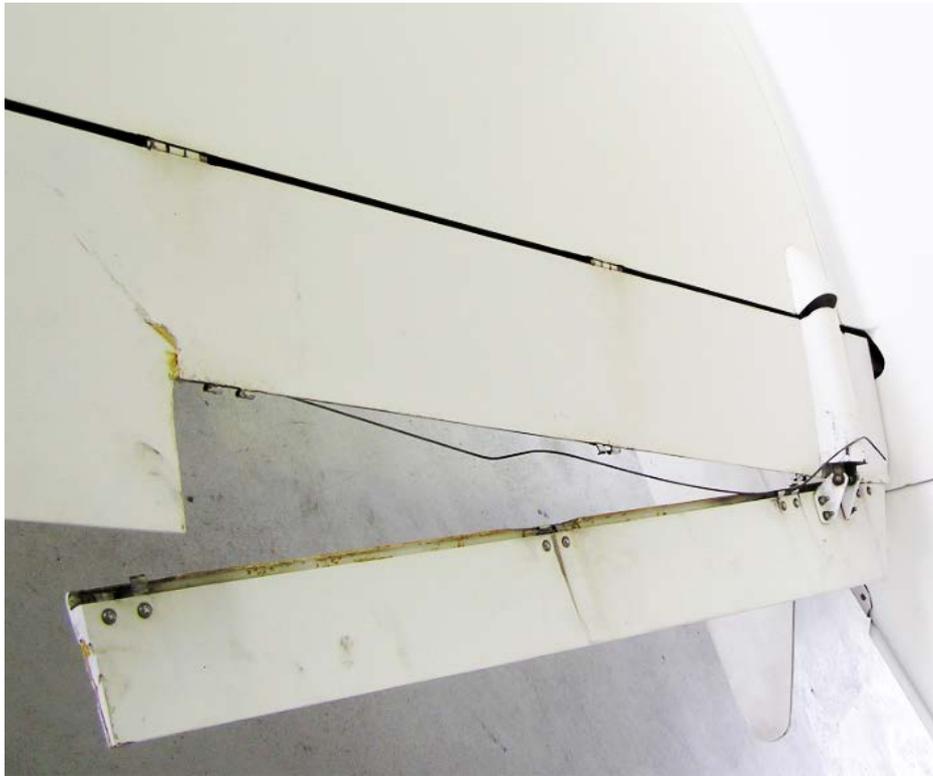
Figure 5. GROB Aerospace 115C. Elevator trim tab separation.

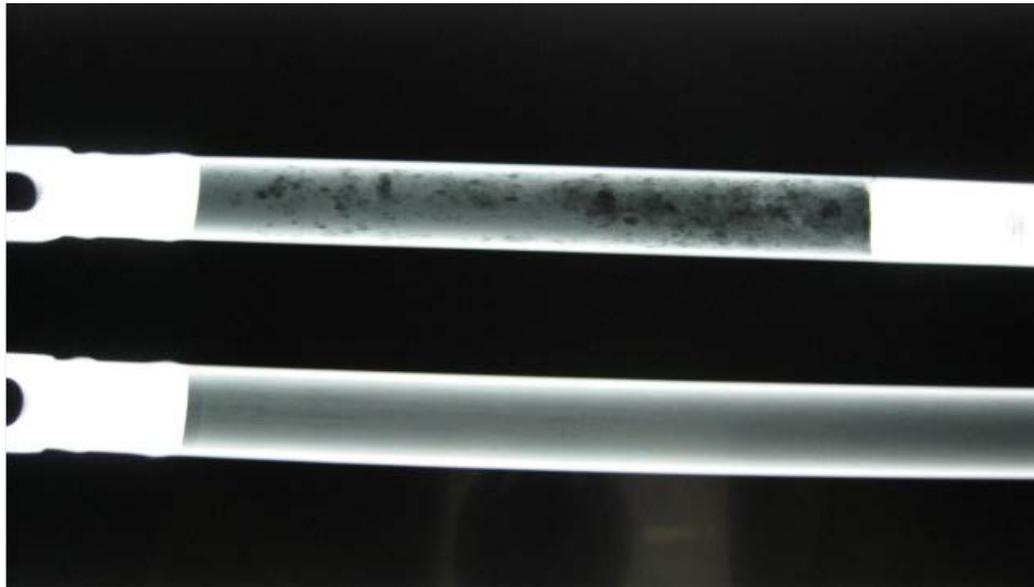
Figure 6. The top rod in this radiographic image is corroded internally. For comparison, the bottom rod has no detectable internal corrosion.

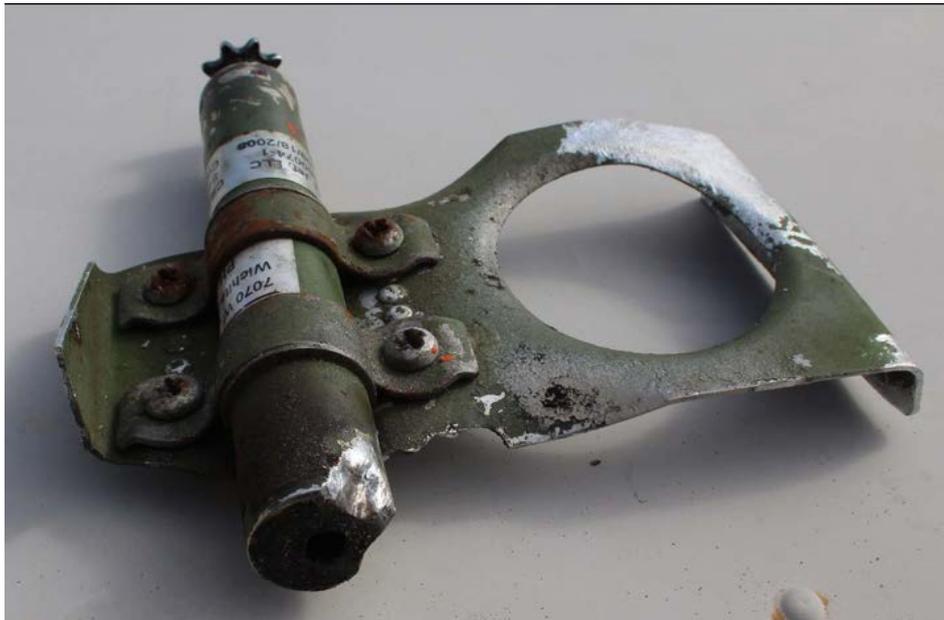
Figure 7. A Cessna 206 elevator trim actuator (rod end removed) still secured to a detached actuator mounting bracket.

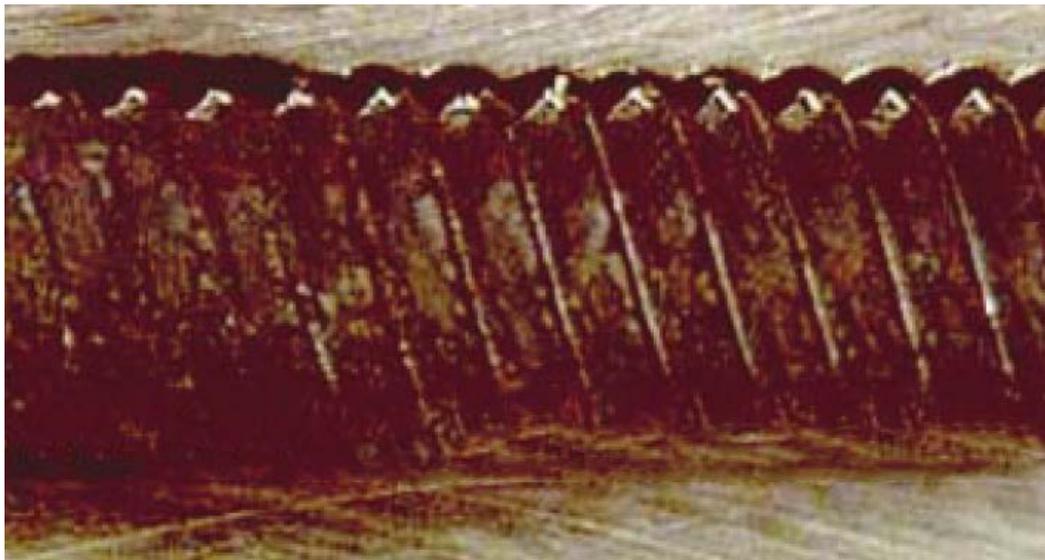
Figure 9. Worn trim actuator screw threads. (Flight Safety Australia “The Trouble with Trim Tabs”)

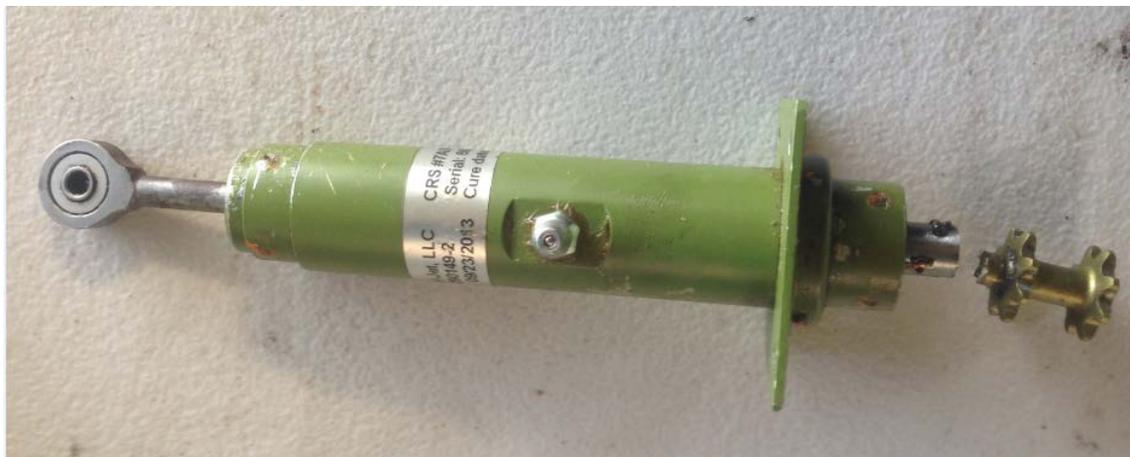
Figure 10. The elevator trim actuator drive failed in the area where the chain sprocket shaft is secured to the drive shaft by roll pins.
