1. Effectivity

All aircraft that utilise tubular steel structure that is or forms part of the primary (or secondary) structure of the aircraft.

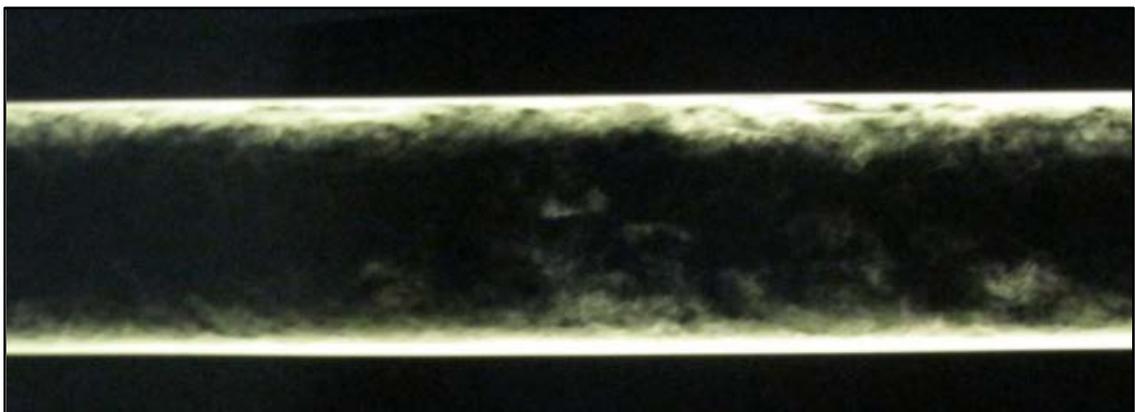
Figure 1 - A radiographic image of a steel tube in the aircraft primary structure showing indications of major internal corrosion and thinning of the wall structure.

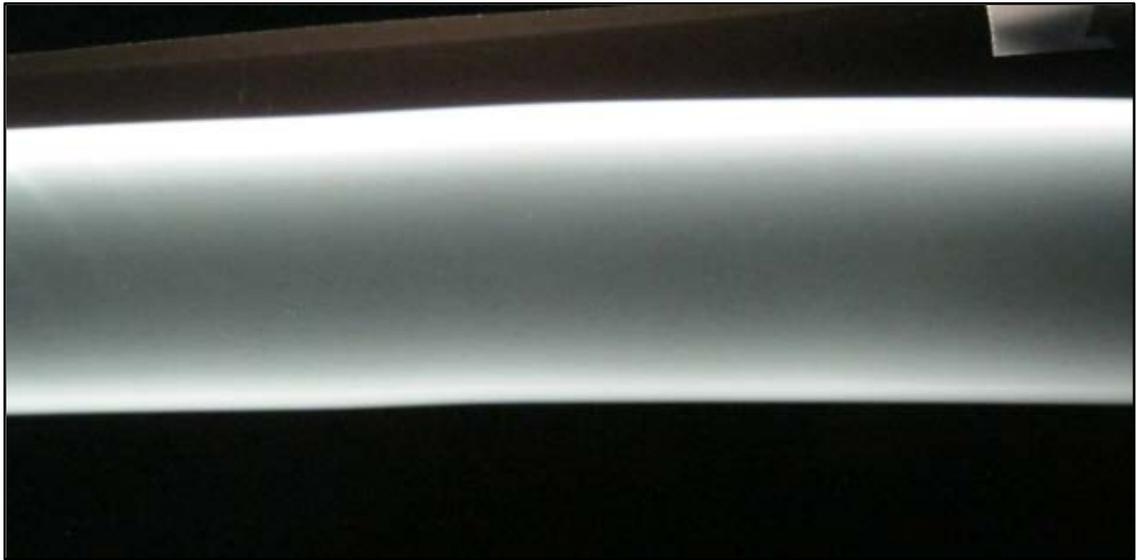
Figure 2 - Comparison. A radiographic image of a structural steel tube with no corrosion.

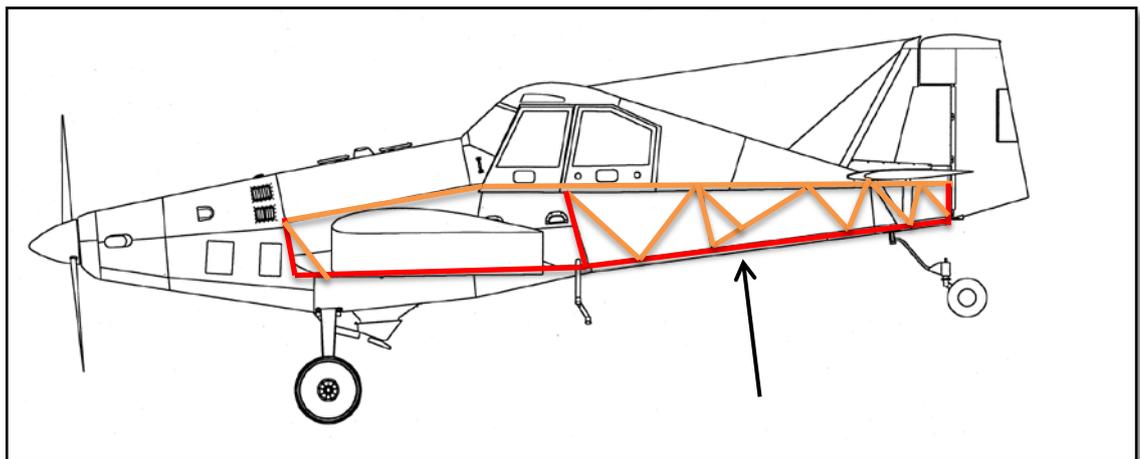
Figure 3 - Areas of corrosion suspected and detected in the lower longeron area (red) using radiographic NDT methods.

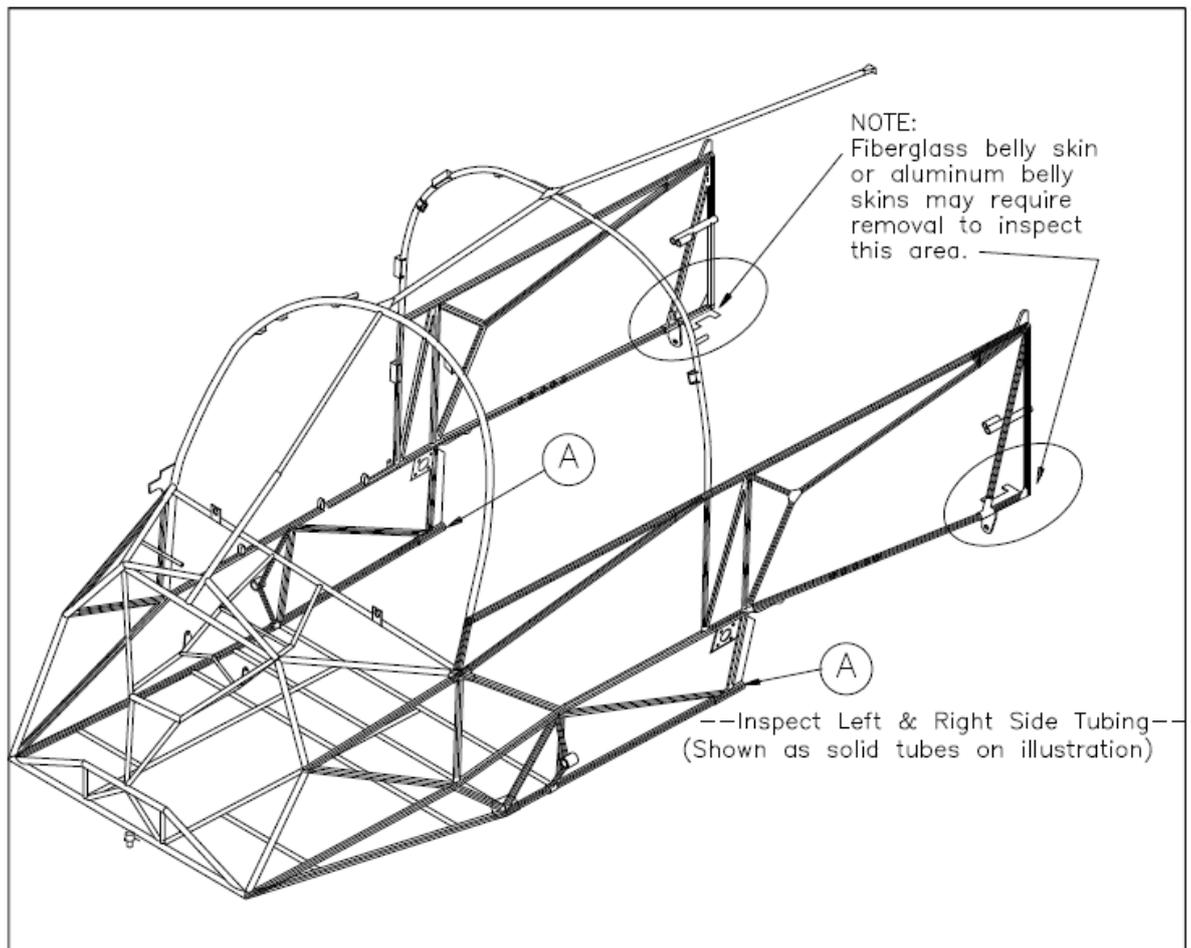
Figure 4 - Mooney M20 Series cabin section. Example of primary steel tubular structure to be periodically inspected externally and internally for corrosion in accordance with SB M20-208 B, mandated by AD/M20/32.

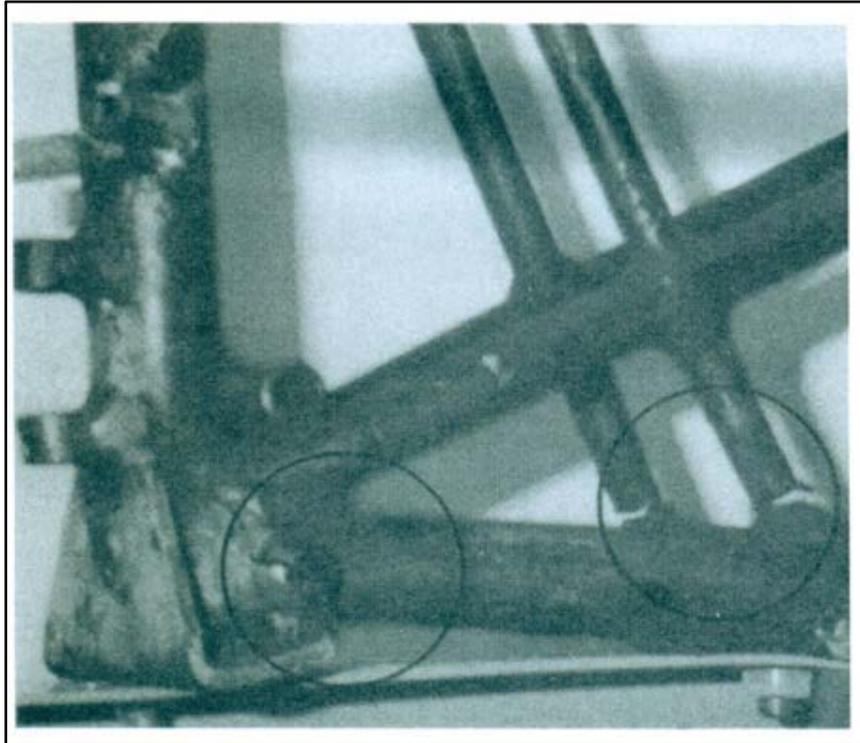
Figure 5a - (above) Typical fractured or separated tubes and cracks at tail wheel attachment fittings and Figure 5b (below) the general location of the failures

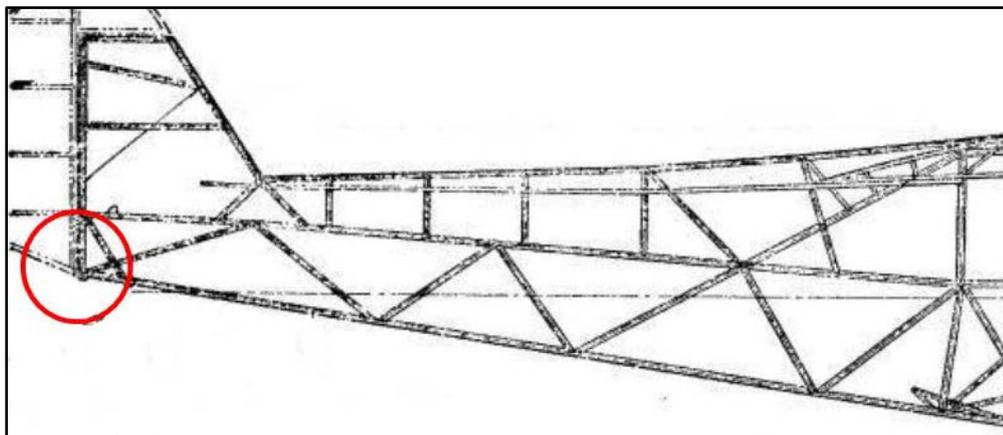
The Piper PA18 is a typical example. Fuselage tube cracking and tube separation occurs in the fuselage longerons, bracket joints and cross braces of any aircraft constructed from welded steel tubular structure (Fig. 6 below).

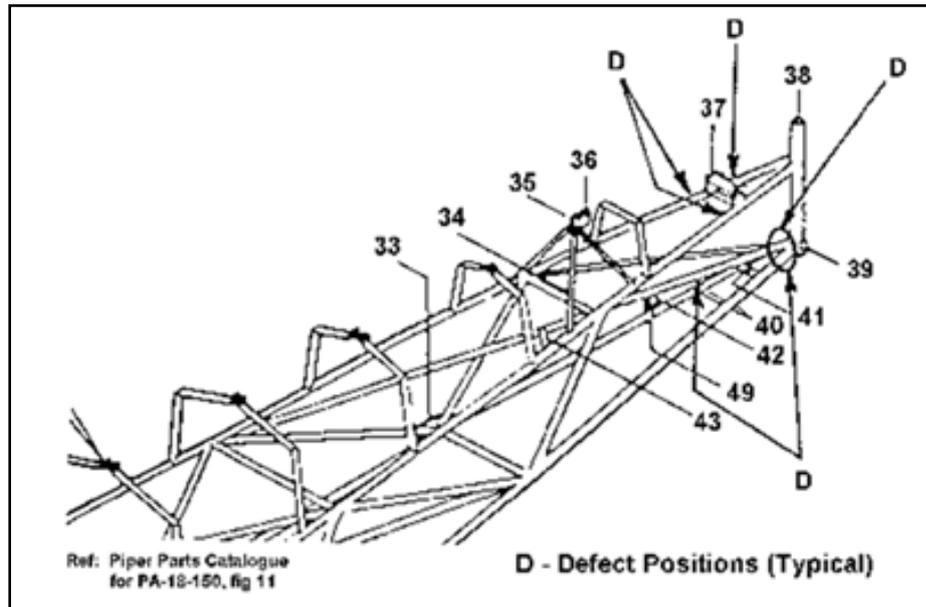
Figure 6 - Piper PA18. Typical fatigue cracking sites in the aft fuselage.

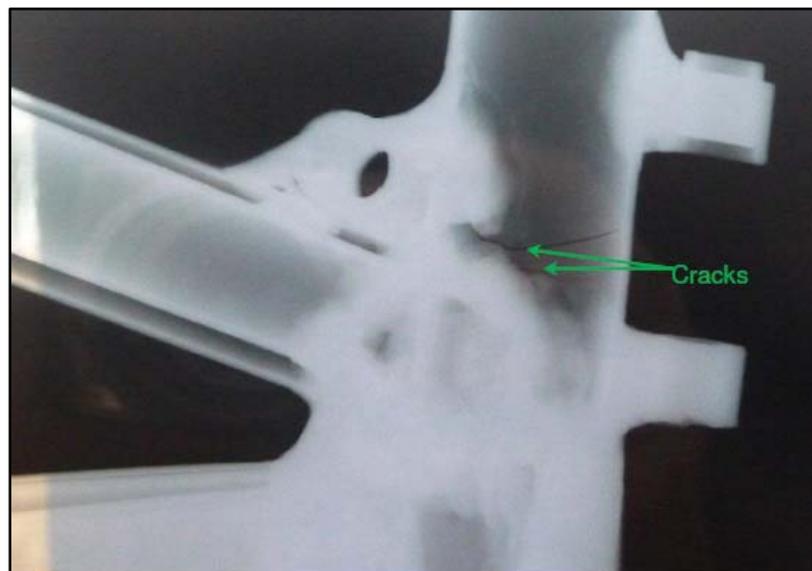
Figure 7 - Sample image of areas covered by fabric and showing cracks found during a radiographic inspection.
