Propellers.

To provide guidance on propeller continuing airworthiness/maintenance practices.

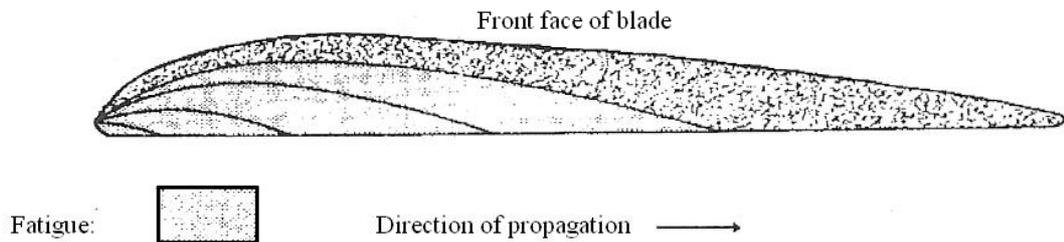
3. Analysis has shown that a single crack propagating in a chordwise direction may intersect the rear face of the blade for up to 75% of the chord length without intersecting the front face of the blade, therefore detection of the crack may only be possible from the rear of the blade (see figures 1a and 1b). The crack propagates in this manner due to thrust bending loads applied during operation.

Figure 1a. A schematic diagram of the crack propagation. Note the shape of the crack front intersecting the rear face but not the front face of the blade.

4. Investigation has shown that cracks have propagated over a long period, which in some cases exceeds thirty ground/air/ground cycles i.e. thirty flights. There is no evidence to suggest that failures have occurred where a crack may have propagated from initiation to final failure in one ground/air/ground cycle i.e. one flight. Therefore detection of the crack and prevention of failures of this nature should be achievable.
5. Some blade paint schemes are not conducive to easy inspection of the rear surface of the blade; therefore detection of the crack will rely on a more vigilant inspection of the blade in general, with particular attention being paid to the rear face and leading edge during the pre-flight inspection.

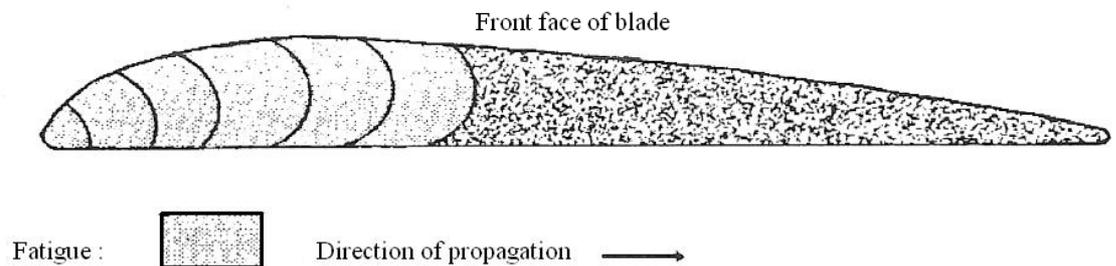
Figure 1b. A schematic diagram of the generally perceived nature of the crack propagation. Note the shape of the crack front.
