Airworthiness Bulletin

AWB 85-026 Issue 2 - 21 April 2022 Lycoming Engines - Valve Train Failure Checks

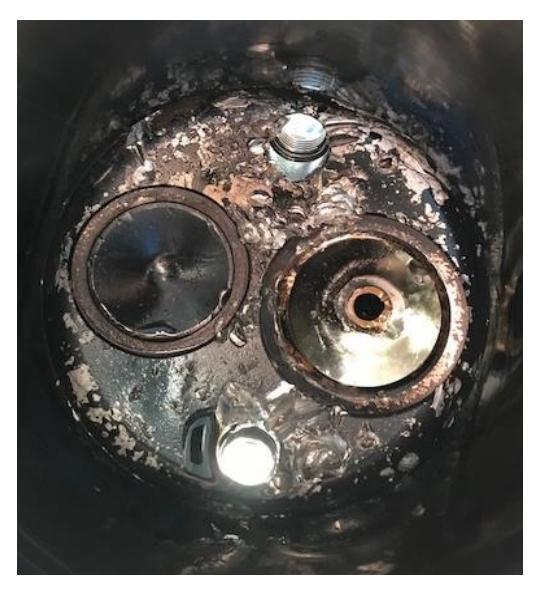
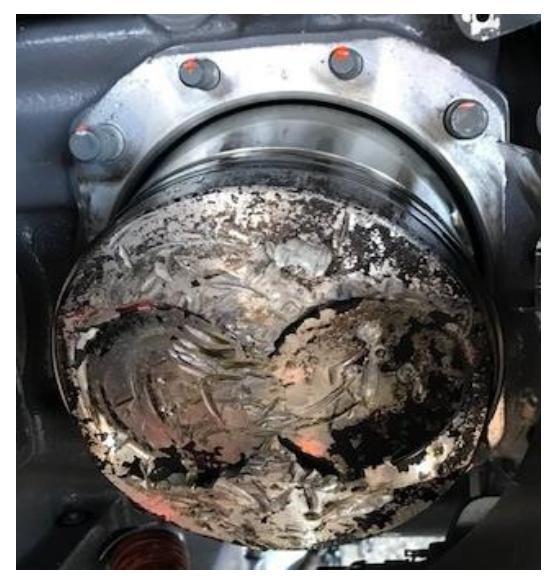
Figure 1
 Figure 2

Combustion Chamber and Piston Crown damage following Intake Valve Tip Failure

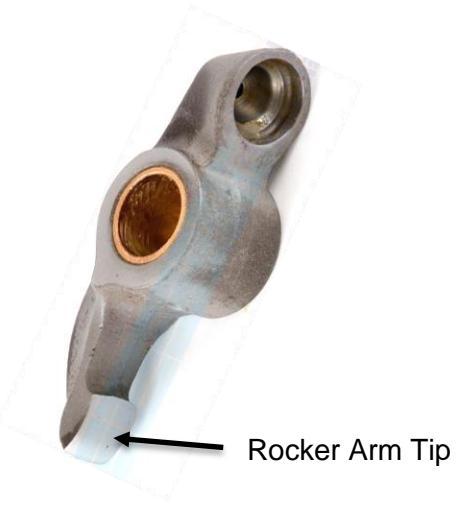
Figure 3 Rocker Arm Assembly (Typical)

In a recently reported intake valve failure, it was identified that the failure of a valve tip was most likely caused by the use of a rocker arm where the tip had been altered and no longer conformed to the approve tip geometry. Whilst the Lycoming overhaul manual does allow the replacement of worn rocker arm bushings, the manual is not inclusive of instructions for repairing / refacing rocker arm tips, (Figure 3). If refurbishment is attempted, it is extremely difficult to maintain the original geometry (radius and parallelism) as it relates to the valve tip/cap interface. A misalignment between matting surfaces can impose side-loads on the valve tip leading to an overload condition and valve tip fracture, (Figure 4).

- a) Tight rockers, when valves are closed can be an indication of valve regression or a damaged valve tappet. If valve rocker lifts excessively when the valve is closed this can be an indication of a bent push rod or collapsed plunger assembly.
- b) Replace rocker arms when mechanical refacing of the rocker arm tip (pad) is required or has been previously performed.
 If the geometry of the rocker arm tip (pad) is not correct, a greater part of the force created by the motion of the rocker arm will push the valve stem laterally as well as vertically. When this happens, the valve stem scrubs against the valve guide causing excessive wear in the guide. This wear will open up the valve guide leading to poor valve control.

Any refurbishment of the rocker arm tip (pad) can only be carried out in accordance with the applicable provisions of the approved maintenance data for the component.

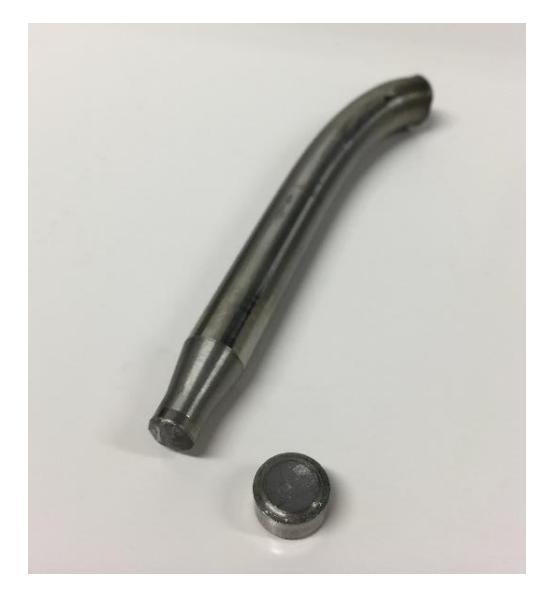
Figure 4 Valve Stem/Tip Fracture

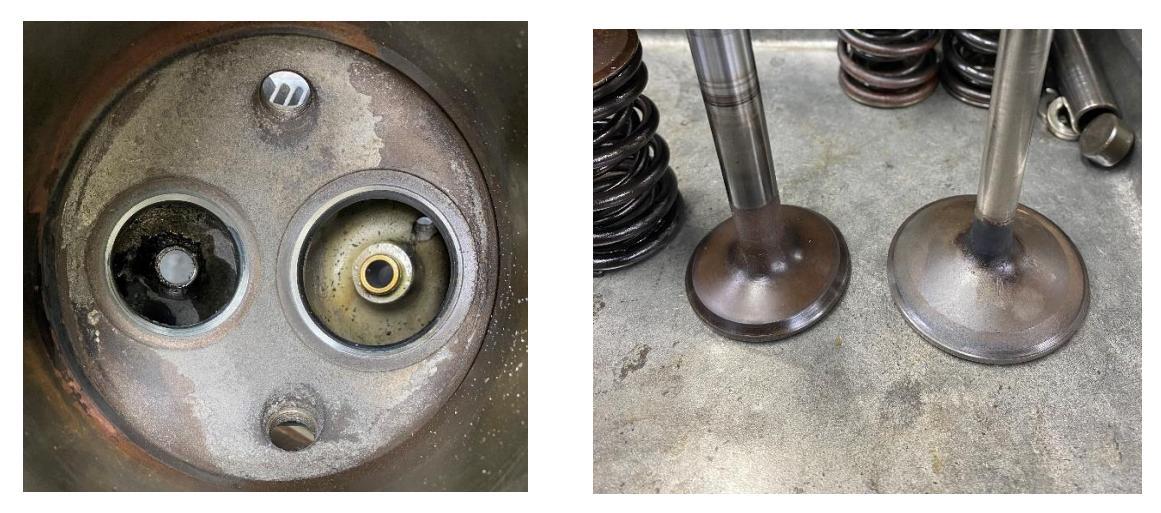
Figure 5

Further, if a dry tappet clearance check is performed indiscriminately, the required running clearance will not be obtained. An excessive dry tappet clearance will not fully open the corresponding valve leading to a noisy engine and some loss of power. A diminished dry tappet clearance will not allow the valve to fully seat, which can lead to a damaged / burned valve, (Figures 5 and 6). In either case, the engine will become rough and mechanical failure may be the end result.

Valve and Valve Seat Damage as a consequence of inadequate Dry Tappet Clearance

- a) Clearances can change in service however, the most common cause of a change of dry tappet clearance is the replacement or servicing of a cylinder, especially if that servicing involved any valve work.

- b) As a valve seat is ground to restore proper sealing the valve tends to move further into the cylinder head, thus closing-up the dry tappet clearance. If a valve is replaced, it would likely sit further out from the valve seat and thus open-up the dry tappet clearance. If a cylinder is replaced with a new cylinder assembly, the new valve is likely in a slightly different position in the cylinder head compared to the old one. The difference may only be a few thousandths of an inch, but it could be more. The only way to be sure is to check, which is why the dry tappet clearance should be measured and adjusted as necessary in accordance with the applicable Lycoming Maintenance or Overhaul Manual instructions as part of any cylinder service or replacement procedure.

c) If the clearance is not within the prescribed limit, insert a longer or shorter push rod to obtain the correct clearance. Refer to Lycoming SI 1060 or the applicable parts catalogue for applicable push rods.

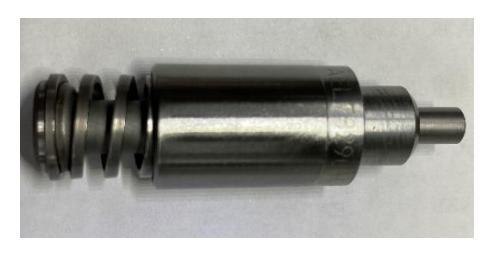
The failure of a valve can also be caused by a leaking / collapsed hydraulic tappet plunger assembly, (Figure 7).

Collapsed Hydraulic Tappet Plunger Assembly (Continental Aerospace P/No: AEL78290 - shown)

- a) During engine overhaul all plungers should be replaced regardless of their apparent condition, (Lycoming SB No. 240 refers). Prior to installation, examine all new plunger assemblies in accordance with Lycoming SI No.1011 to ensure correct operation.

- b) During scheduled maintenance or any other in-service repair that includes disassembly/reassembly of the valve train, examine the plunger assemblies before reinstallation, in accordance with Lycoming SI No. 1011. However, if valve train failure was identified, replace the hydraulic plunger with a new hydraulic plunger.

- c) Do not mix plunger assemblies with different part numbers in the same engine. The different leak down rates can cause incorrect engine operation. Mating parts are to be kept together, if there is any doubt as to whether the parts have become mixed, install new plunger assemblies.
