Good vibrations

Vibration-monitoring techniques for rotorcraft have become a vital diagnostic tool, reports Roger Alder.

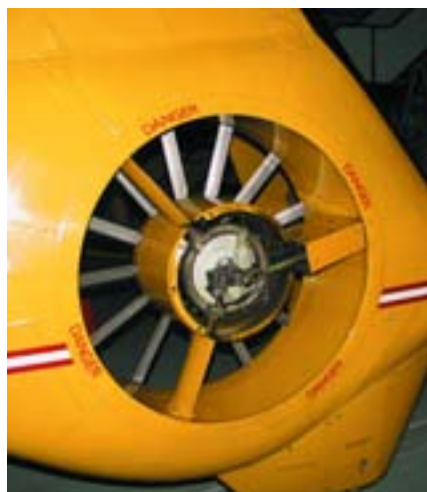
An SA 365 tail rotor gearbox installation under maintenance.
