To provide guidance to aircraft operators, owners and maintainers regarding the application and maintenance of flammable fluid-carrying aircraft flexible hoses.

Flexible Hose Assemblies - Maintenance
Practices

AWB 02-006 **Issue** : 2
Date : 8 May 2015

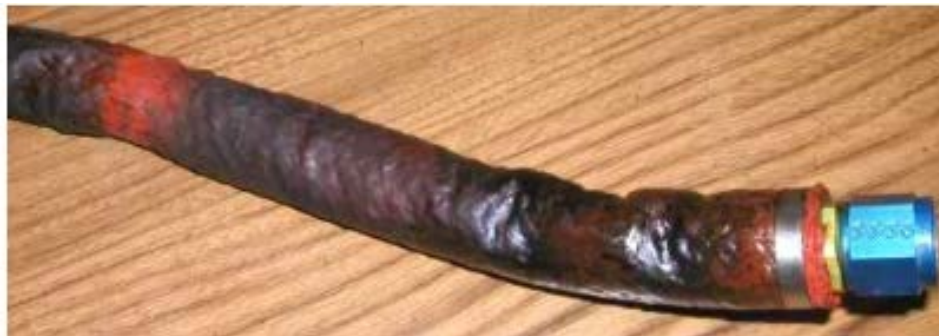
Figure 2. Contaminated fire sleeving

Trapped water could result in corrosion of the hose lay-up wires or braid. Oil or fuel contamination on the inside of the fire sleeve will result in serious deterioration of the fire resistant characteristics of the sleeving.

Any slip-on fire-sleeving, including any sleeving in addition to that specified by the aircraft or aircraft engine manufacturer, should be incorporated only in accordance with approved data including the applicable Technical Service Order (TSO). Fire sleeving must cover the end fitting as shown below. Be aware that slip-on fire sleeves can mask hose defects, and nicks and cuts in the fire sleeve. Unsealed hose sleeve ends can also admit and retain fuel, oil or moisture against the outer braid.

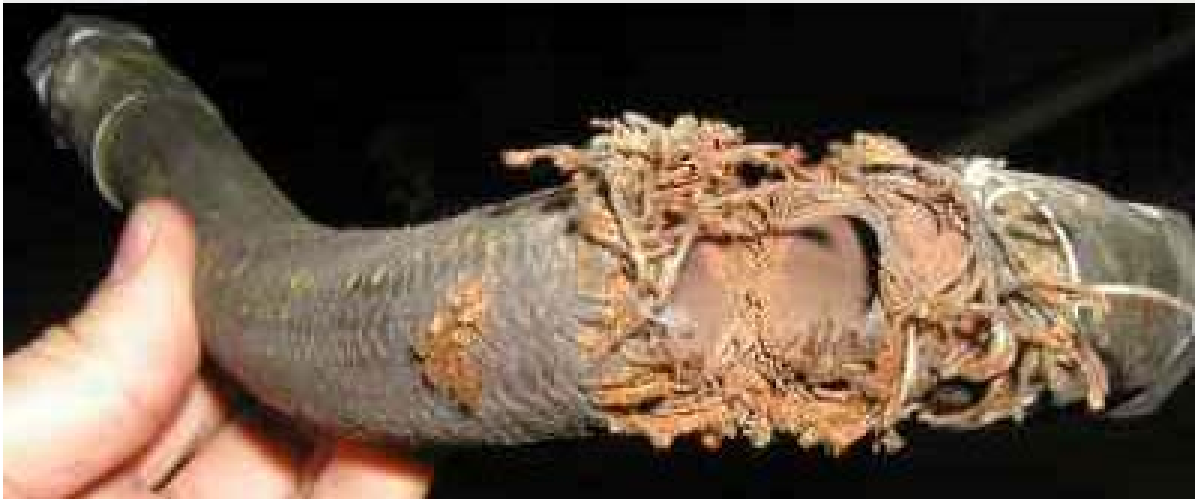
(a) Brittle

The typical piston engine oil hose consists of a rubber compound inner liner with a structural carbon steel braid covered with a grey woven fabric cover. Heat from the engine oil and the engine compartment will harden the rubber compound hose. Such a hose may appear to be serviceable and slight defects in the cover may not seem too serious (or be completely hidden under a fire sleeve) until the hose is flexed by hand.

Careful flexing of accessible sections of installed hose by hand to assess hardness or flexibility may well result in 'creaking' noises or a 'crackling' noise and feel. This immediately indicates that the hose rubber liner has failed, is unserviceable and should be removed before further flight. The discovery of a brittle hose before the planned replacement time may also indicate an incorrect type of hose for the application and should be investigated. The carbon steel wire braids in the hose pictured above have also been severely affected by corrosion.

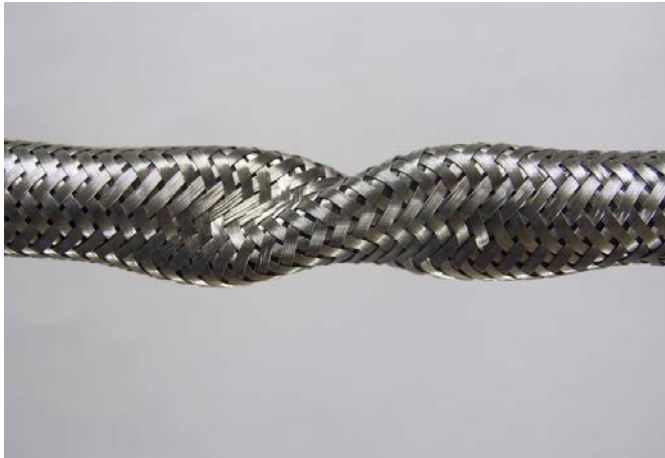
(b) Twisted

Typically caused by incorrect installation, where, during final torquing of the second union, the nut picks up on the back of the hose nipple fitting, and twists the hose.

Twists cause permanent damage to the structure of the hose, and if undetected, cause restricted flow, local 'hot spots' and rapid deterioration of the inner hose liner or pressure vessel.

A hose which has been kinked during installation, or found kinked or twisted during inspection should be replaced before further flight.

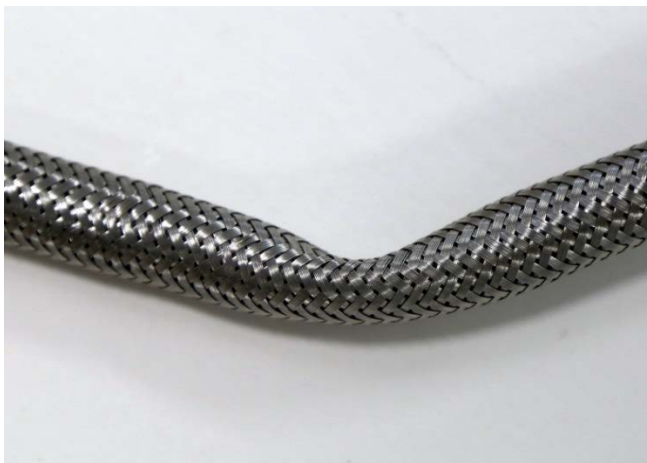
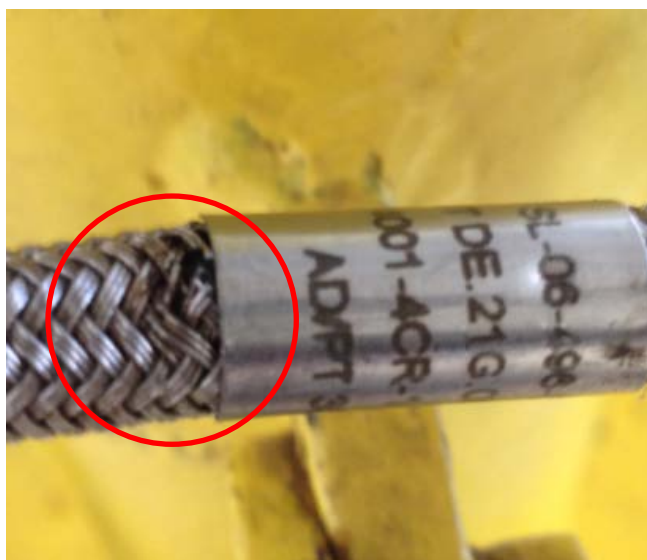
(c) Kinked

Typically caused by incorrect installation, attempting to bend the hose around a radius too small for the specified installation radius, or hose diameter. A new hose may initially resist kinking, but over time the hose wall may yield and collapse.

PTFE type hoses can fail after being kinked - even temporarily. During component removal and installation for example.

As with twists, kinks restrict flow and frequently result in local 'hot spots' and rapid deterioration of the inner hose liner or pressure vessel. These hoses should be replaced before further flight

Hose failure at or near the edge of the data tag can be an indicator that the hose was kinked at that point at some stage. ([FAA SAIB NE-06-67](#)).

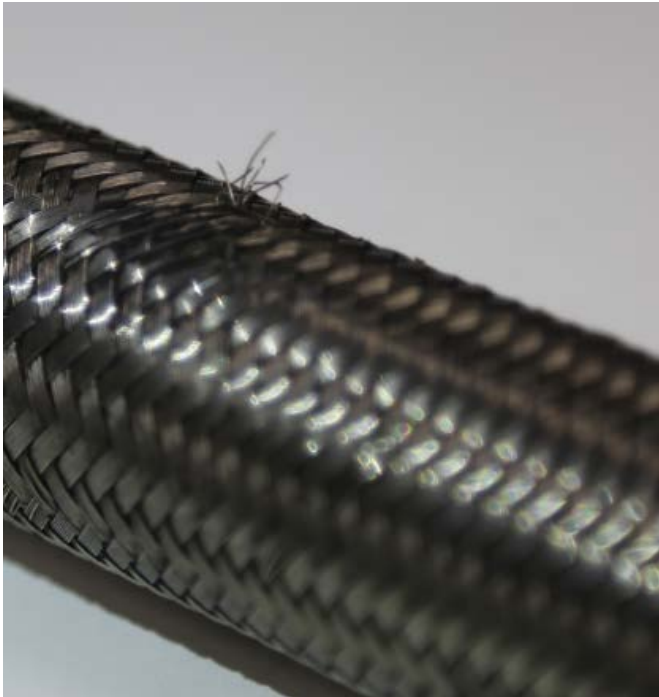
(d) Broken Braids

Braiding is part of the hose structure. Some aircraft and hose manufacturers do not allow any broken braid wires at all, while others permit isolated random breakage of a braid wire.

Hose and aircraft manufacturers seem to agree that if several wires are broken in any single concentrated area, or if two or more wires in a single braid are broken, it is considered cause for rejection.

Braid failures can be due to chafing and/or fatigue.

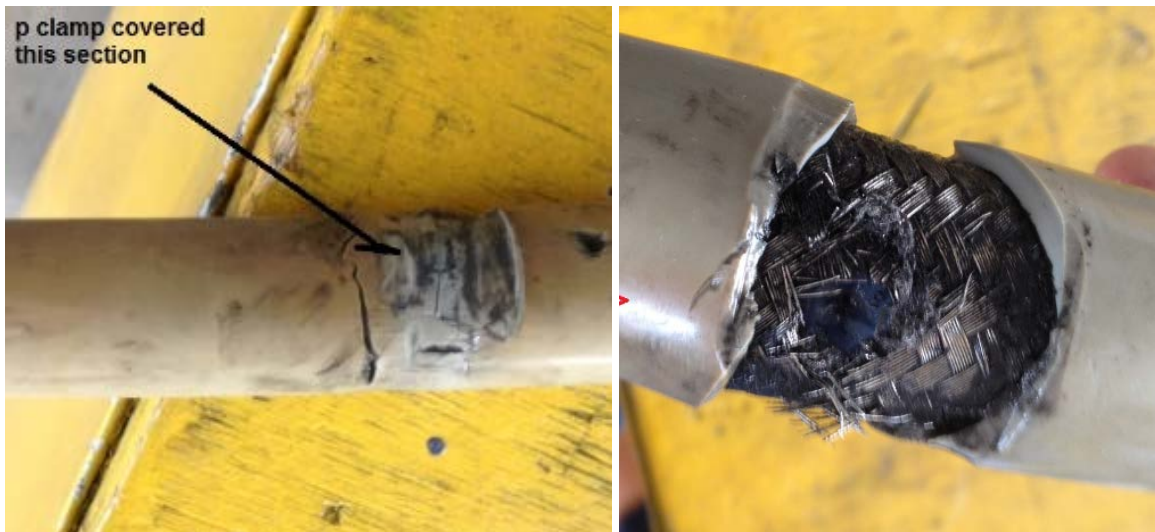
(e) Chafed

Hose in-flight failure and loss of system fluid due to the hose chafing and flexing under and adjacent to the 'P' clamp.

Chafing damage is usually a cause for rejecting the hose. Ensure the hose routing, clamping and securing scheme is in accordance with approved data.

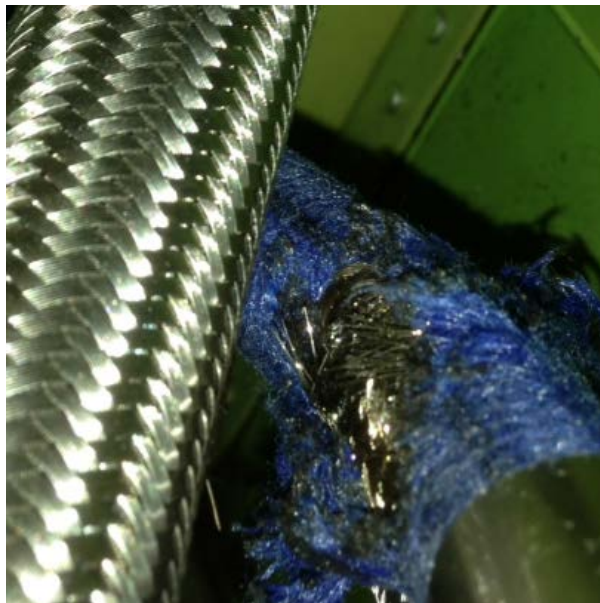
Even slight changes in the way the hose is installed between the clamps and subtle end fitting alignment, fitting angle changes during torquing and incorrect torquing procedures etc. can result in loss of clearance between the hose and the aircraft structure and/or other hoses.

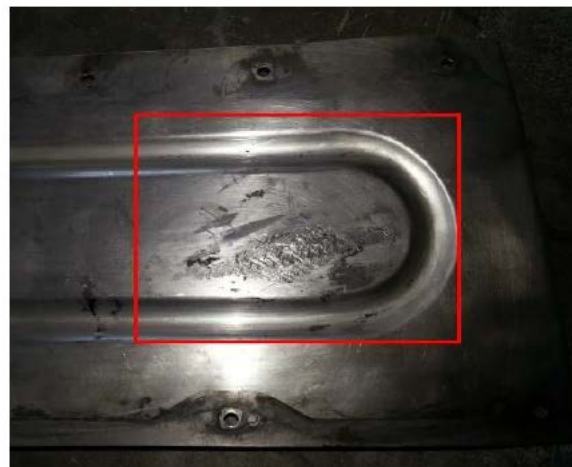
Hose (above) failed due to chafing against the structure (right).

Chafing is frequently difficult to detect before hose failure, because the contact areas are concealed and the aircraft maintenance instructions typically do not state how and where to check for hoses chafing.

Special hose chafing inspections are frequently issued via aircraft manufacturer's Service Bulletins and Service Letters. Chafing damage and failure often occur because the hose has been made too long (or too short).

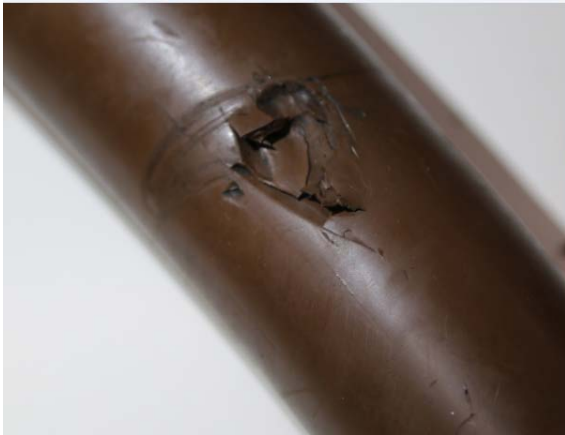
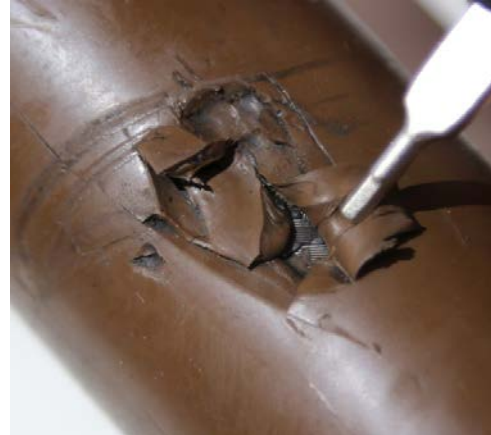
Chafed PTFE/Teflon hose (above) with integral silicone fire sleeve. Damaged sleeve flap folded back (right) to show extent of damage.

Such damage not only severely reduces the Type Design fire resistance requirement, it allows moisture and other fluids to penetrate the stainless steel hose braid under the covering. Stainless steel braid will corrode when exposed to contaminants and denied direct contact with atmospheric oxygen.

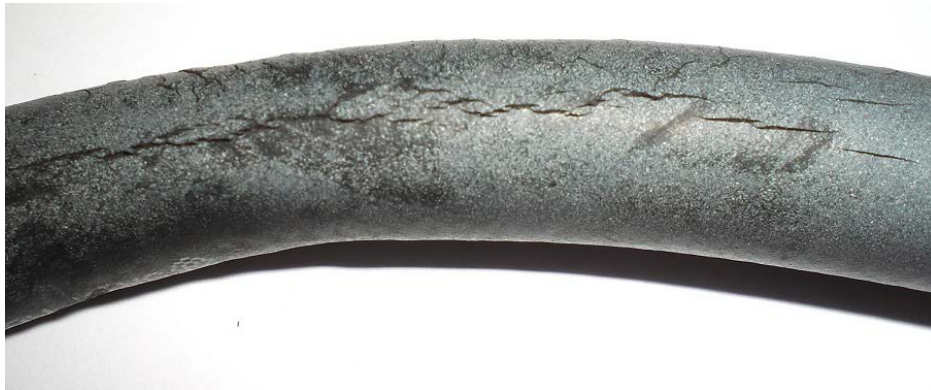
(g) Contaminated / crazed / cracked

Instances of airframe rubber push-on fuel hose hardening and crazing at significantly less than half the aircraft manufacturer's calendar life of 10 years have been reported. The hose (above) was hard and cracked only on the side which had been exposed to paint overspray during aircraft manufacture, some 4 years previously. The hose wall was still soft and pliable on the unexposed side in the same section.

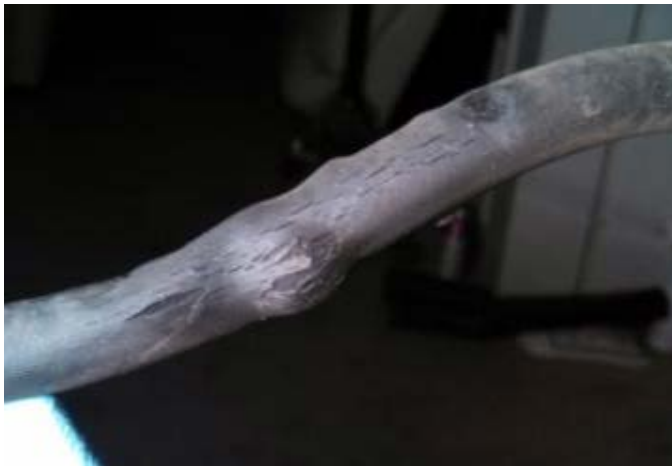
(j) Blistered / bulged

Blistered hoses may be the result of age, fluid incompatibility or internal layer separation. Check for any evidence of swelling or 'ballooning' along any length of the hose during testing or operation. Swelling indicates catastrophic structural failure of the hose braid and the hose should be rejected immediately.

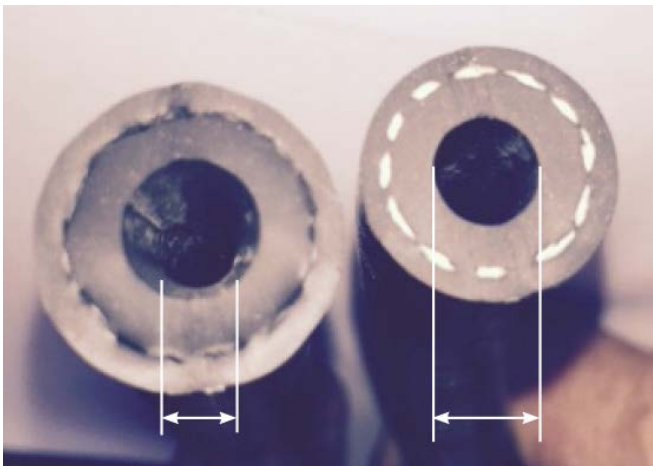
(k) Swelling / soft

Swollen / soft hoses usually indicate hose material is incompatible with the fluid the hose is carrying or exposed to. This example shows the result of MIL-H-6000 / MIL-DTL-6000 hose on the left after being soaked in Mogas overnight. The internal bore of the affected hose has reduced by approximately half of that of the same size MIL-DTL-6000 hose on the right. Avgas 100LL may have similar effects on certain rubber compound hoses.

When the Mogas is drained from the rubber hose and the fuel evaporates, the swelling will greatly reduce. However, because fuel leeches the plasticisers from the rubber, the hose will now become hard and brittle.
