Hawker Beechcraft 200 Series Wing
Attach Barrel Nuts.

AWB 57-012 **Issue :** 1
Date : 06 February 2013

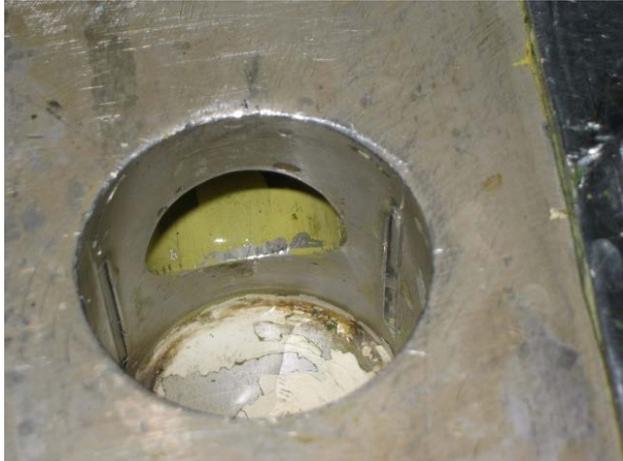
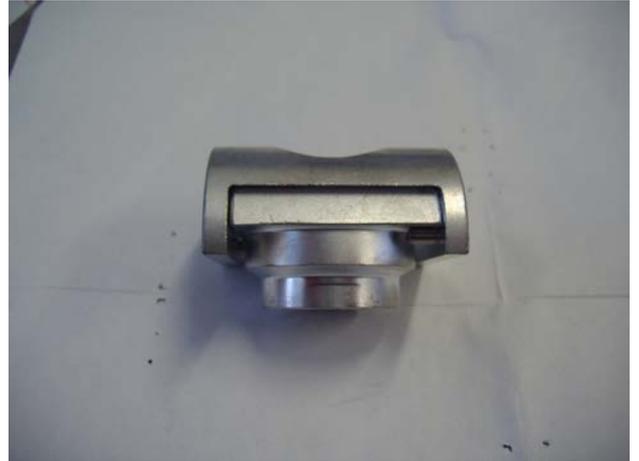
The wing attach barrel nut consists of the nut and cradle. It is possible to assemble the nut such that the bevelled area does not match the cradle contour. This protruded section when installed and tightened up in the nut bore scores the sides of the barrel nut hole.

That CAUTION be exercised when carrying out the wing attach barrel nut assembly and installation procedure as documented by Hawker Beechcraft in the SIRM.

Note: The wing attach barrel nut bore cannot be readily inspected to ensure that the wing attach barrel nuts have been correctly assembled once they have been installed in the wing.

Report any further occurrences of incorrect installation of barrel nuts assemblies and any resultant wing structure damage to CASA via SDR.
