1. Applicability

Single piston engine 200 series Cessna aircraft over 15 years since date of manufacture.

A recent incident on a Cessna 210N has prompted a reissue of this AWB to highlight the failure of Cessna 200 series Horizontal Stabilisers. There has been a number of Service Difficult Reports (SDR) regarding spar (and attachment) cracking on Cessna 210 aircraft horizontal stabilisers. Aircraft featured in the reports typically have a TTIS greater than 9,500 hours and covered a range of different 210 models.

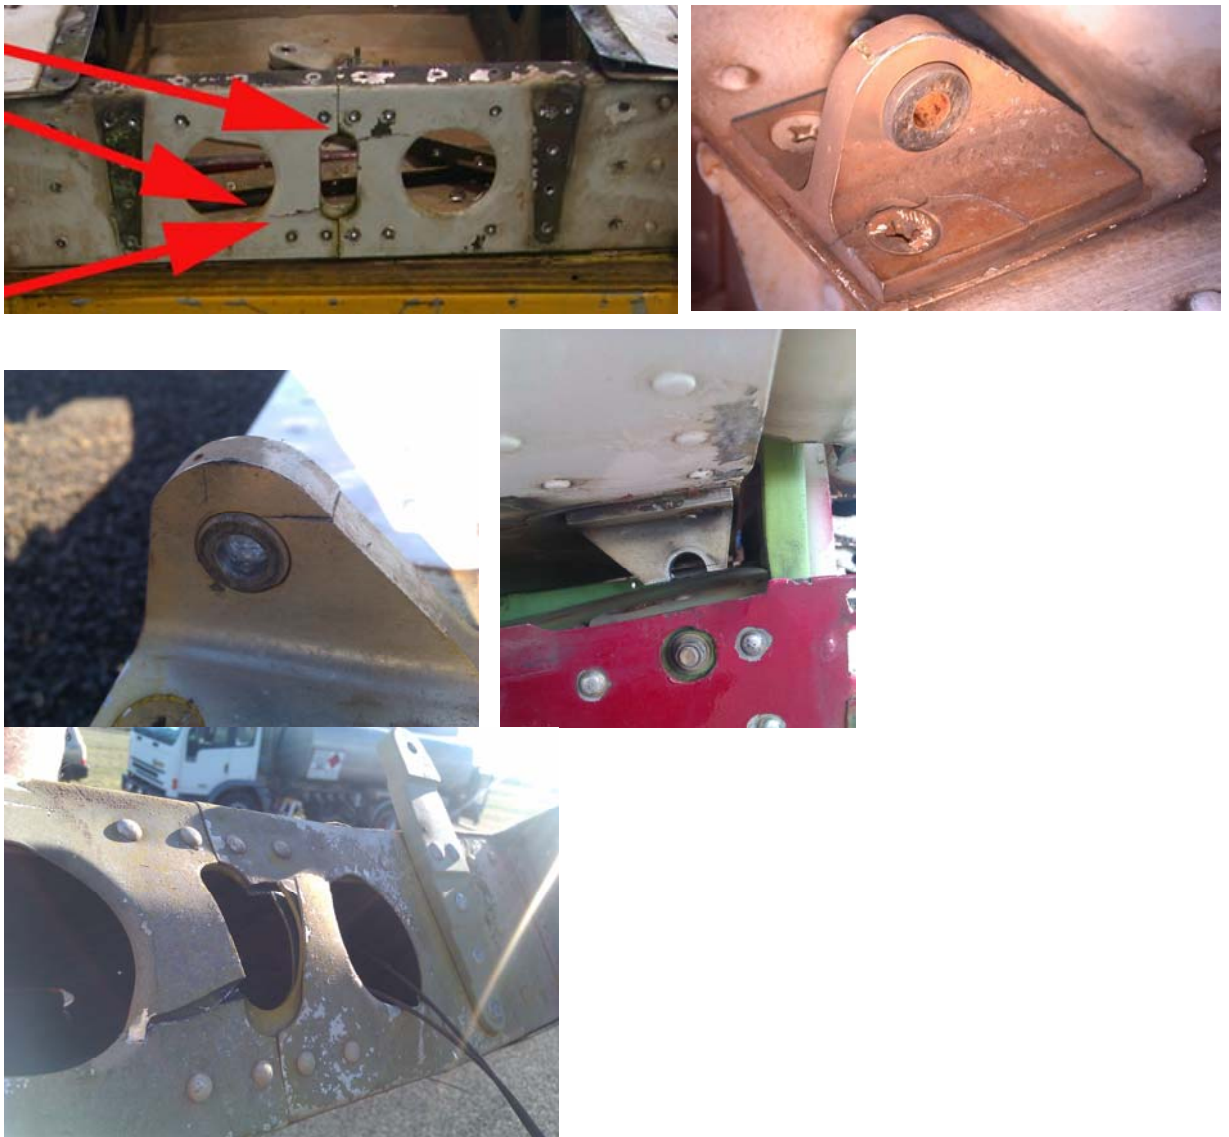
Figure 1 - Examples of cracking

All Cessna 210 Owner Operators review their maintenance schedule to ensure that all manufacturers data is incorporated either in the maintenance schedule or the Log Book Statement.

Maintenance personnel should pay particular attention while inspecting this critical structural area. Some disassembly is required to satisfy the LAME of the integrity of the structure. However, further disassembly should only be attempted if the workshop has the appropriate tooling, jigs and expertise to undertake the task.
