Hot Air Balloon Load Frame and Burner
Bracket Cracking

AWB 14-004 **Issue :** 1
Date : 30 November 2012

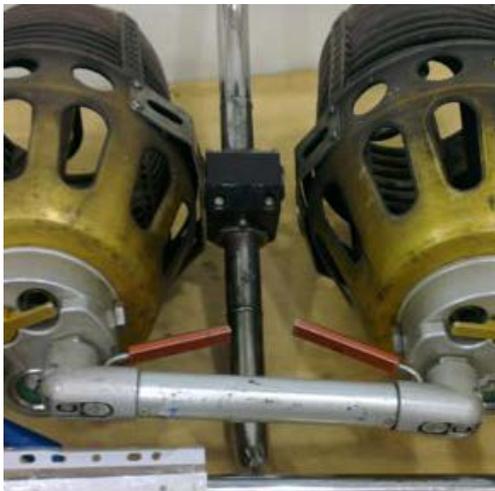
Cracking compromises the structural strength and integrity of structural members, potentially leading to failure. These conditions have led to instances where burner units have become dislodged on Australian registered balloons (see Figures 1 – 3). Such failures can cause catastrophic damage to the balloon and/or occupants should the burner(s) be in use.

Figure 1: Double Stratus burner unit. Note dislodged burner on the right.

1. Undertake daily pre-flight inspections for any cracks or breakages in the frame, brackets and burner-attach points.
2. Monitor the frame, brackets and burner-attach points for any uncharacteristic structural movement or distortion. This may indicate the presence of a crack in the structure;

3. Inspect gimbal/frame assemblies during each 100-hourly scheduled maintenance or as per the manufacturer's maintenance schedule, being particularly vigilant for cracking or welding defects;

4. Repair any brackets found cracked with the manufacturer's approved repair scheme, or replace with a serviceable approved bracket assembly;
5. Review operator ground handling and transportation procedures and ensure they comply with manufacturer's instructions;

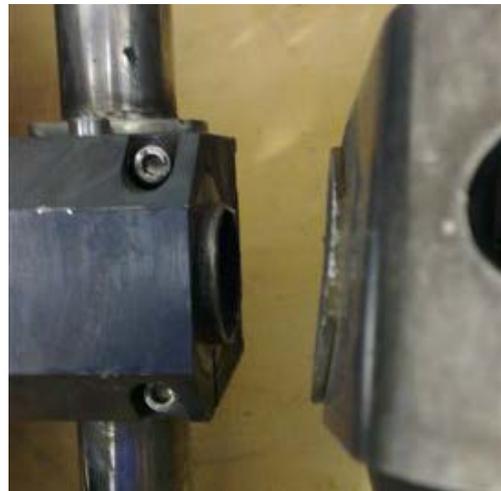
Figure 2: Close-up of weld-failure

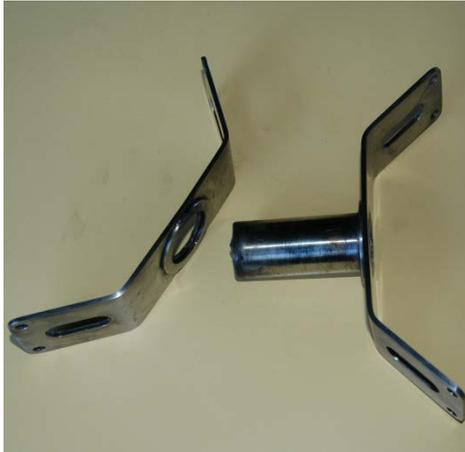
Balloon manufacturers advise that the leading cause of structural cracking in load frames and burner brackets is attributed to ground handling and transportation techniques. The vibration and impact-loads induced by ground handling are more severe than normal flight loads. Some ground handling practises that are not in line with manufacturer instructions or advice has led to greater instances of cracking.

Figure 3: Failed burner gimbal mount
