Aircraft fitted with B/E Aerospace 119003-11 Protective Breathing Equipment (PBE) also known as smoke hoods.

AIRWORTHINESS BULLETIN

Personal Breathing Equipment - Fires

AWB 35-005 Issue : 1
Date : 25 September 2015

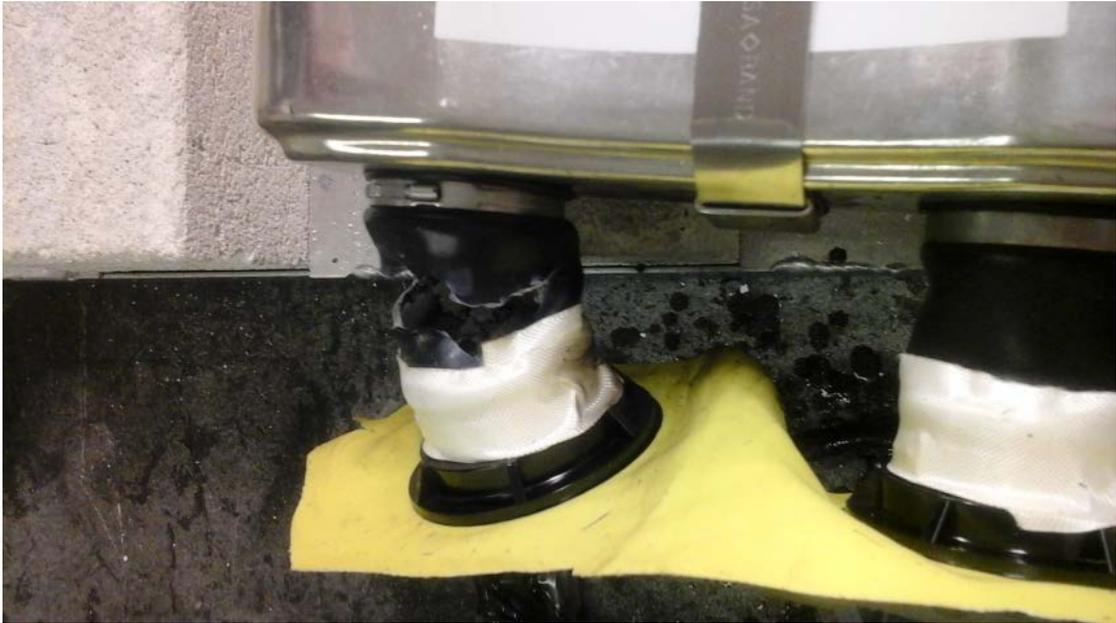
Figure 4 - Subsequent fire from outlet

The PBE was removed from service as it had lost its vacuum seal (inflated). The unit was stored in a clean, ventilated store cupboard until several units were collected and discharged as a batch.

During the disposal process, the PBE was removed from the vacuum bag for disposal; it was actuated and then placed in a mesh cooling bin. A loud explosion was heard when the activation pin was released followed by fire from the outlet side of the canister. A fire emanated from the outlet side of the canister see Figure 4, burning the rubber duct and into the plastic tubing leading to the mask see Figure 5. The rubber duct and mask plastic tubing burnt before the fire self-extinguished after approximately 30 seconds. The unit was completely extinguished with water.

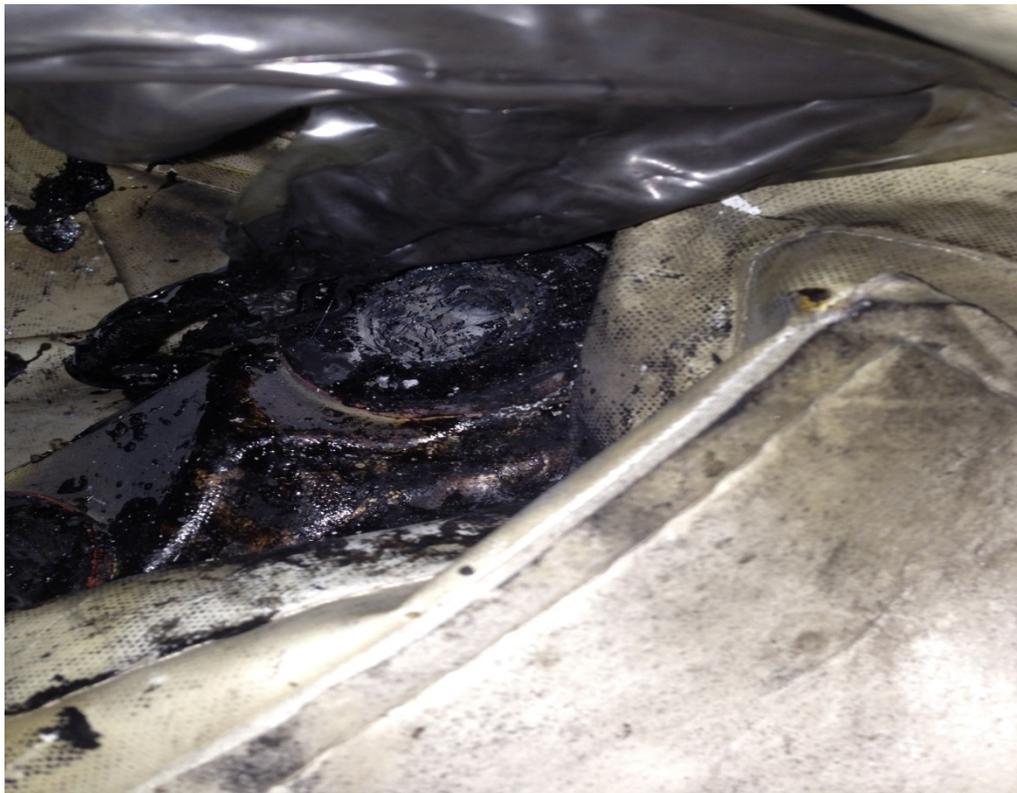
Figure 9 – Soot from exploded canister

PBE was removed from the aircraft for use as a training aid see Figure 10. The PBE was in date and considered serviceable. When the PBE was activated, the canister exploded Figure 9 and it caught fire, burning the scalp of the operator.

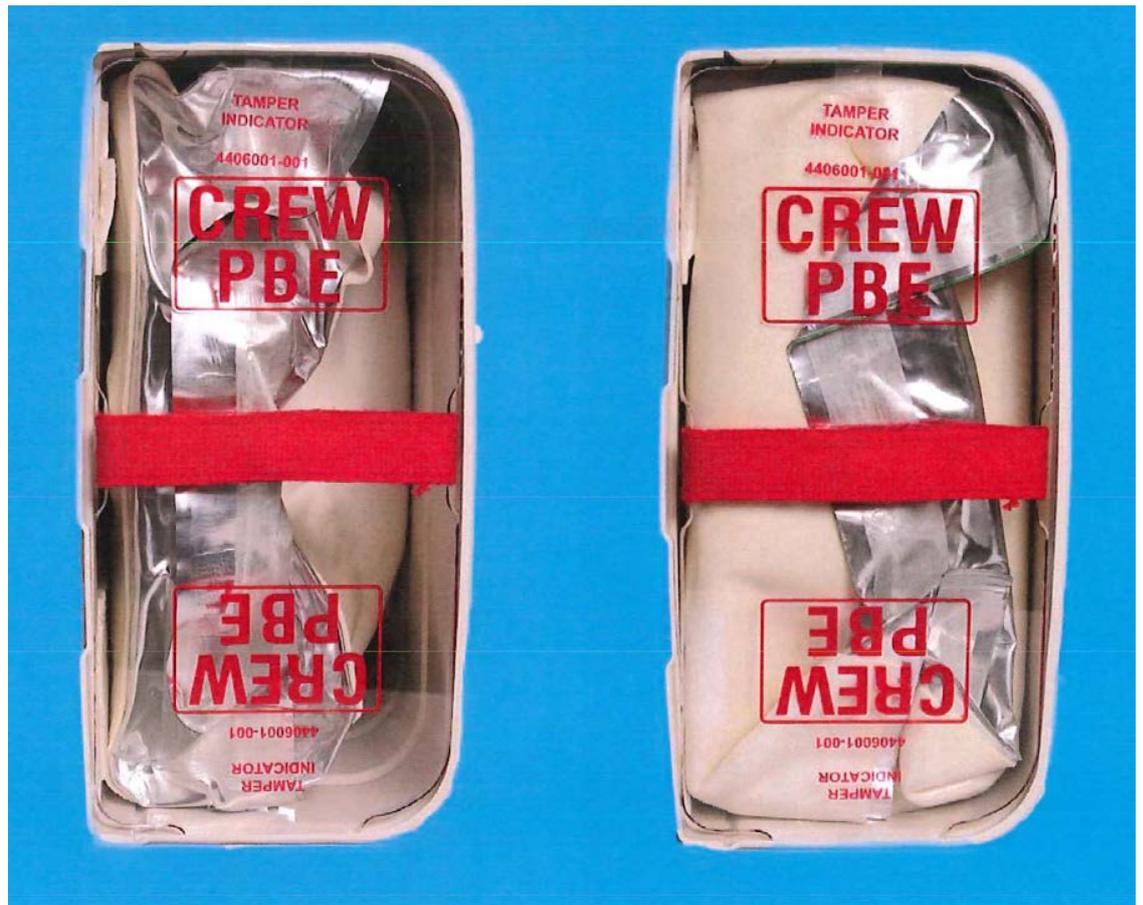
Figure 12 - Condition of pouch

- Replace any PBE units with damaged vacuum seals with serviceable units as moisture can get inside the canister from humidity in the cabin or from aircraft disinsectant chemicals – organic solvents are typically easy to ignite. The seal should feel tightly contracted around the folded PBE contained within the pouch and should not exhibit looseness or bloating. If any amount of compression or spingback is evident, the seal is considered compromised see Figure 12.

Condensed Pouch Indicates Intact Seal

Inflated Pouch Indicates Compromised Seal
