Airworthiness Bulletin

AWB 02-052 Issue 6 - 14 July 2021

Wasp Nest Infestation - Alert

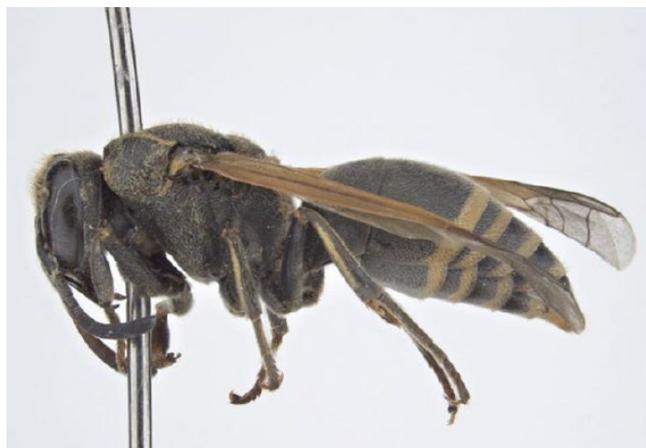
CASA had been notified of the Key Hole wasp hazard (*Pachodynerus nasidens*), by the Department of Agriculture and Water Resources (DoAWR). This species of wasp has been monitored by the National Biosecurity Consultative Committee (NMBCC). This wasp was first identified in Brisbane in 2010. DoAWR advised CASA that these wasps are not as aggressive as paper wasps but would try to sting if they were physically removed.

Figure 1. *Pachodynerus nasidens* or Keyhole wasp
(Source; PaDIL Species Factsheet)

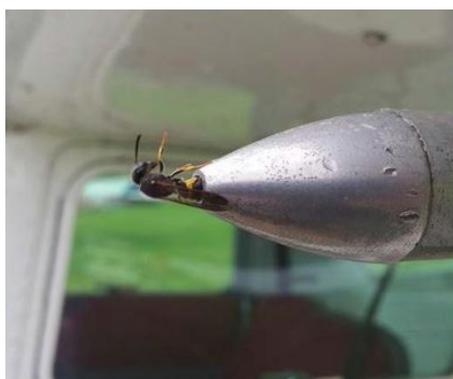
A wasp nest can completely block pitot tubes, fuel tank vents and drains.

Figure 3. Mud Dauber wasp emerging from an uncovered pitot tube.

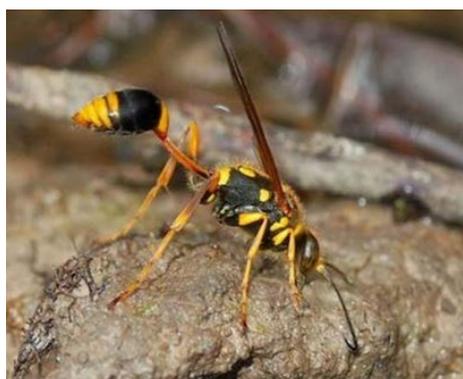
Figure 4. Australian Mud Dauber Wasp

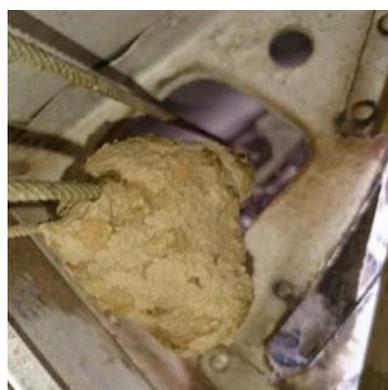
Figure 5.a.

Defect report investigation found several wasp nests inside the wing of a Cessna 182, in the cavity formed between the rear spar and the flap fairing (**Figure 5.a.**).

There was also one large wasp nest entirely suspended on the flight control cables in the rear fuselage.

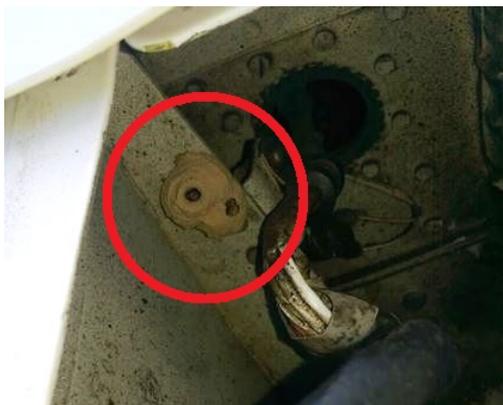
Figure 5.b.

During visual inspection on the left and right elevator actuator/hinge area, a small mud wasp nest was found on the left side adjacent to the actuator (Figure 5.b.).

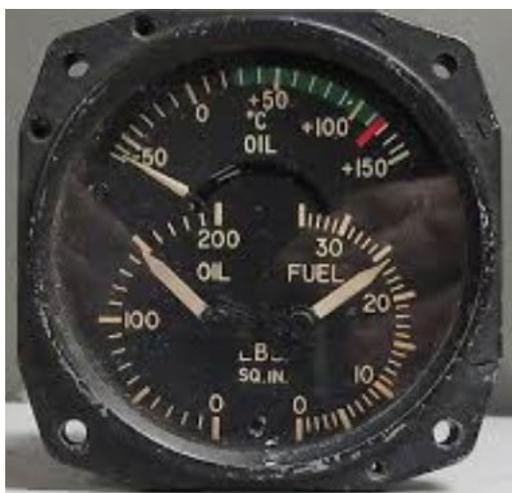
Figure 6.a.

Triplex fuel gauge in an Aerocommander 500s had a blockage in the external fuel vent line. The fuel pressure indication has a capsule which is ported overboard via this vent line. The vent line is common to both indications and because of the blockage both gauges indicated zero (Figure 6.a.).

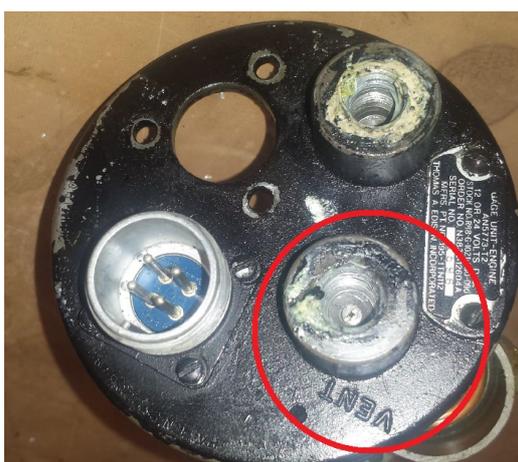
Figure 6.b.

Vent connection on rear of Triplex fuel gauge (Figure 6.b.)

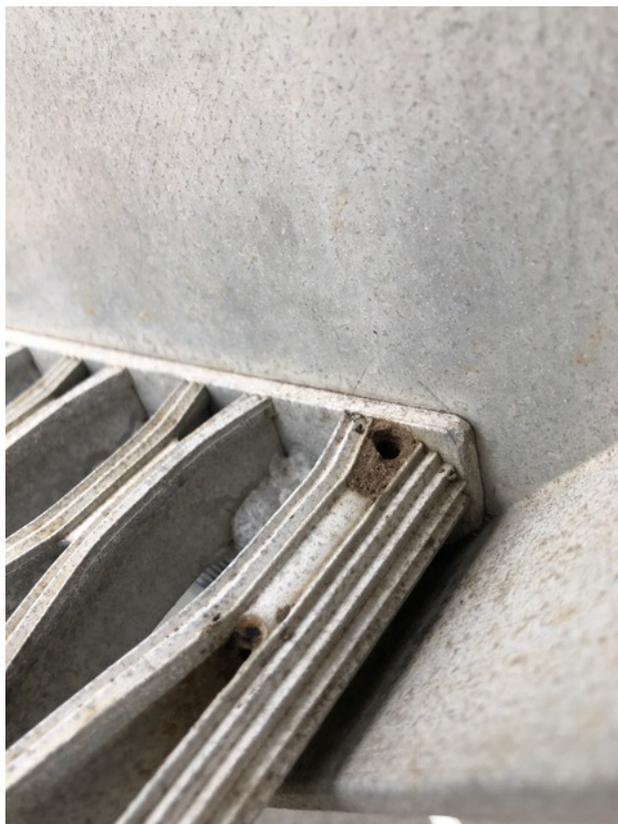
Figure 9. Wasp nest found in stairs

9. Check ground support equipment regularly. Grease has been temporarily used to block cavities such as roll pins. Wasp nest can exist behind or within structures.

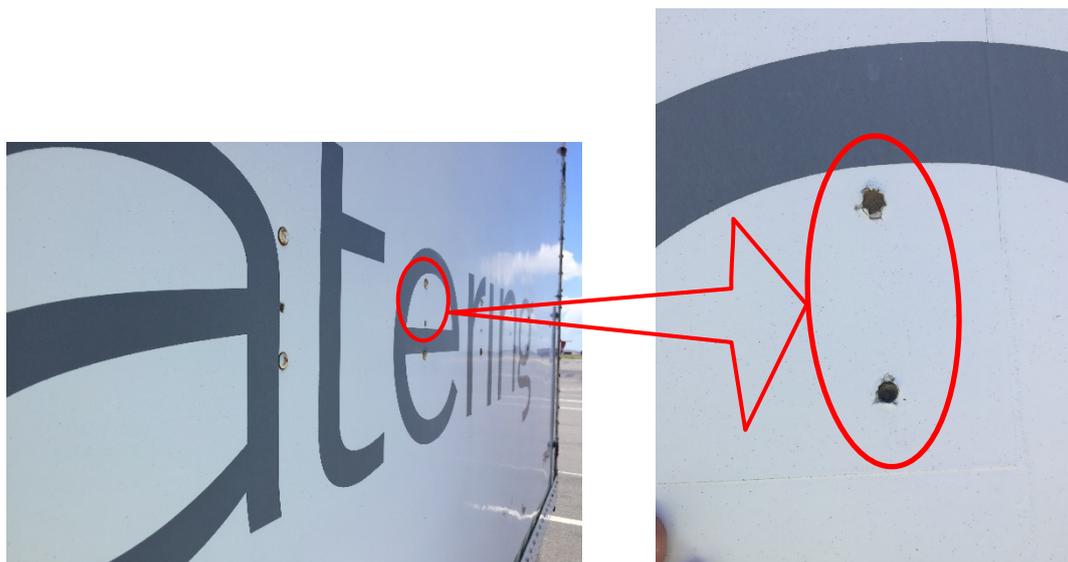
Figure 11. Wasp nest in catering truck panel holes

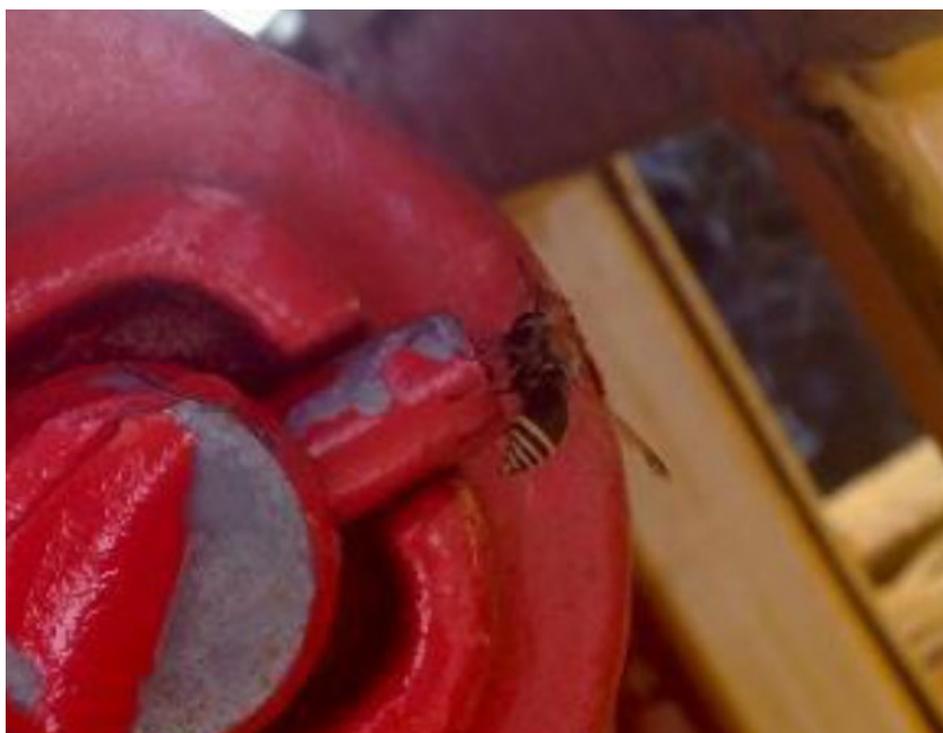
Figure 12. Keyhole Wasp on bay equipment

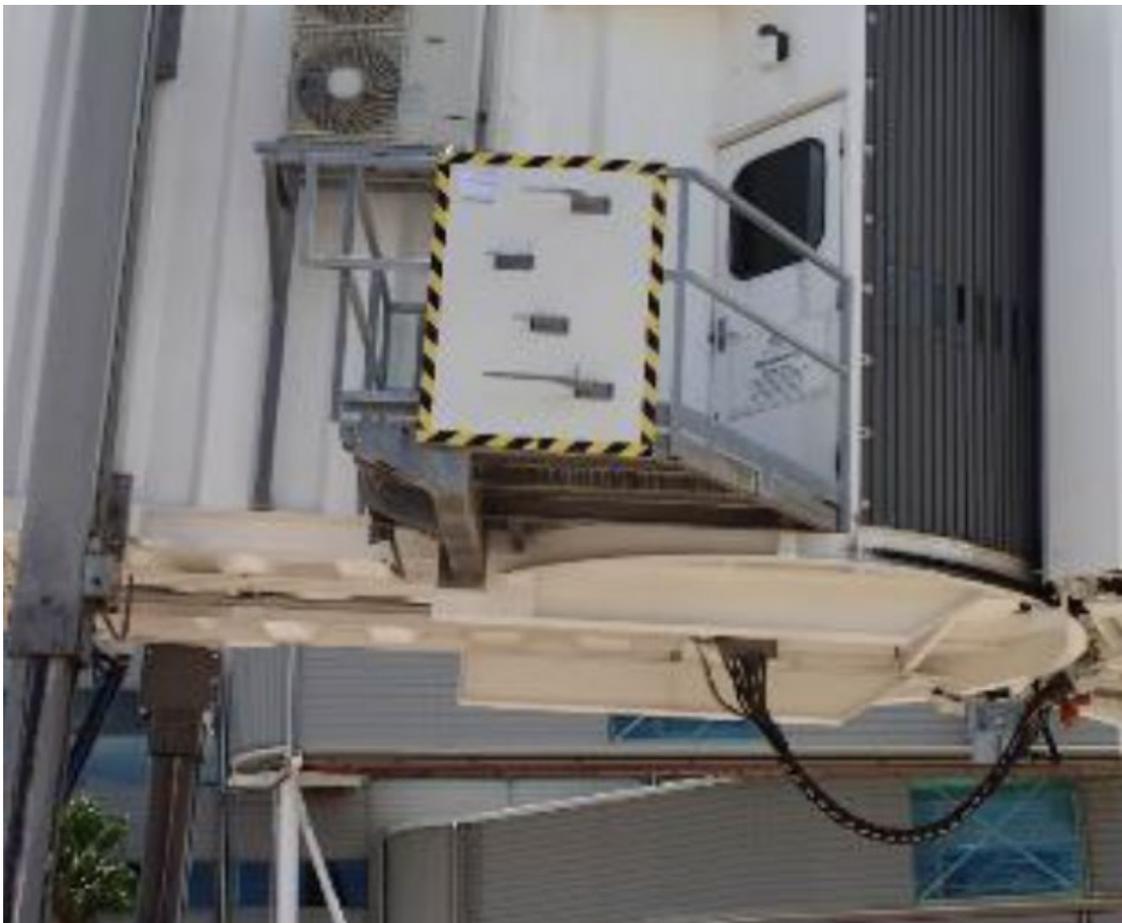
Simulation pitot probe panels have been installed at some areas at Brisbane airport to check for the presence of wasp nests, as part of the BAC sponsored study. The probes are regularly checked by Ecosure and/or BAC staff. The wasps are then sent to Queensland Museum for identification.

Figure 13. Simulation Pitot probe panels
