Preliminary Airspace Review Bathurst, NSW

February 2018

1 EXECUTIVE SUMMARY

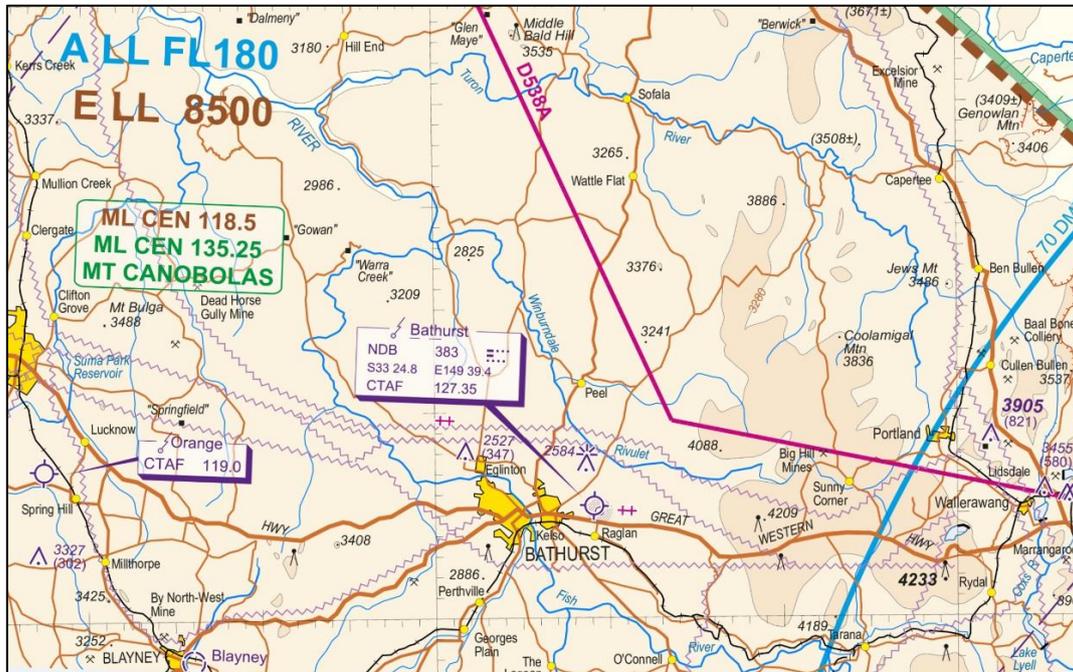
Figure 1: Extract of Newcastle Visual Navigation Chart (VNC) (Effective date 25 May 2017).

3.1.2 Bathurst is located within Class G airspace and is designated as an uncontrolled aerodrome where Common Traffic Advisory Frequency (CTAF) procedures apply. Class E airspace starts at 8,500 ft AMSL above the Bathurst aerodrome (see Figure 1).

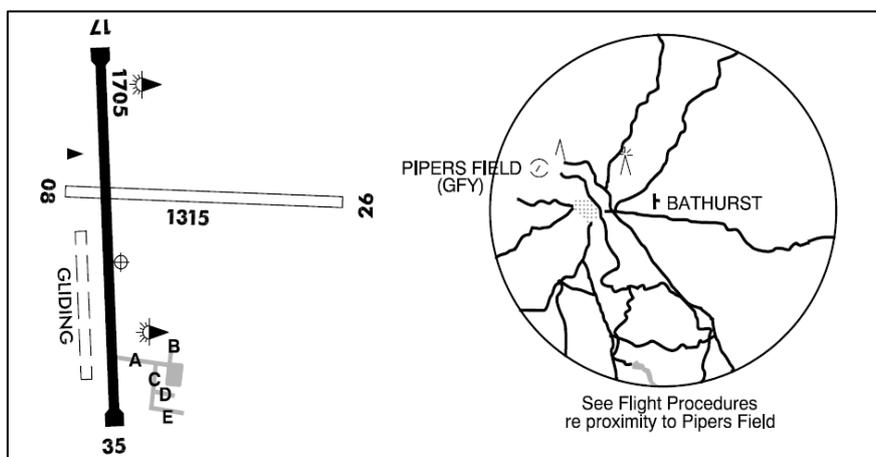
Figure 2: Extract of En Route Supplement Australia (ERSA) (Airservices: Effective date 25 May 2017).

3.2.1 Bathurst is a certified aerodrome located approximately four NM to the east of the city of Bathurst (see Figure 2). The aerodrome supports regional passenger transport operations currently Regional Express (REX), charter aircraft, general aviation, and recreational flying. Flying training is provided by WardAir and Central West Flying Training. The Bathurst Aero Club also operates from the airport. Gliding camps are conducted by the Australian Air Force Cadets, (AAFC) mainly during school holidays. The aerodrome is in close proximity to Pipers Field, which is a busy gliding field.
