Air Safety Investigations

A most dramatic runway incursion

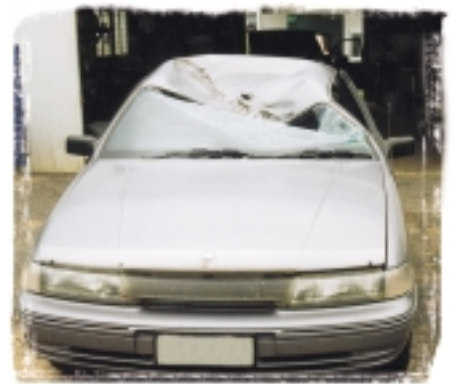
When the accident happened the pilot was fatigued, and because of the low sun angle, had not noticed the vehicle travelling south. The left main wheel collided with the front left corner of the car's cabin and ran across its roof before breaking off and coming to rest in an adjacent paddock. The pilot considered that the aircraft was operating normally so continued with the spraying operation and returned to home base for landing.
