# The Australian Air Safety

## Main landing gear door separation

Occurrence 200105518

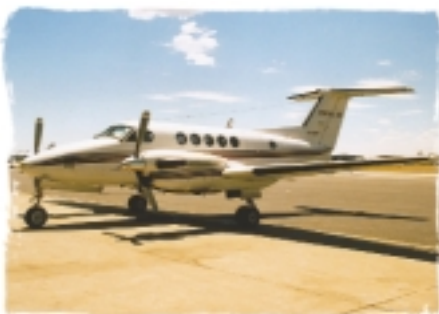
Occurrence: 200003771

For the first 12 minutes of the flight, the operation of the aircraft and the communications with the pilot appeared normal. However, shortly after the aircraft had climbed through its assigned altitude, the pilot's speech became significantly impaired and he appeared unable to respond to ATS instructions. Several open microphone transmissions over the next 10-minute period revealed the progressive deterioration of the pilot towards unconsciousness and the absence of any sounds of passenger activity in the aircraft. Five hours after taking off from Perth, the aircraft collided with the ground near Burketown, Queensland, and was destroyed. There were no survivors.

The investigation concluded that the incapacitation of the pilot and passengers was probably a result of hypobaric hypoxia due to the aircraft being fully or partially unpressurised and their not receiving supplemental oxygen. Due to the extensive damage to the aircraft the investigation could not determine the reason for the aircraft being unpressurised, or why the pilot and passengers did not receive supplemental oxygen. ■

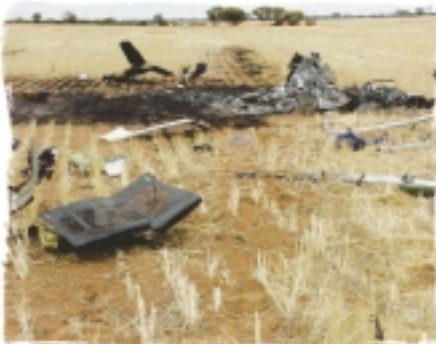
Occurrence: 200100252

The pilot of the Bell 206 helicopter had been tasked to conduct a powerline inspection for the local electricity power company, with two power company employees on board as observer and inspector. After inspecting an anomaly on a structure the pilot transitioned the helicopter from the hover to forward flight. The pilot and front seat observer received fatal injuries and the rear seat inspector received serious injuries in the crash that followed.

Neither power company employee had undergone any formal training from their employer or the operator to enable them to carry out their roles in helicopter powerline inspections as active crew members, despite there being a requirement to do so in the operator's operations manual.

The investigation found that the only published guidance and operating standard in Australia for helicopter powerline work, was the Electricity Supply Association of Australia Ltd (ESAA) document "Guidelines for use of helicopters for live line work", August 1995. Neither the power company sub-division or the helicopter operator involved with the accident was aware of this document. Consequently their procedures were inadequate for the task.
