CRACK ATTACK

It is two years since Ansett Australia's last flight. Mark Wolff and Martin Aubury report on the lessons learnt from the airline's collapse.

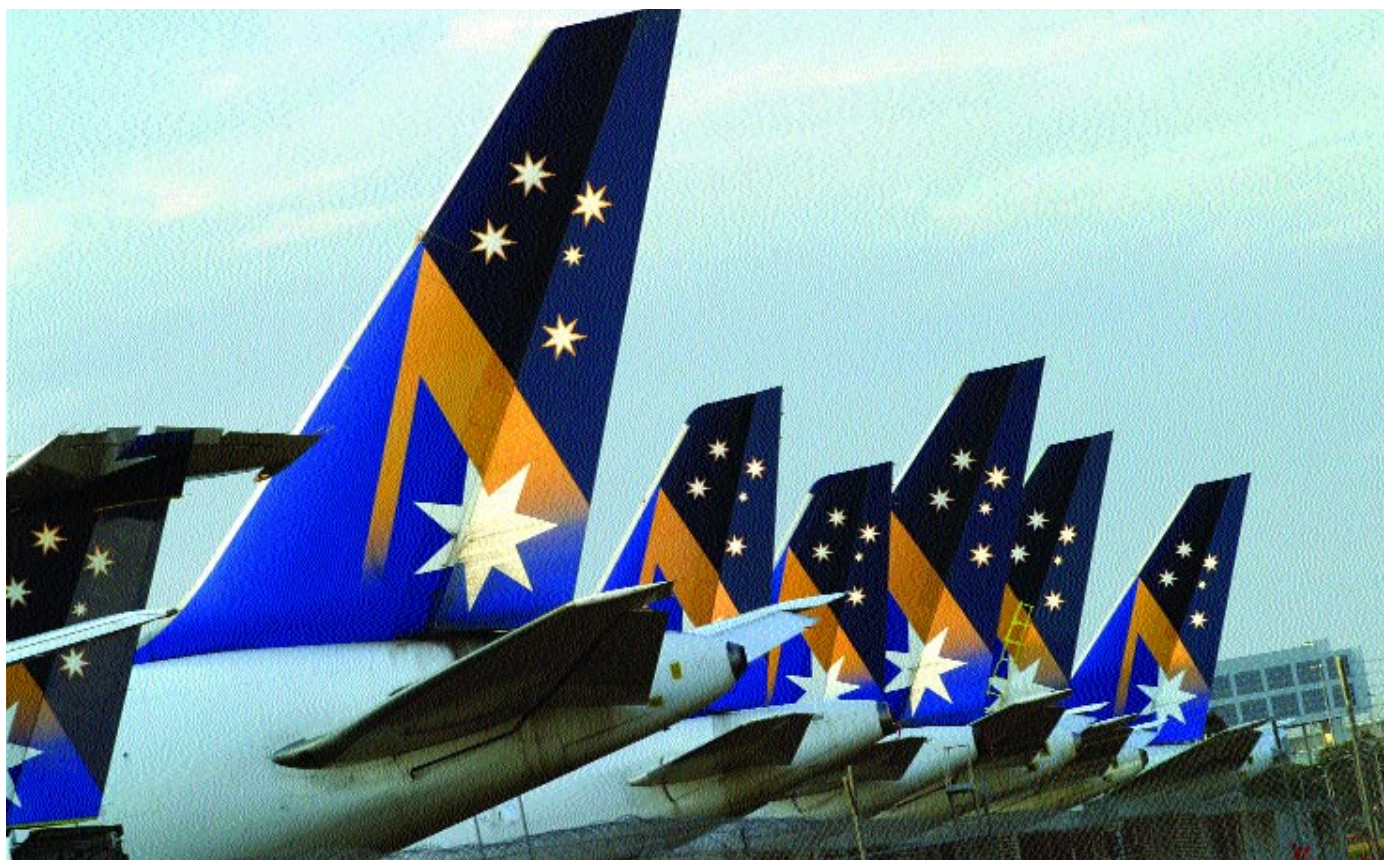
Grounded Ansett B767s parked at Tullamarine Airport, Melbourne.

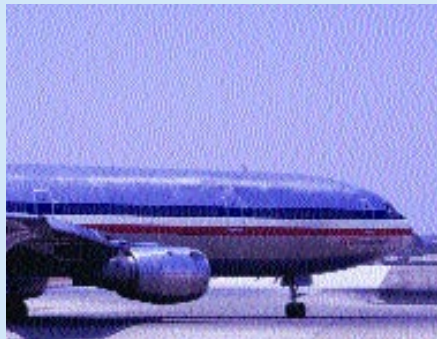
McDonnell Douglas DC-10, N110AA, Chicago, Illinois, USA

During take-off rotation the left engine and pylon assembly and about three feet of the leading edge of the left wing separated from the aircraft and fell to the runway. The aircraft collided with the ground. 271 people on board and two people on the ground died. Investigation revealed that damage by improper maintenance procedures resulted in an overload fracture and fatigue cracking of the pylon aft bulkhead upper flange.
