Australian Transport Safety Bureau

The Australian Air

Crash after takeoff at El Questro, Western Australia

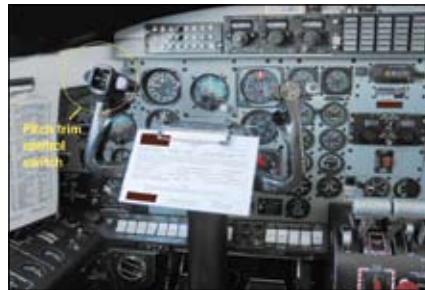
Occurrence 200400998

On Monday, 22 March 2004, the pilot in command of the Fairchild Industries SA-227 aircraft, registered VH-HPE, operating a scheduled Regular Public Transport flight, reported that excessive force was required to maintain the nose of the aircraft down during departure from Sydney Airport. The trim selector was switched to the 'copilot' position and control was passed to the copilot, who was then able to trim the aircraft, and the flight continued to Taree, NSW. After landing, an examination by the crew revealed that the pilot in command's (left side) control yoke pitch trim switch was operating in the reverse sense from normal operation.

A subsequent engineering examination revealed that the pilot in command's pitch trim switch had been installed upside-down during maintenance to replace the left side control column pivot bearings.

The maintenance contractor and the aircraft operator conducted separate investigations into the trim switch misalignment and concluded that the only plausible scenario leading to the misalignment was that the engineers responsible for the pitch trim switch installation had installed the switch incorrectly. The discrepancy had not been detected during the installation and duplicate functional checks or the flight crew's pre-flight checks.

A number of procedural changes were made by the aircraft operator and the maintenance contractor to prevent a recurrence. ■
