# AIRWORTHINESS BULLETIN

AWB 25-034 Issue 2 – 24 April 2020

Helicopter Rescue Hoist Wire Rope – Wear, Fatigue and Failure

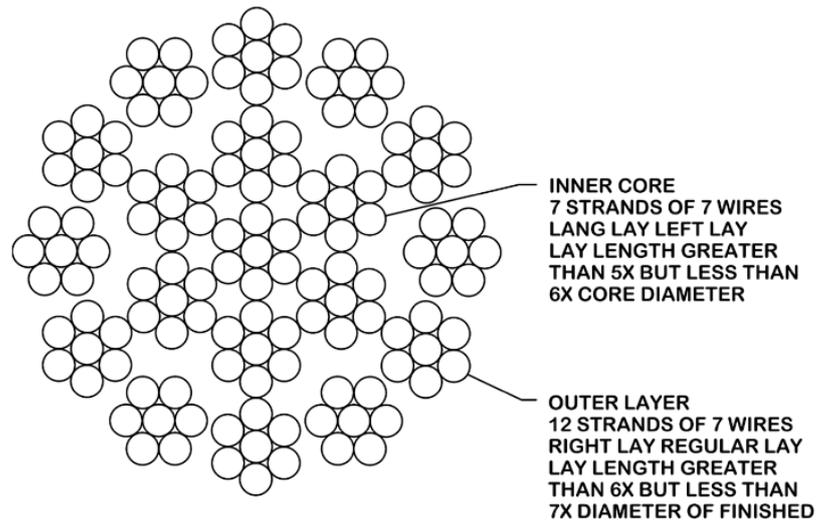
Figure 4. Type 1, Wire Rope Construction

The failed cable is an aviation winch grade Type 1, 19 x 7 configured cable. Made from austenitic stainless steel (MIL-DTL-83140), each strand contains 7 wires. The strands are then spun into inner and outer wire ropes. The inner wire rope contains 7(strands) x 7(wires), covered by an outer rope of 12(strands) x 7(wires). See Figure 4.
