# Airworthiness Bulletin

## AWB 31-009 Issue 2 - 14 July 2021

### Horizontal Situation Indicator - Premature timing belt failure

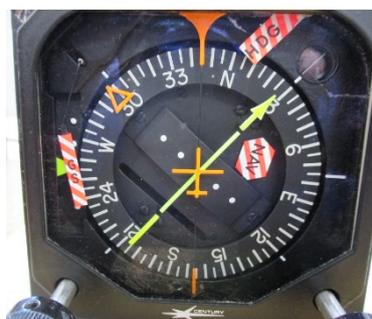
CASA has received reports from various approved maintenance organisations that drive belts fitted to HSI model NSD360 (see Figure 1) are failing prematurely in service.

Figure 1 - HSI model NSD360

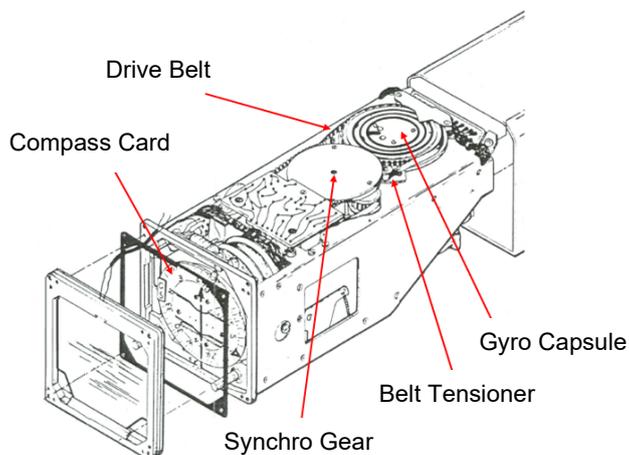
The drive belt drives the compass card on the HSI through 360° of rotation in conjunction with the drive gear motor assembly see Figure 2.

**Figure 2 - HSI drive belt related components**

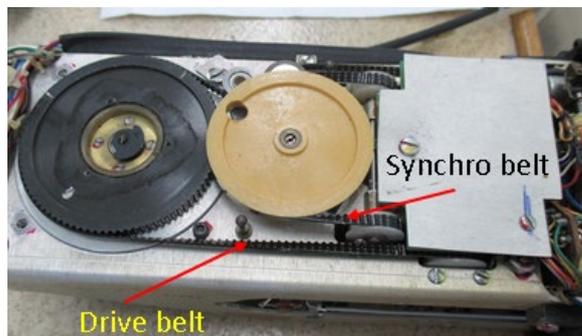
The gyro drive belt is connected to the gyro assembly via a toothed gear that is mounted on top of the gyro capsule/casing see Figure 3.

**Figure 3 - Gyro and motor assembly gear**

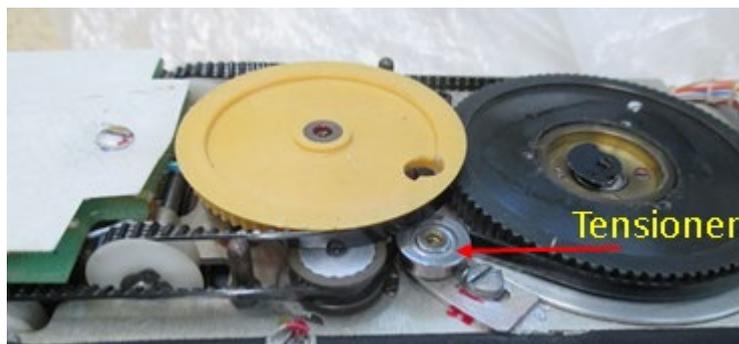
The belt is then tensioned (see Figure 4) around the motor assembly gear and tensioned to medium tension with the belt tensioner bearing and bracket. The belt is held under tension at all times both in operation and in static/standby mode.

**Figure 4 - Belt tensioner**
