This Airworthiness Bulletin (AWB) is a compilation of information contained in Airworthiness Advisory Circulars (AAC), Service Bulletins (SB), Service Difficulty Reports (SDR) and Advisory Circulars (AC) and will be revised from time to time to incorporate new magneto defects.

## Magneto Defects

AWB 74-005 Issue : 3  
Date : 20 October 2014

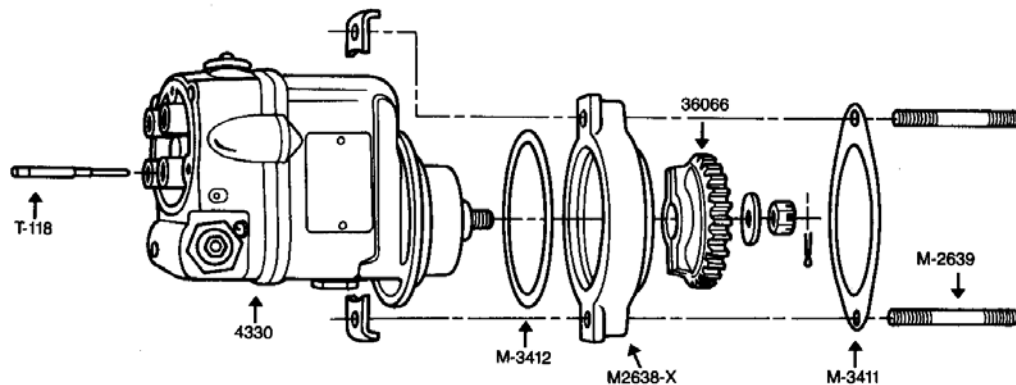
Figure 14 - Extract from SL1-93

"Transport Canada (TC) has recently been informed of certain Piper and Mooney aircraft, powered by Lycoming engines, which had magnetos installed with incorrect gaskets. The magnetos were Bendix S-20 and S-200 series from Teledyne Continental Motors (TCM). The first report was a Piper PA23-250, powered by a Lycoming IO-540 engine, which had a magneto fall off in flight in the USA.

According to the A&P mechanic who repaired the aircraft, the failure was caused by the installation of an incorrect gasket which did not provide proper support for the mounting flange, causing the flange to fail. It is thought that the thickness of the gasket had a bearing on the failure. The aircraft's remaining magnetos were inspected and were also found to have incorrect gaskets installed and, although two of the magnetos were cracked, none had progressed to failure. This particular magneto application calls for the installation of two Lycoming gaskets (P/N 62224), one on each side of the adapter plate see Figure 14. The failed magneto on this aircraft had one P/N 62224 gasket between the adapter and the engine case, but had an LW 12681 gasket, and possibly a TCM P/N 534750 gasket, between the magneto and the adapter plate, which is incorrect.

The repair shop operator, who reported this problem to Transport Canada, has since found two aircraft with the same problem: a Mooney powered by a Lycoming O-360 engine, and a Piper PA24-250 powered by Lycoming O-540 engine. Although incorrect gasket installation was found, none of the magnetos had progressed to failure. None of these magnetos were installed by the engine manufacturer, but had been removed and reinstalled.

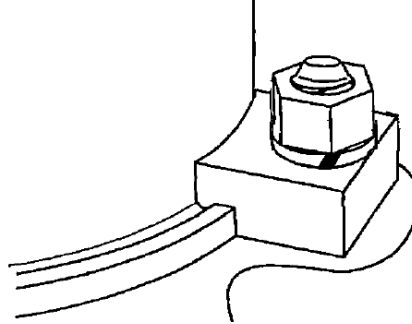
Figure 16 - Adapted from Slick SL3-92C

Over torqueing has also been attributed to distributor block cracks (SDR 510018733).

Example of over-torqued magneto gaskets has been reported to CASA. As a result the gaskets perished in service. Gaskets should not be re-used and the approved data documentation should be followed.

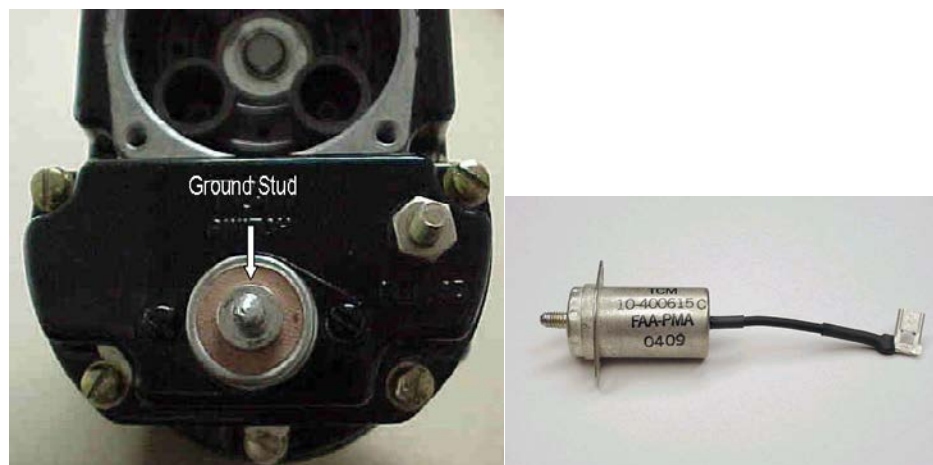
Figure 17 - Capacitor

Teledyne Continental Motors has identified a quantity of particular magneto capacitors which may have ground stud (also referred to as the P-Lead stud) threads that do not meet specification. This may allow the ground wire (P-Lead) to come loose, resulting in a hot (live) magneto. A list of affected magnetos and capacitors are listed in the service bulletin.
