# Airworthiness Bulletin

## AWB 63-004 Issue 4 – 5 March 2024

### Kamatics Corporation KAflex Drive Shafts – UH-1 and Bell 206/407/412

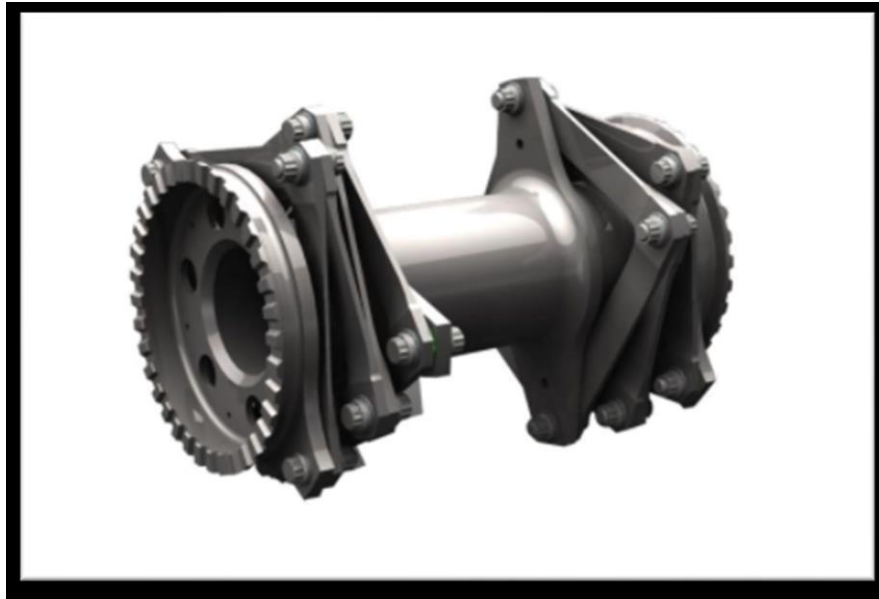
**Figure 1** - Kamatics Corporation KAflex drive shaft assembly

Specifically, CASA considers that the word “Condition” is inadequate to describe a proper check of the drive shaft flexure plates during the pre-flight check in the powerplant area and may result in the person checking the drive shaft missing vital indications that may affect continuing airworthiness of the drive shaft.

It is recommended that when conducting the pre-flight check to determine the "condition" of the KAflex main drive shaft flexures in the Bell 407 and UH-1 series, that the check includes the following:

Check general condition of the KAflex drive shaft;

- a. Visually check for broken, loose and missing flex frame connecting hardware (washers, nuts or bolts).
- b. Inspect flex frame and mount bolt torque stripes for evidence of slippage/misalignment that may indicate rotation / movement of the connecting nuts or bolts.
