AIRWORTHINESS BULLETIN

Cessna Single Engine Wing Flap Control
Switches and Actuators

AWB 02-046 **Issue :** 1
Date : 9 May 2013

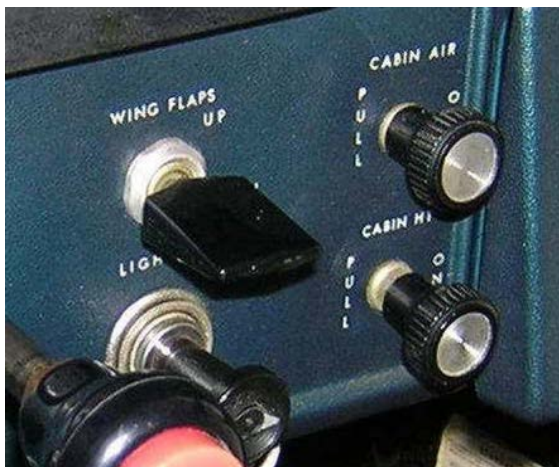
One version of the single engine Cessna electric flap system uses a simple flap position control switch which is internally spring-loaded to return to “off” when released from either the flaps “up” or flaps “down” selection. These switches have suffered internal failures including return-spring failure, resulting in the switch not returning to “off” or null position when released from the flaps “down” selection.

Should the flaps be selected DOWN and the spring-loaded “off” switch does not return to “off” or null when released from being held in the DOWN position, it is possible that the flap motor will continue to run to the end of its travel resulting in uncommanded full flap extension with possible reduction of control and / or climb performance.

Replace cabin flap control switches as required by the manufacturer. Consider replacing the spring loaded centre “off” flap control switches which have accumulated 20,000 operations or cycles or more.
